# Notice of Application for a Planning Permit

| The application is for a permit to: | Use and Development of the Land for a Dwelling and Alteration of Access to a Road in a Transport Zone 2 |

## LAND CAPABILITY ASSESSMENT REPORT

**1000 Pakenham Road  
Pakenham Upper VIC**

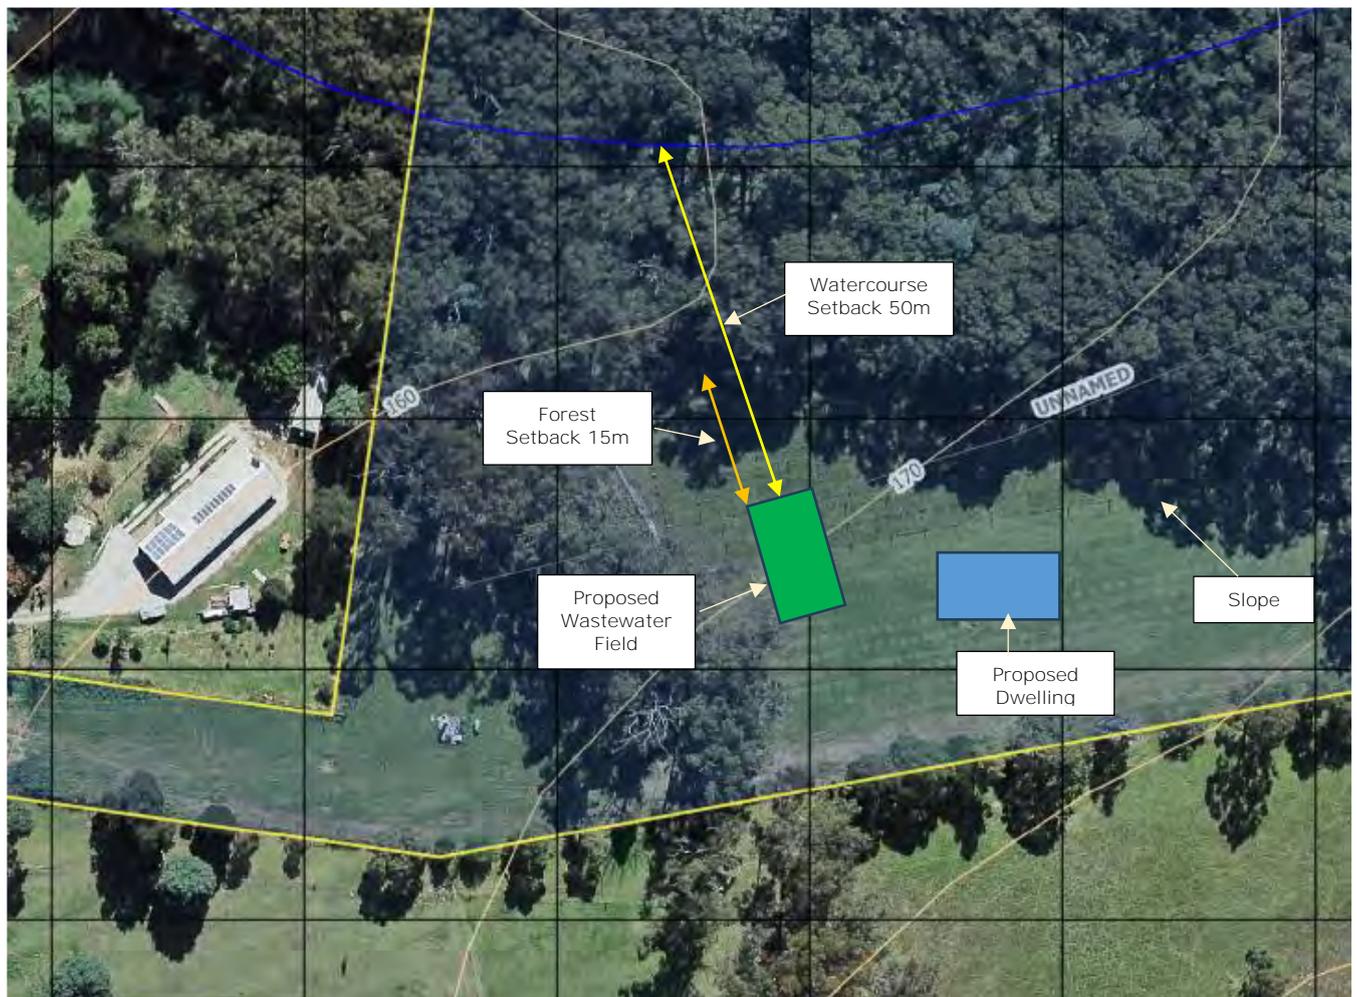
Site Aerial Photo Depicting Watercourse and Forest Setbacks

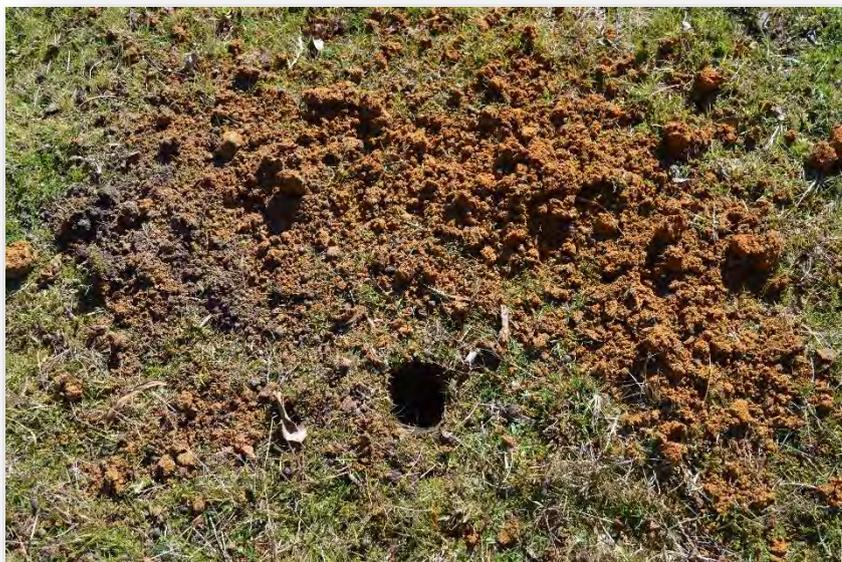
On-site Orange Brown Chromosols at 1000 Pakenham Road, Pakenham Upper

The soil type in the LAA consists of brown grey loam to a maximum depth of 300mm overlying yellow brown loam to a maximum depth of 700mm. Between 700mm to a maximum depth of 1200mm the soil grades into a strongly structured orange brown light clay. Below 1200mm to 1500mm the soil grades into an orange brown slightly red mottled medium clay. There was moisture throughout the soil profile, however given the recent wet weather the on-site soils inspected were not waterlogged. No groundwater within the proposed LAA was encountered during the site inspection.

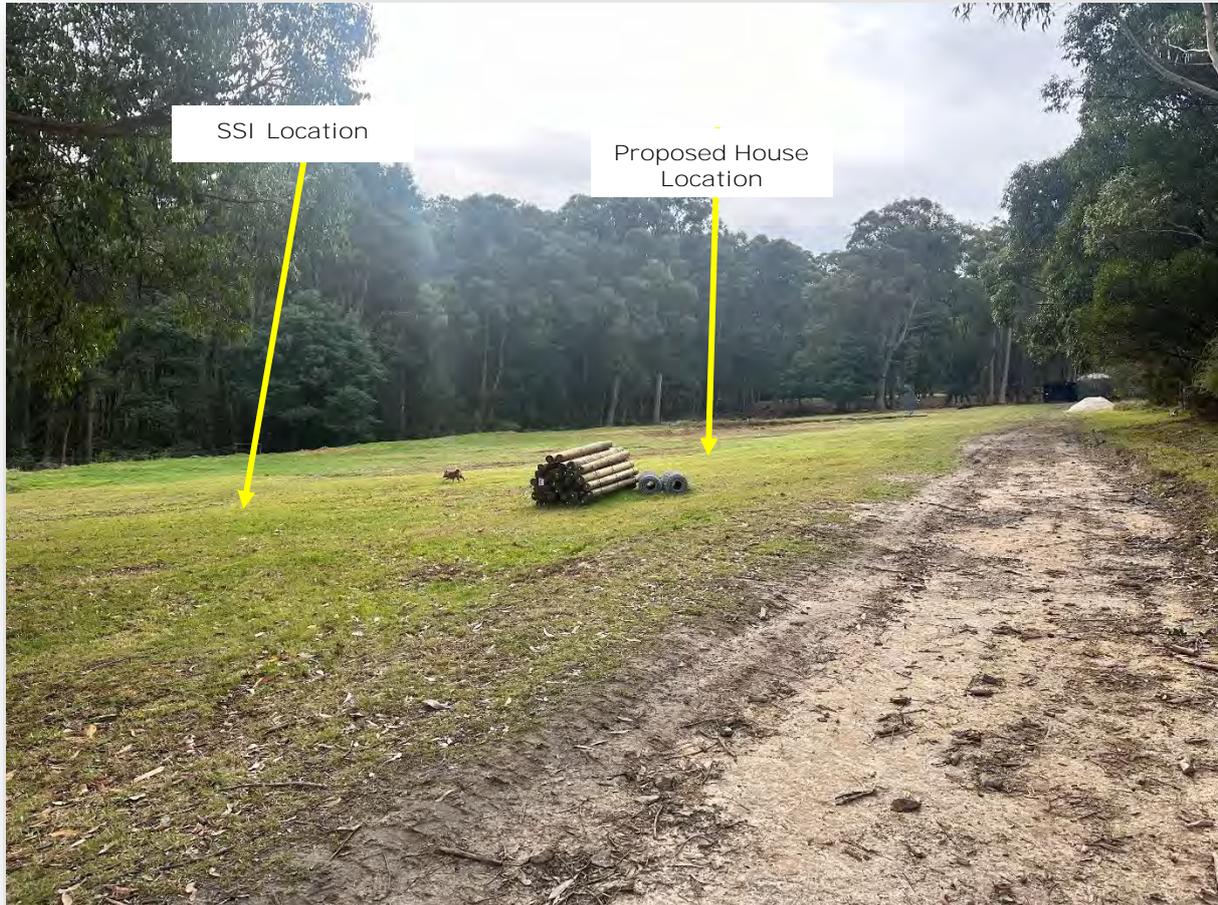
P1 - View towards the east depicting high moderate exposure SSI location that can be adjusted in consultation with Eco Vision – to be located in natural soil profiles away from the construction zone that will have a cut and fill (1000 Pakenham Road, Pakenham Upper).

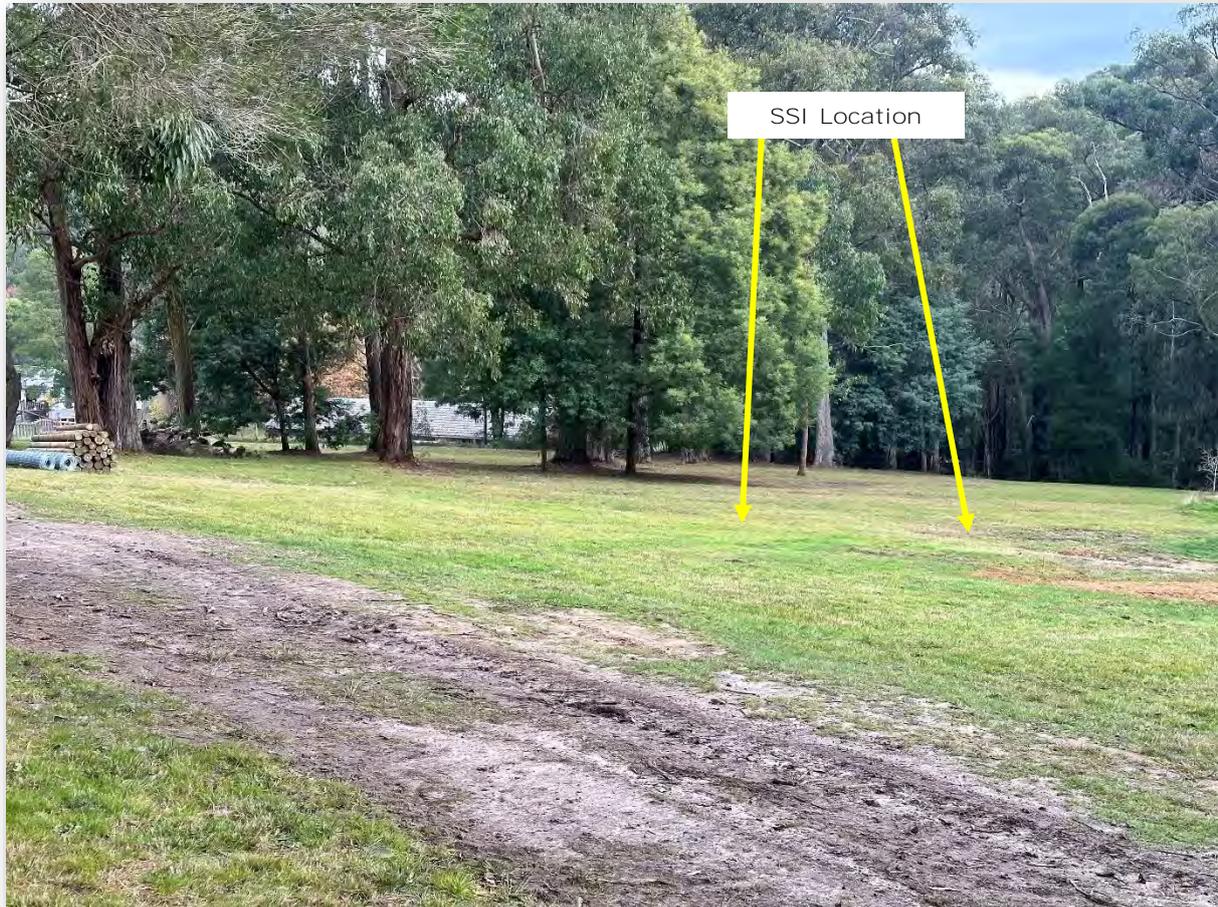
P2 - View towards the east depicting high moderate exposure SSI location that can be adjusted in consultation with Eco Vision – to be located in natural soil profiles away from the construction zone that will have a cut and fill (1000 Pakenham Road, Pakenham Upper).

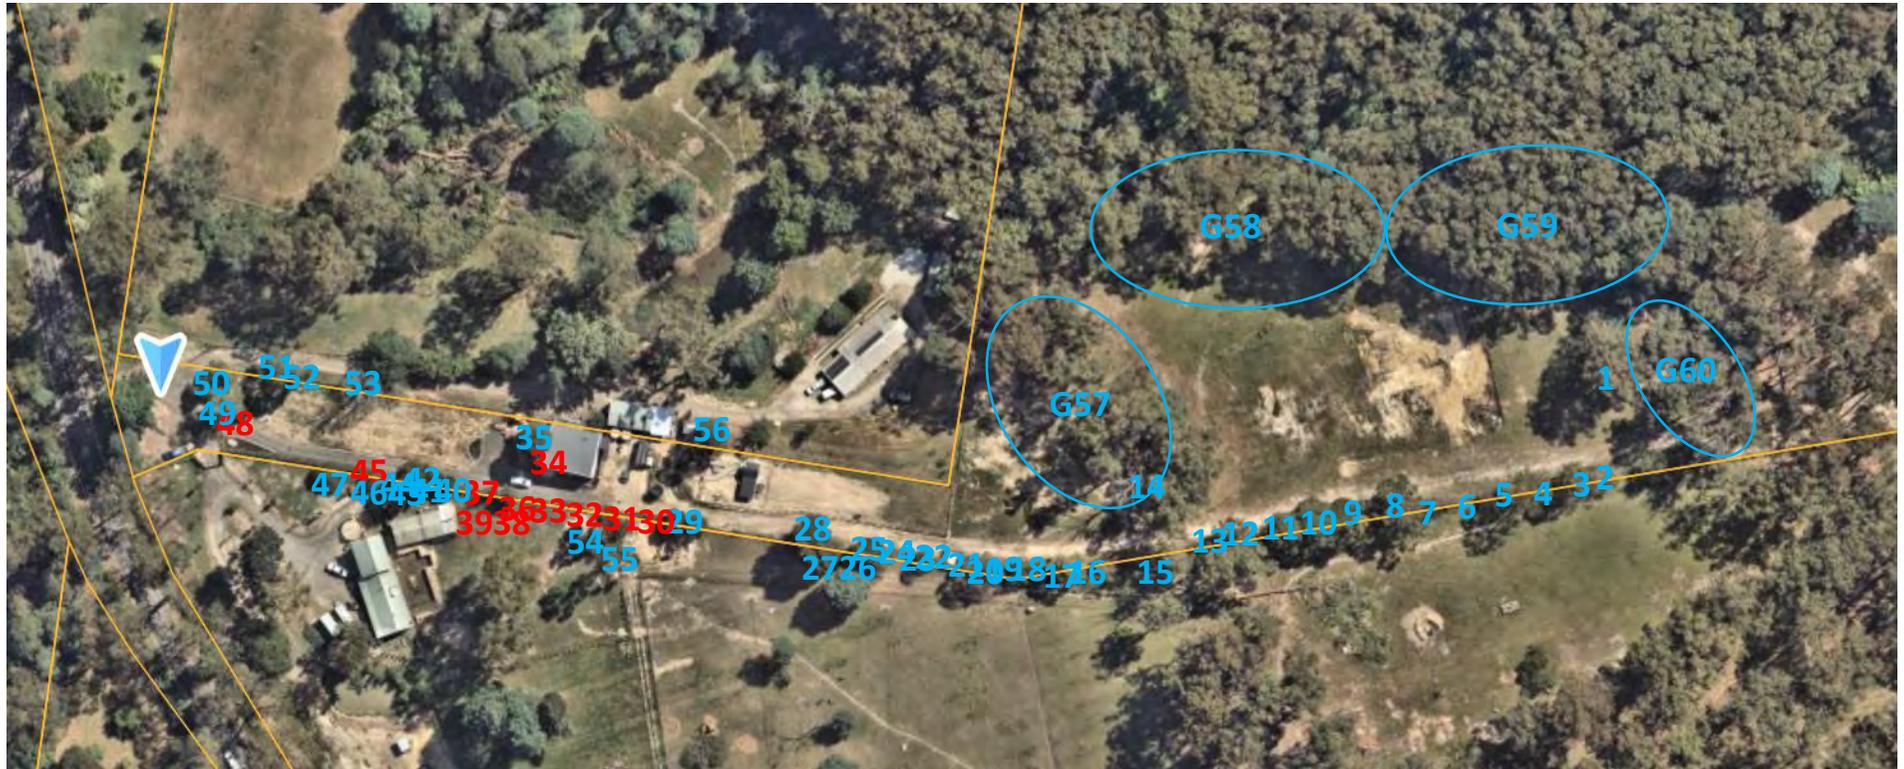
Figure 1 Aerial image (Nearmap Feb 2024) shows tree locations and numbering. Red numbers indicate trees no longer present.

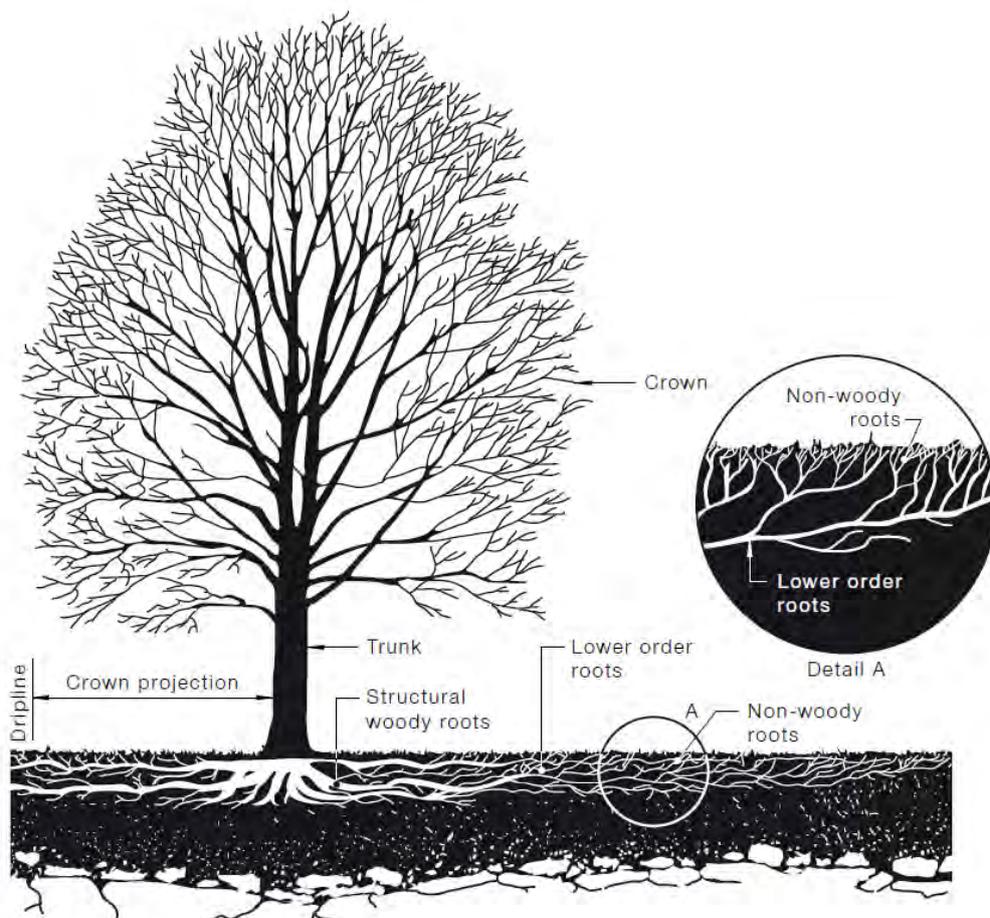
Figure 3 Example of typical root growth habits (AS4970-2009)

Roots can be impacted by development in two ways, directly by being severed during excavation or by the soil environment becoming uninhabitable through soil compaction or the placement of structures or surfaces that restrict water and oxygen supply. The effects of root damage are not immediately visible, it may take several years for the tree canopy to decline following impacts to the root system (Matheny and Clark 1998).

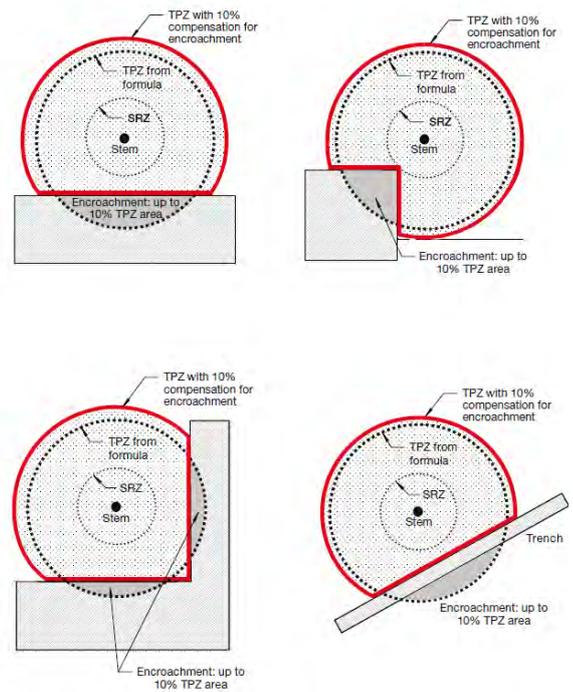
Figure 4 Example of TPZ encroachments (AS4970-2009)

Minor encroachments up to 10% of the total TPZ area are generally considered acceptable. Encroachments that exceed 10% of the TPZ or enter the SRZ are considered major, and must either be justified by the Project Arborist, reduced to an acceptable level or allow for the tree to be removed and replaced.

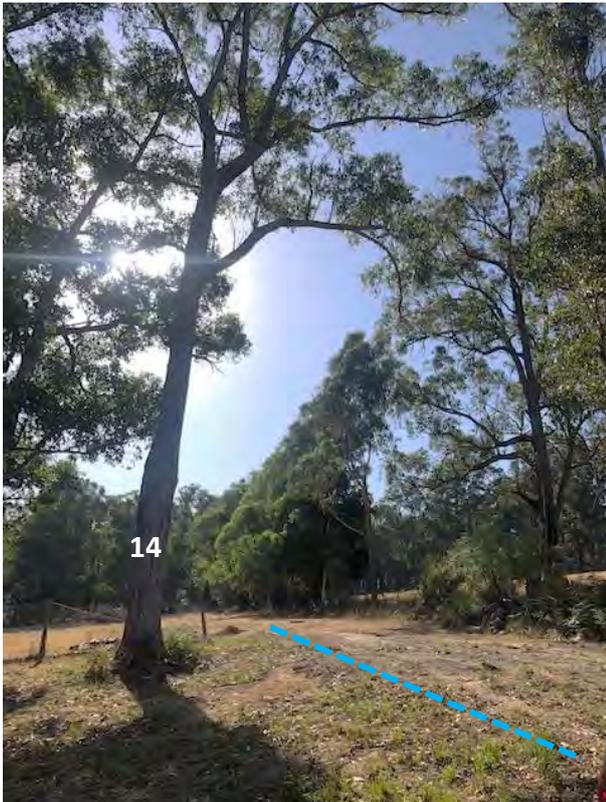
Figure 8 Tree 14 in approximate proximity to above grade gravel driveway

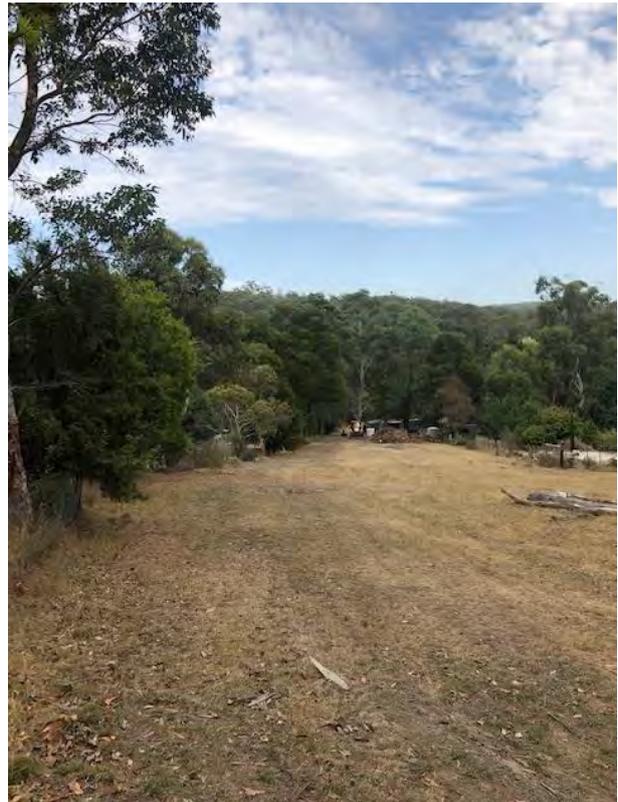
Figure 9 Location of proposed driveway from tree 16 looking west

Trees 14 and 15 will incur TPZ encroachment resulting from the proposed driveway. Proposed plans show the driveway to be above grade and permeable, these works are unlikely to affect the health or structure of trees 14 and 15. Figure 8 shows tree 14 in relation to the proposed above grade portion of driveway.

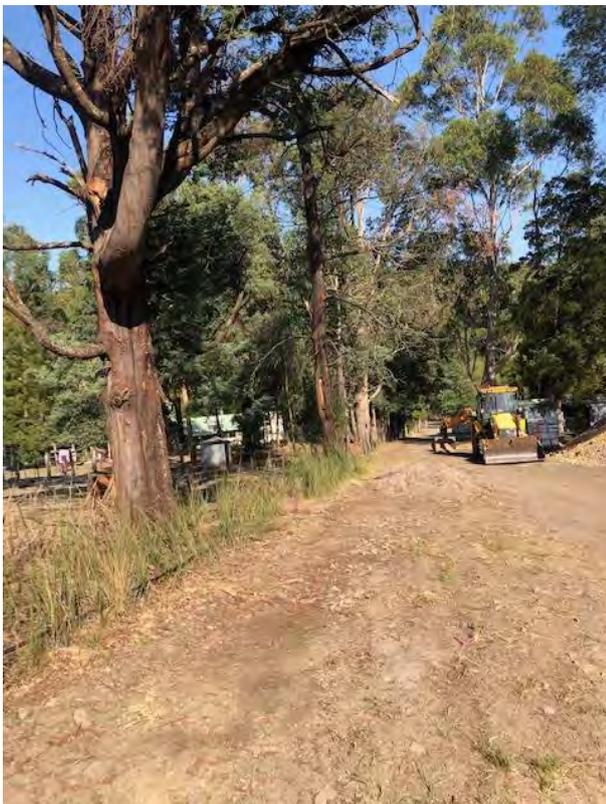
Figure 10 Location of proposed driveway from tree 29 looking west

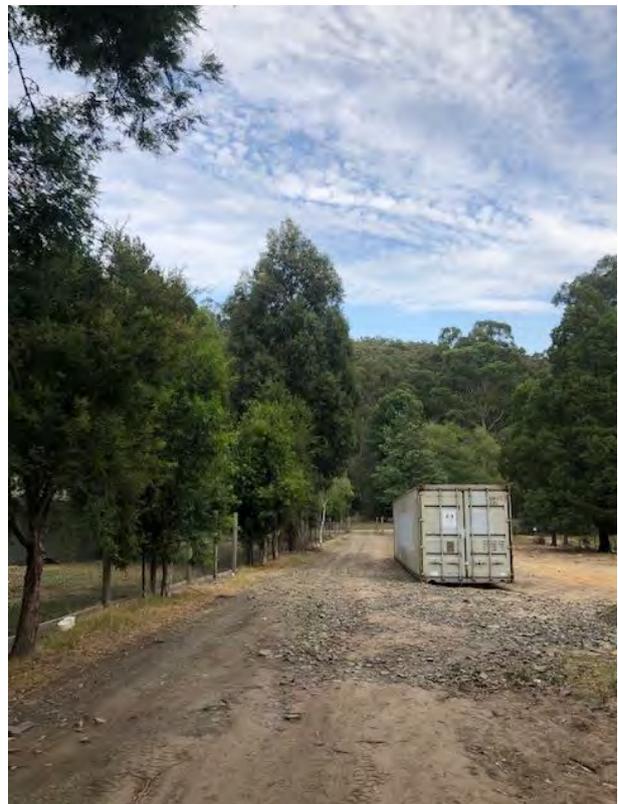
Figure 11 Location of proposed driveway from tree 40 looking west

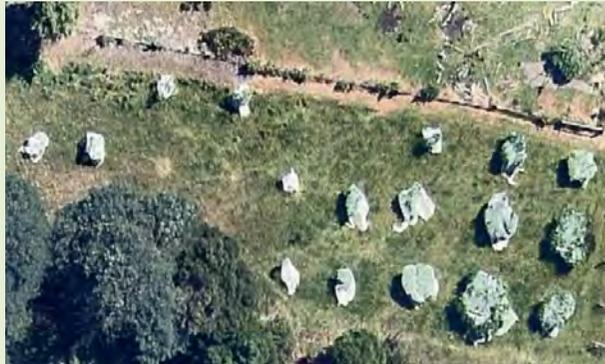
| Image Date | Description | Image |
|---|--|--|
| <b>30/11/2017</b> | Aerial imagery taken in November 2017 shows several netted fruit trees occurring within the area that will later undergo hard landscaping. Due to the presence of these fruit trees, it is likely that the understorey vegetation that was later landscaped, did not consist of a minimum 25% cover abundance of native species to qualify as a patch. | |

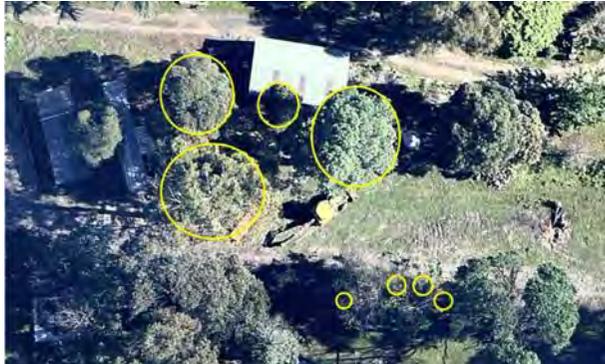
| Image Date | Description | Image |
|---|--|--|
| <b>23/12/2018</b> | Aerial imagery taken in December 2018, when referenced against the arboricultural report (Melbourne Arborists Reports Pty Ltd 2019), it is understood that the three trees on the northern boundary were mature native <i>Acacias</i> , one of which was assessed as Tree 35: a Blackwood. The largest tree (centrally located) was a remnant, large, Manna-gum, assessed as Tree 34, the four small Blackwoods on the southern boundary, were reported to be in poor health, both by the landowner and arboricultural report, being Trees 28-31, this is visually evident in later aerial imagery (Melbourne Arborists Reports Pty Ltd 2019; Nearmap 2023). | |

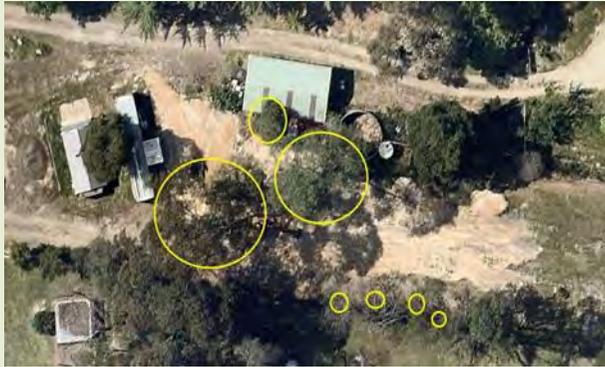
| Image Date | Description | Image |
|---|--|--|
| <b>18/12/2019</b> | <p>Prior to this image dated December 2019, one of the northern <i>Acacias</i> was removed, and some hard landscaping undertaken. This tree was not mentioned within the arboricultural report (Melbourne Arborists Reports Pty Ltd 2019); however the landowner recalls it being a Blackwood.</p> <p>As per the aerial imagery from 2017, much of the area around the buildings has historically been managed as orchards and vineyards. In turn it is highly unlikely that the hard landscaping on site has affected remnant understorey vegetation.</p> | |

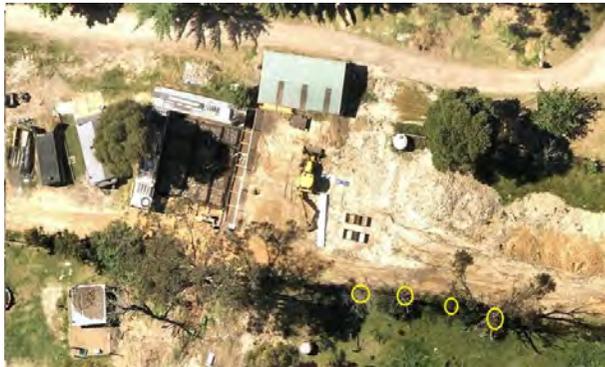
| Image Date | Description | Image |
|---|--|--|
| <b>28/11/2021</b> | <p>Prior to this image in November 2021, the other northern <i>Acacias</i>, consisting of Tree 35, an unassessed Blackwood and Tree 34, a Manna-gum, were removed. Trees 28-31 have been removed; however, removal has occurred recently such that the aerial imagery has not updated (Plate 5).</p> | |

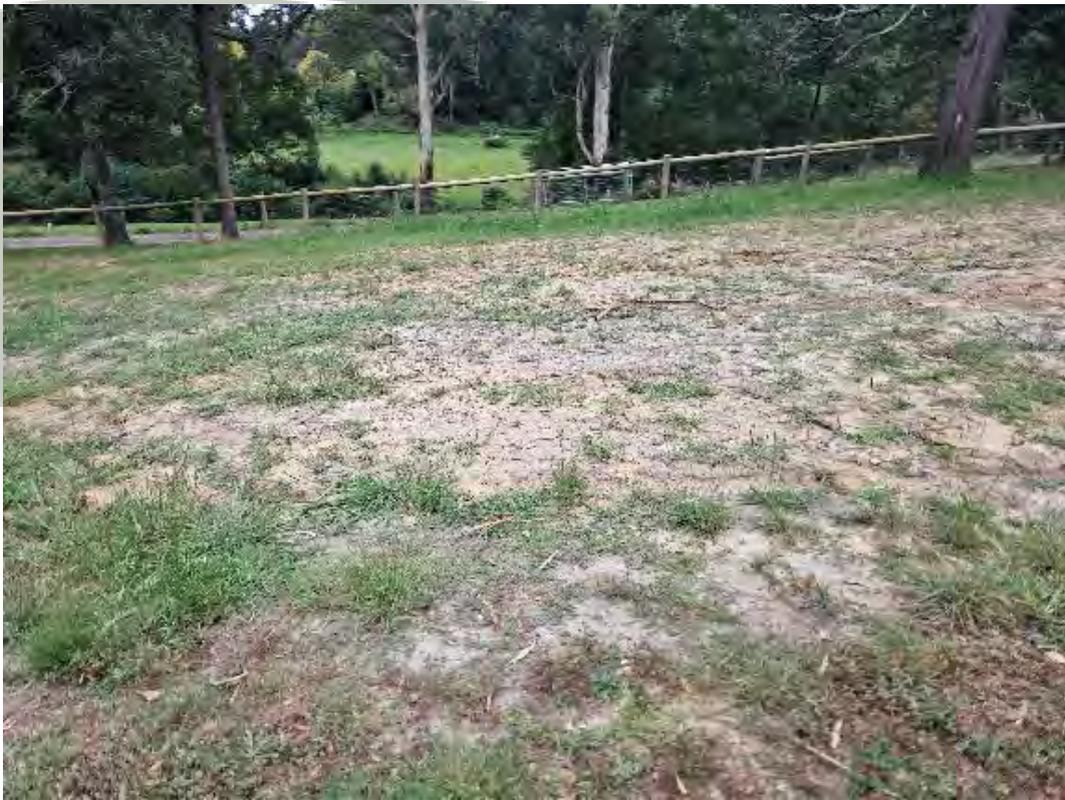
**Plate 1.** The weedy vegetation that covers much of the study area (16 February 2024).

The study area exhibited a highly modified understorey that consisted of exotic pasture species including Sweet Vernal-grass *Anthoxanthum odoratum*, Yorkshire Fog *Holcus lanatus*, Kikuyu *Cenchrus clandestina*, Perennial Ryegrass *Lolium perenne* and Couch *Cynodon dactylon* var. *dactylon*, as well as environmental weeds including White Clover *Trifolium repens*, Ragwort *Senecio jacobaea*, Flatweed *Hypochaeris radicata* and Ribwort *Plantago lanceolata* (Plate 1).

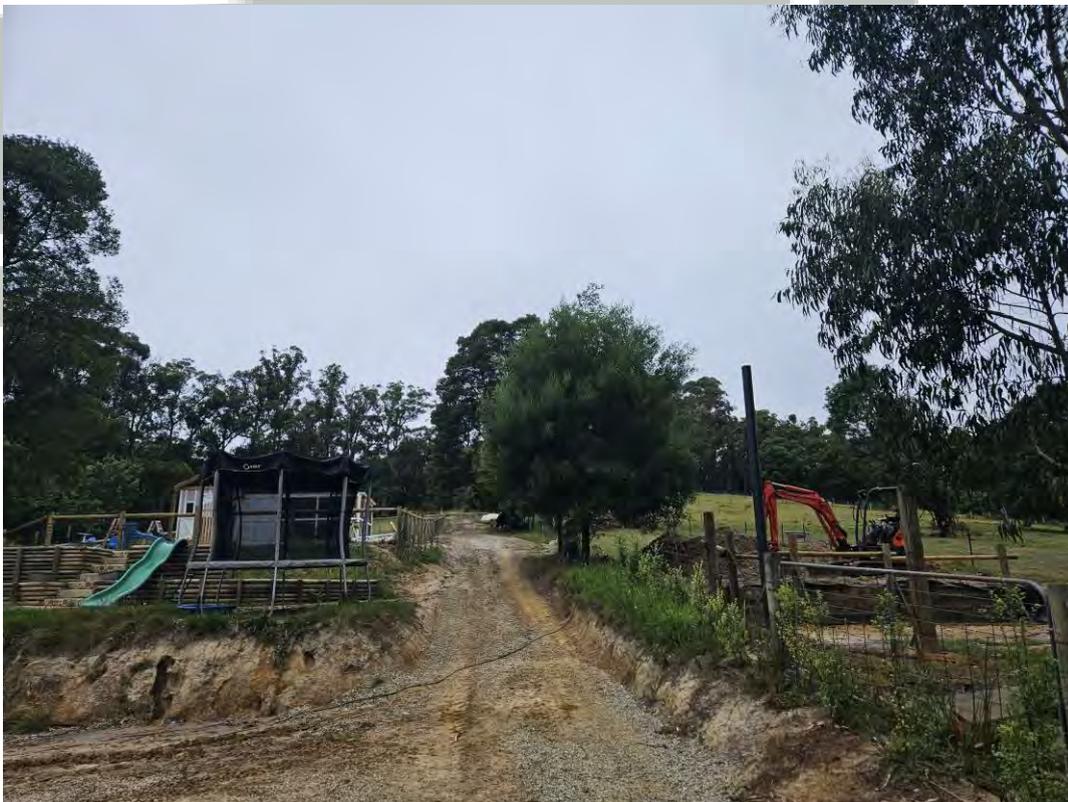
**Plate 2.** Patch 1 consisting of a stand of Blackwood (16 February 2024).

Two small patches of native vegetation were located on the southern boundary of the property (Plate 2). This vegetation largely consisted of an understorey tree layer of Blackwood *Acacia melanoxylon* or Black Wattle *Acacia mearnsii*, interspersed with planted, horticultural trees. The understorey in these patches included Thatch Saw-sedge *Gahnia radula*, Common Raspwort *Gonocarpus tetragynus* and Weeping Grass *Microlaena stipoides* (Plates 3). One scattered Narrow-leaf Peppermint *Eucalyptus radiata* was recorded within the study area (Plate 4).

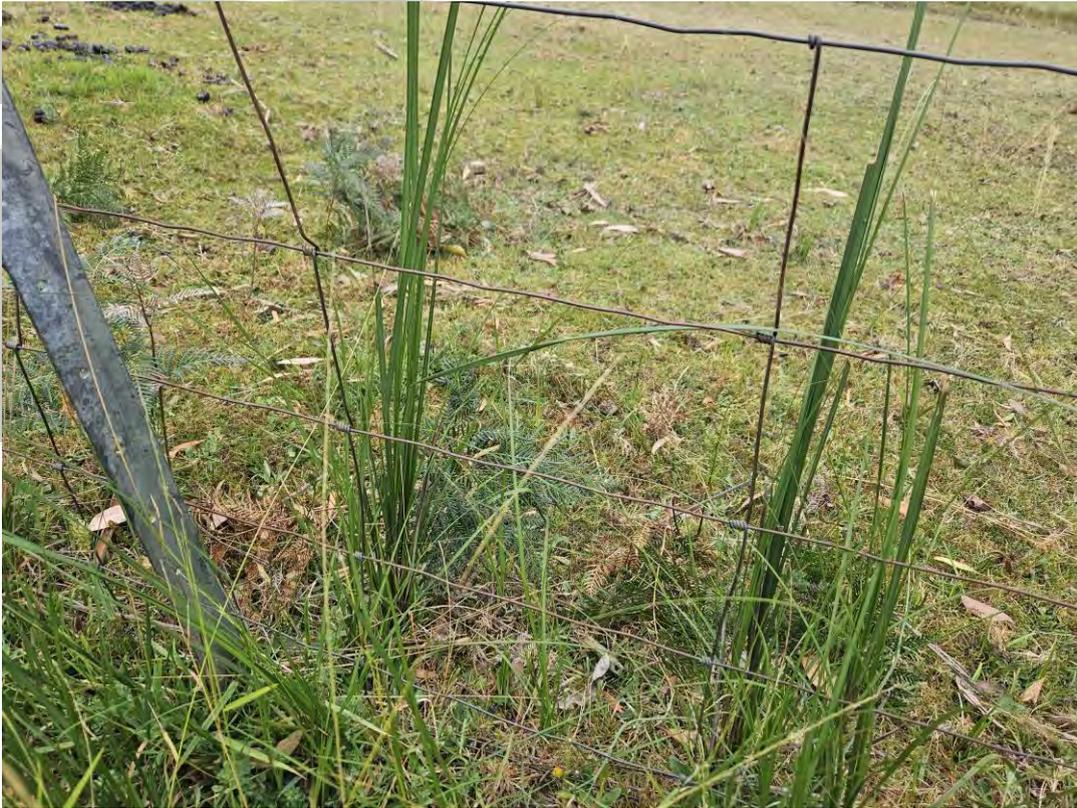
**Plate 3.** The understorey vegetation within the patches largely consisted of Thatch Saw-sedge *Gahnia radula* (16 February 2024).

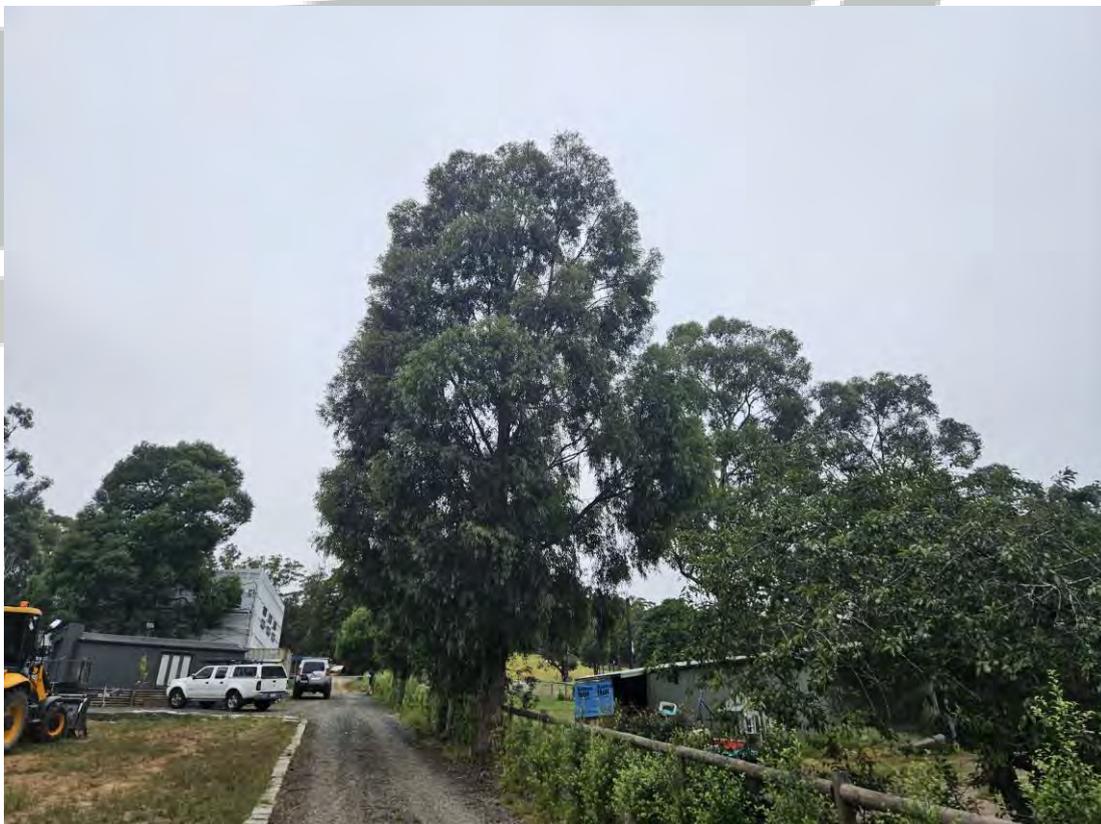
**Plate 4.** Scattered Tree 1, a Narrow-leaf Peppermint (16 February 2024).

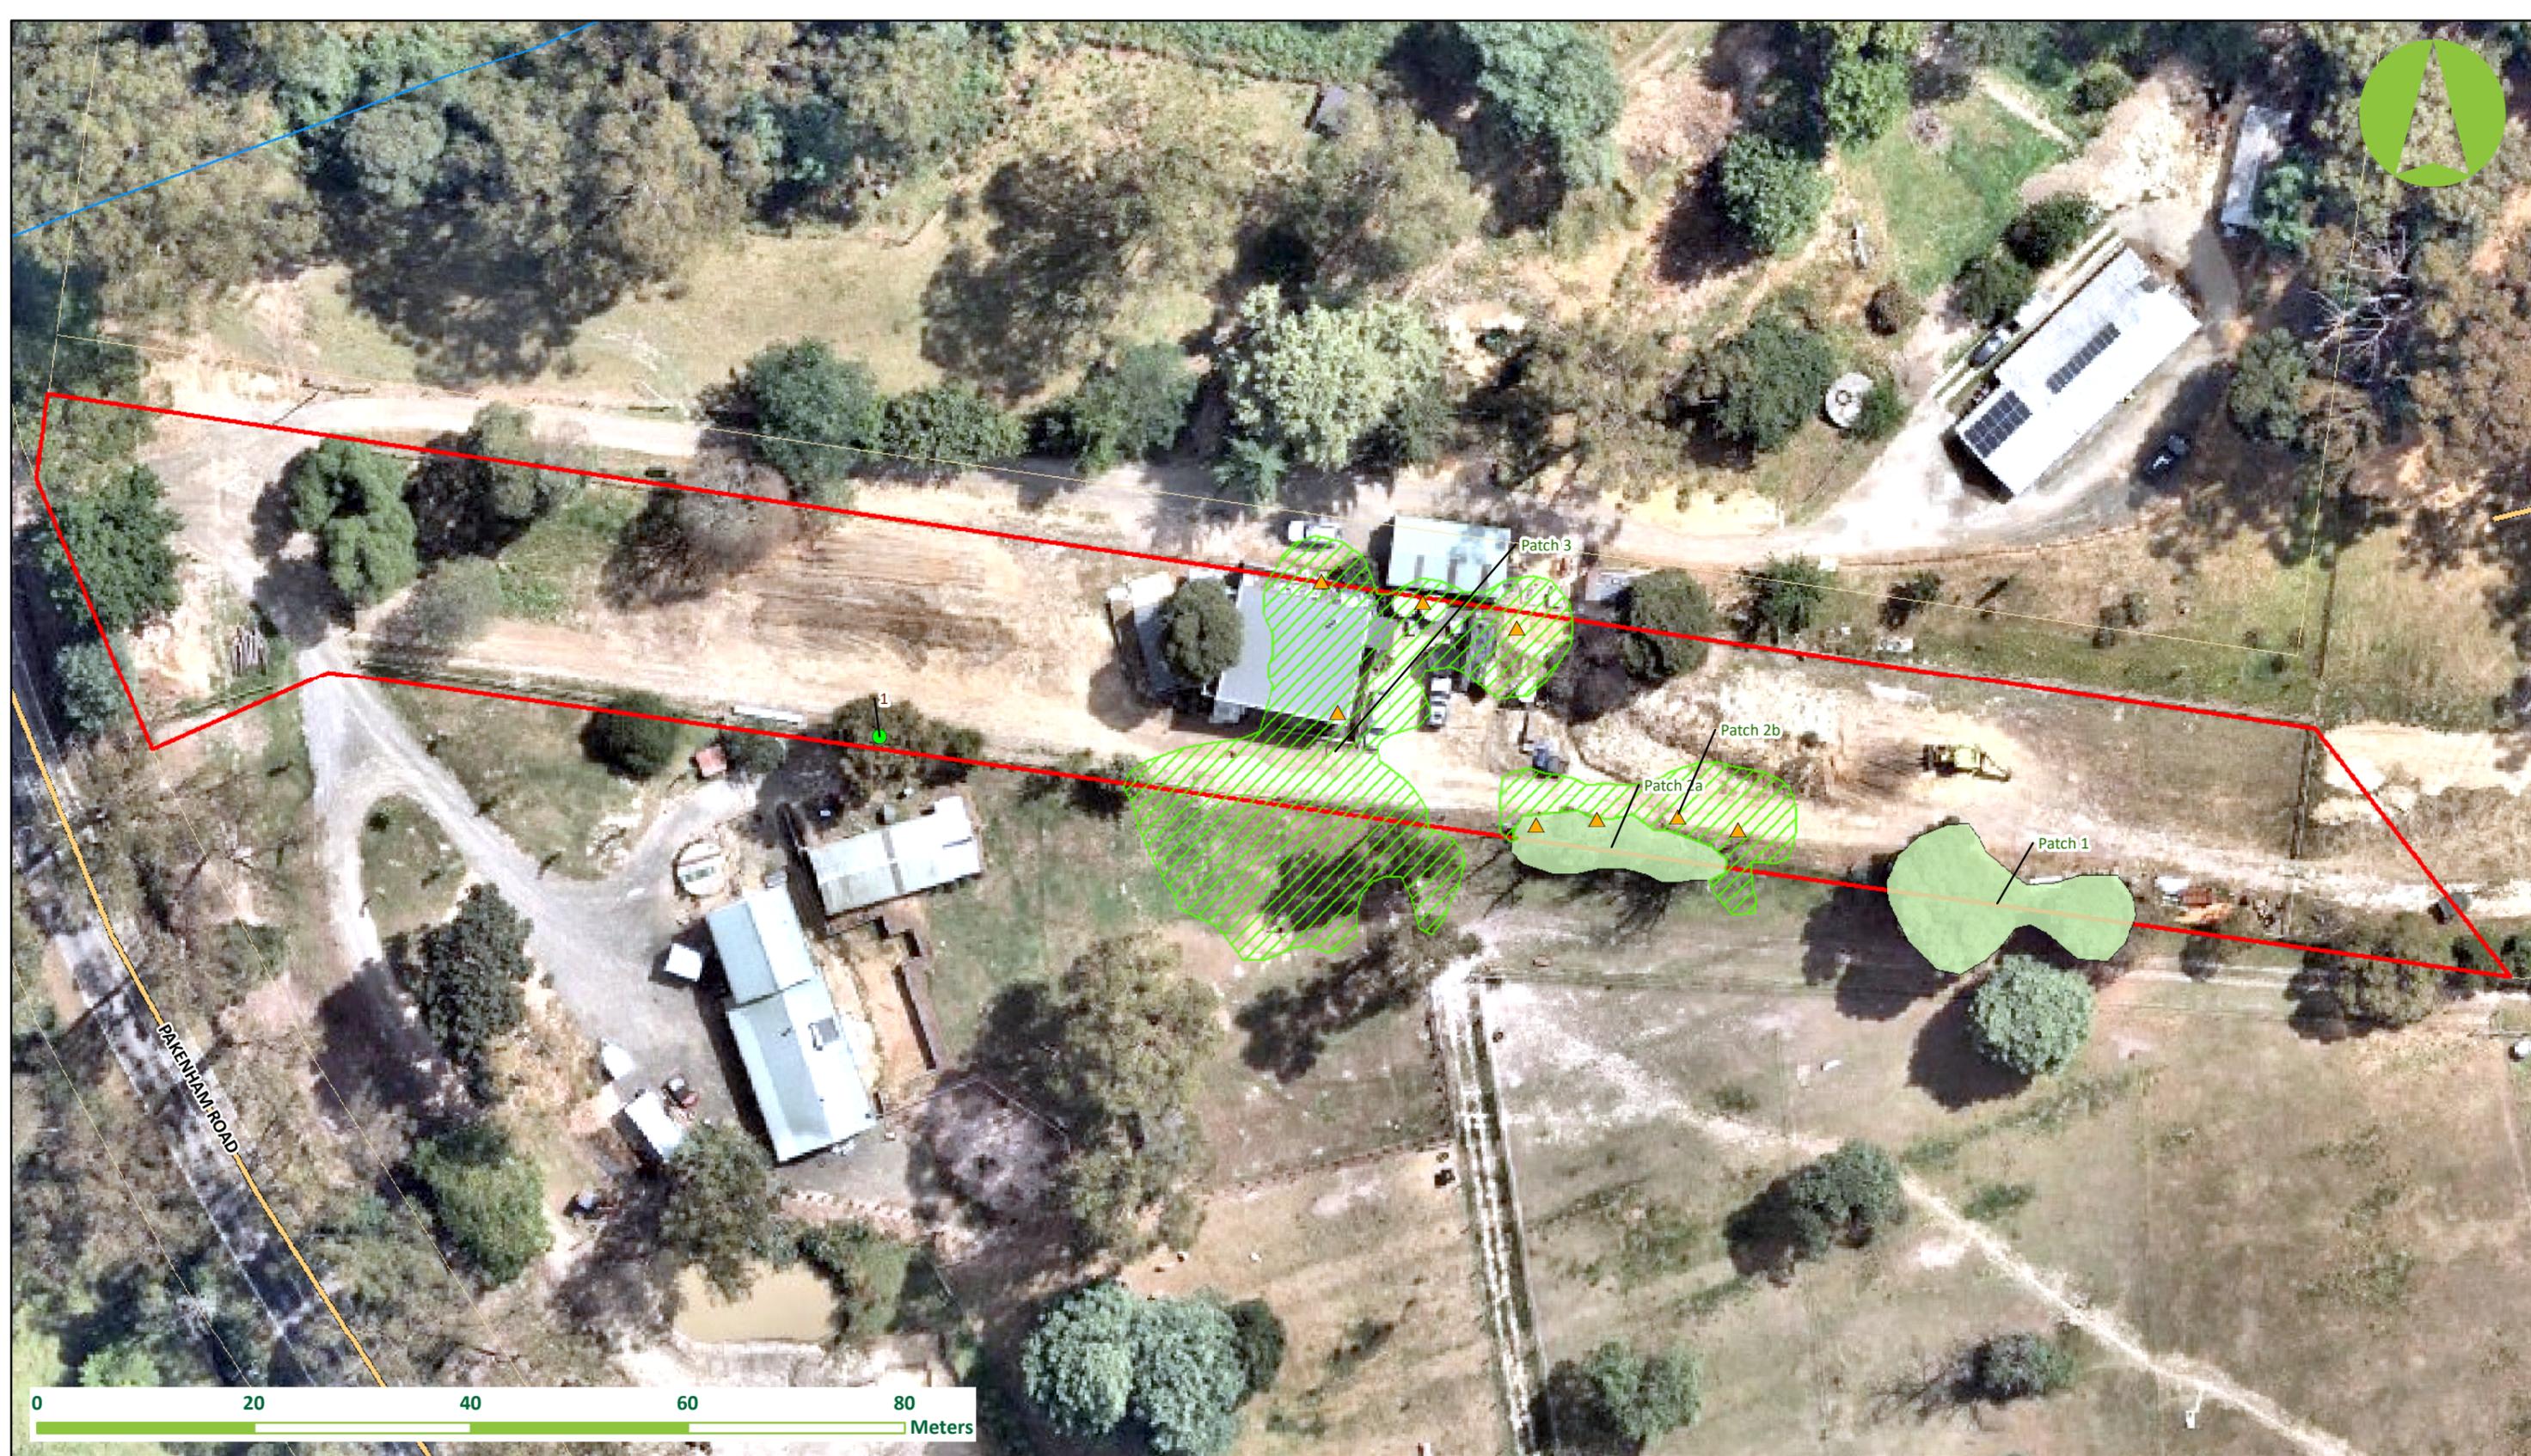
**Figure 1:** Results of the current assessment.

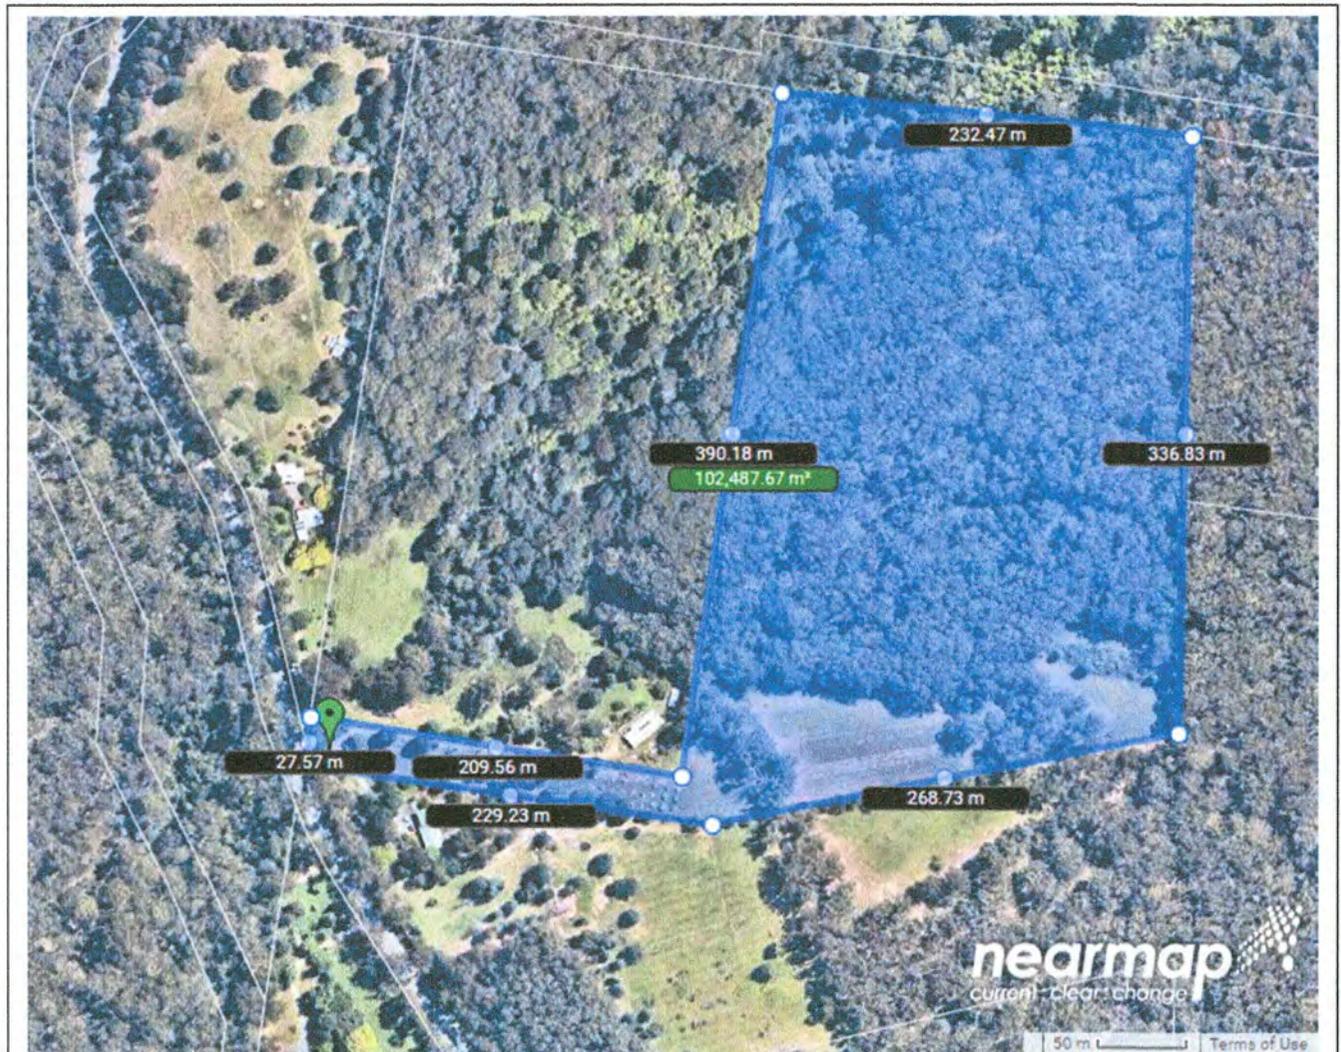
**Figure 2** Property's area *QGIS data.vic.gov.au, google maps & nearmap*

The proposal seeks development approval to **construct a building (dwelling)** on the land known as; **1000 Pakenham Rd Pakenham Upper 3810**. The property comprises of one parcel as seen in *Figure 1 & Figure 2*

| <i>The dimensions of the site are:</i> | Please refer to Fig2 Site Dimensions |

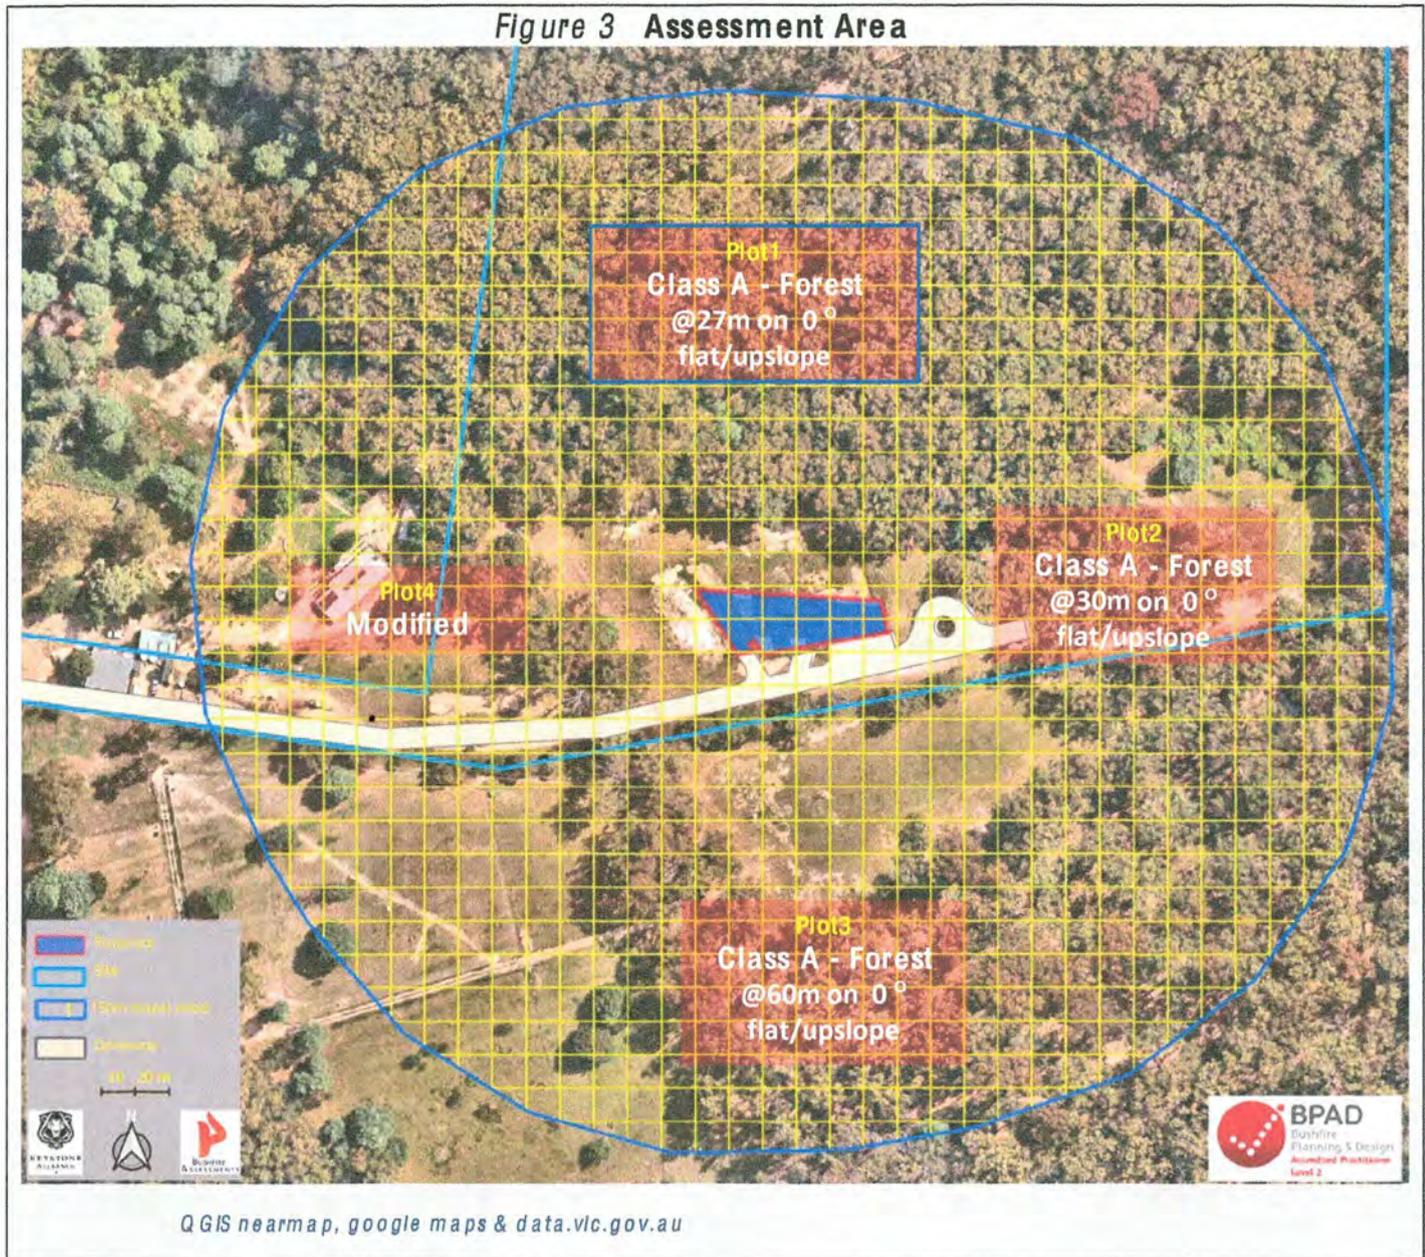
A vegetation hazard assessment was carried out within a 150m radius from the proposed development. Within this area our interest was directed on the type of vegetation surrounding the proposal the distance from the proposal and the effective slope it stood (see Figure 3 below).

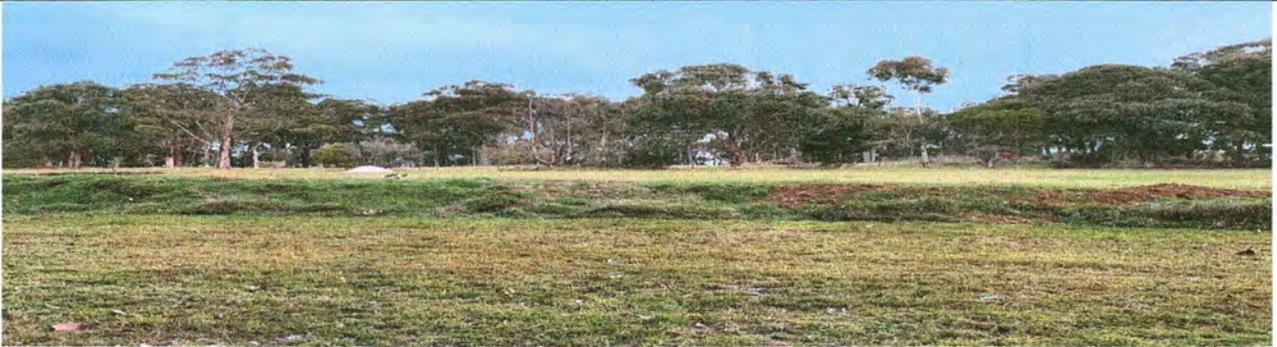
**PLOT1** *Northern vegetation*

Much of the vegetation to the north and east of the site has been identified as 'modified vegetation' (see Map 2). Planning Practice Note 65 notes that modified vegetation can occur where fuel loads are high but the vegetation is modified because of urban development, gardens, the way the vegetation is configured (for example, limited or no understorey), or because the fuel loads are different from the fuel loads assumed by AS3959-2009 but the vegetation cannot be excluded as it is not low-threat or low-risk (DTPLI, 2014).
