# Notice of Application for a Planning Permit

| The application is for a permit to: | Use and Development of the Land for a Dwelling and Alteration of Access to a Road in a Transport Zone 2 |

## LAND CAPABILITY ASSESSMENT REPORT

**1000 Pakenham Road  
Pakenham Upper VIC**

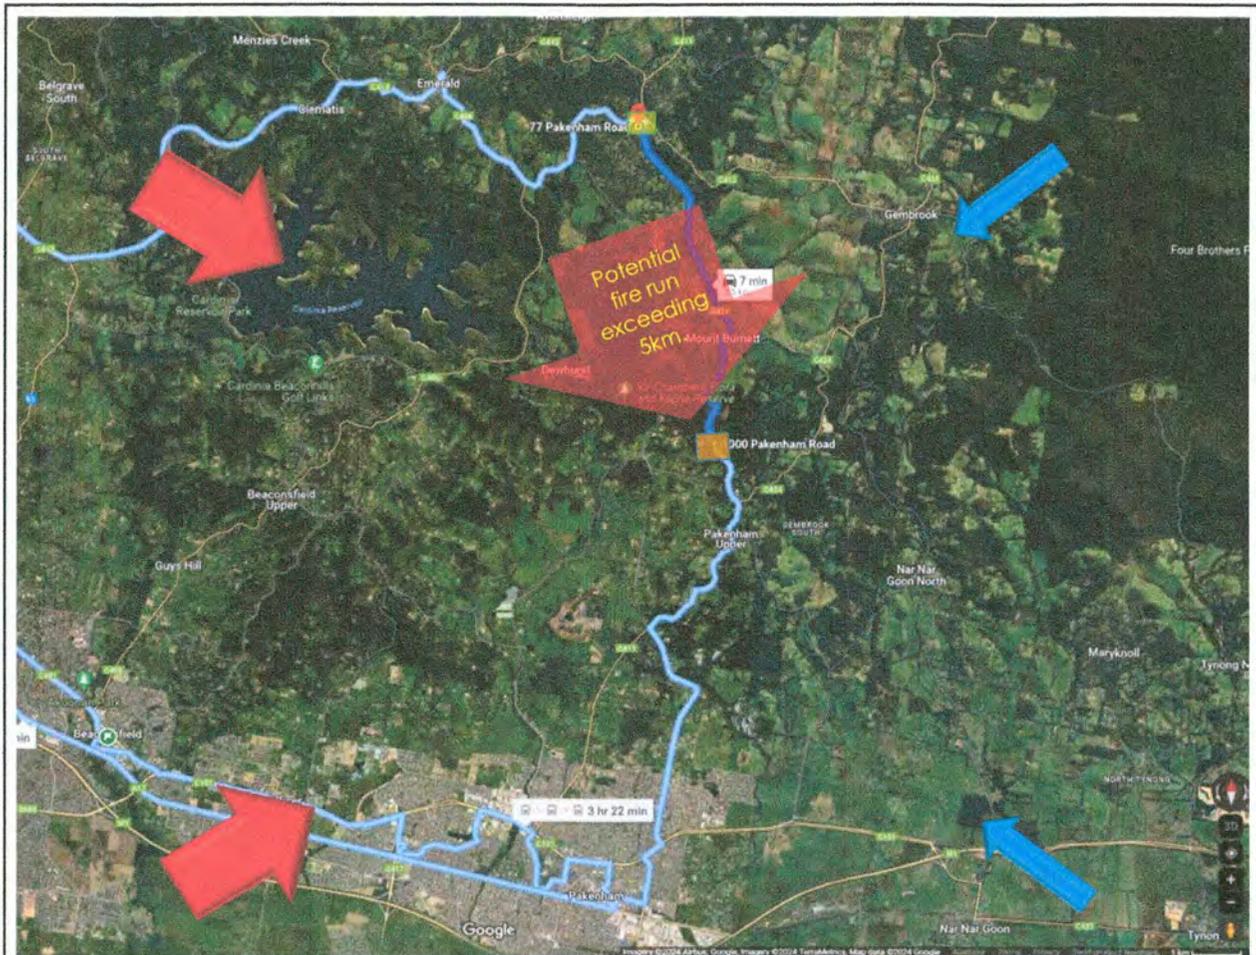
**Figure 4** Location of site

**Cardinia Shire** has several designated Neighbourhood Safe Places (NSP). The Cockatoo Complex Community Hall is the closest NSP at approx. 3.1km as you can see in *Figure 4* above.

The main driveway access into the site is from **Pakenham Road**. This is a dual carriageway, linking to **Chewton's** closest CFA Fire Station located 1.5 km via road on **Mount Street** east of the entrance driveway.

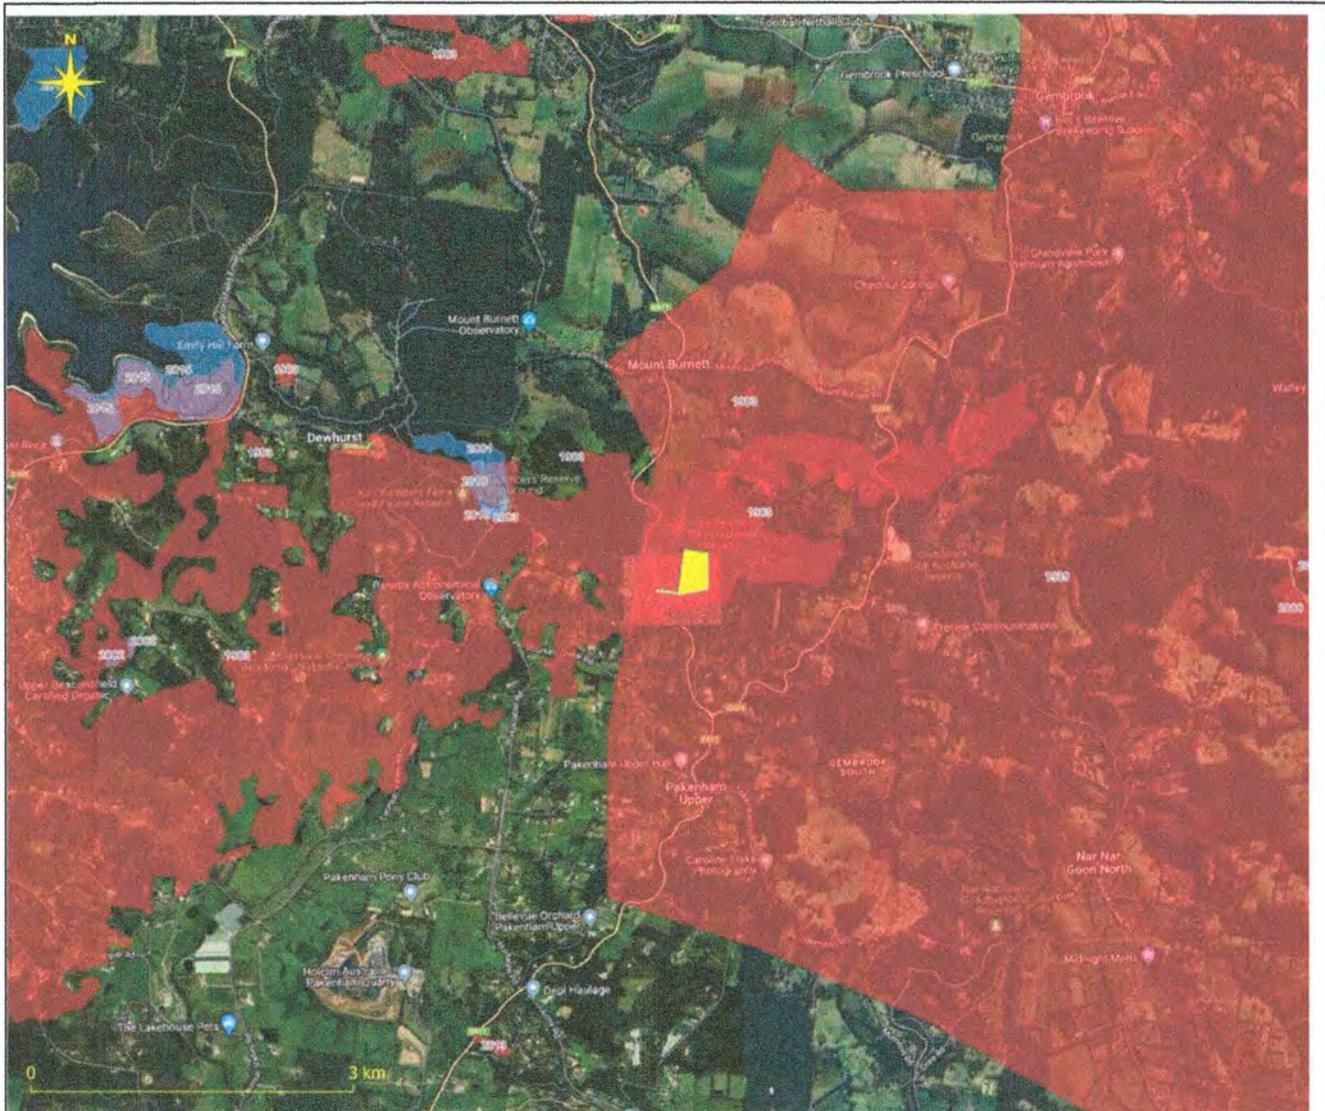
Figure 5 Bushfire history & planned burns around the proposal QGIS data.vic.gov.au, google maps & nearmap

Controlled burns have taken place and a wildfire history has been recorded in the wider areas surrounding the proposal as you can see on Map 2. The immediate area has a fire history, and the publicly available database indicates that the site itself has experienced bushfire in 1983.

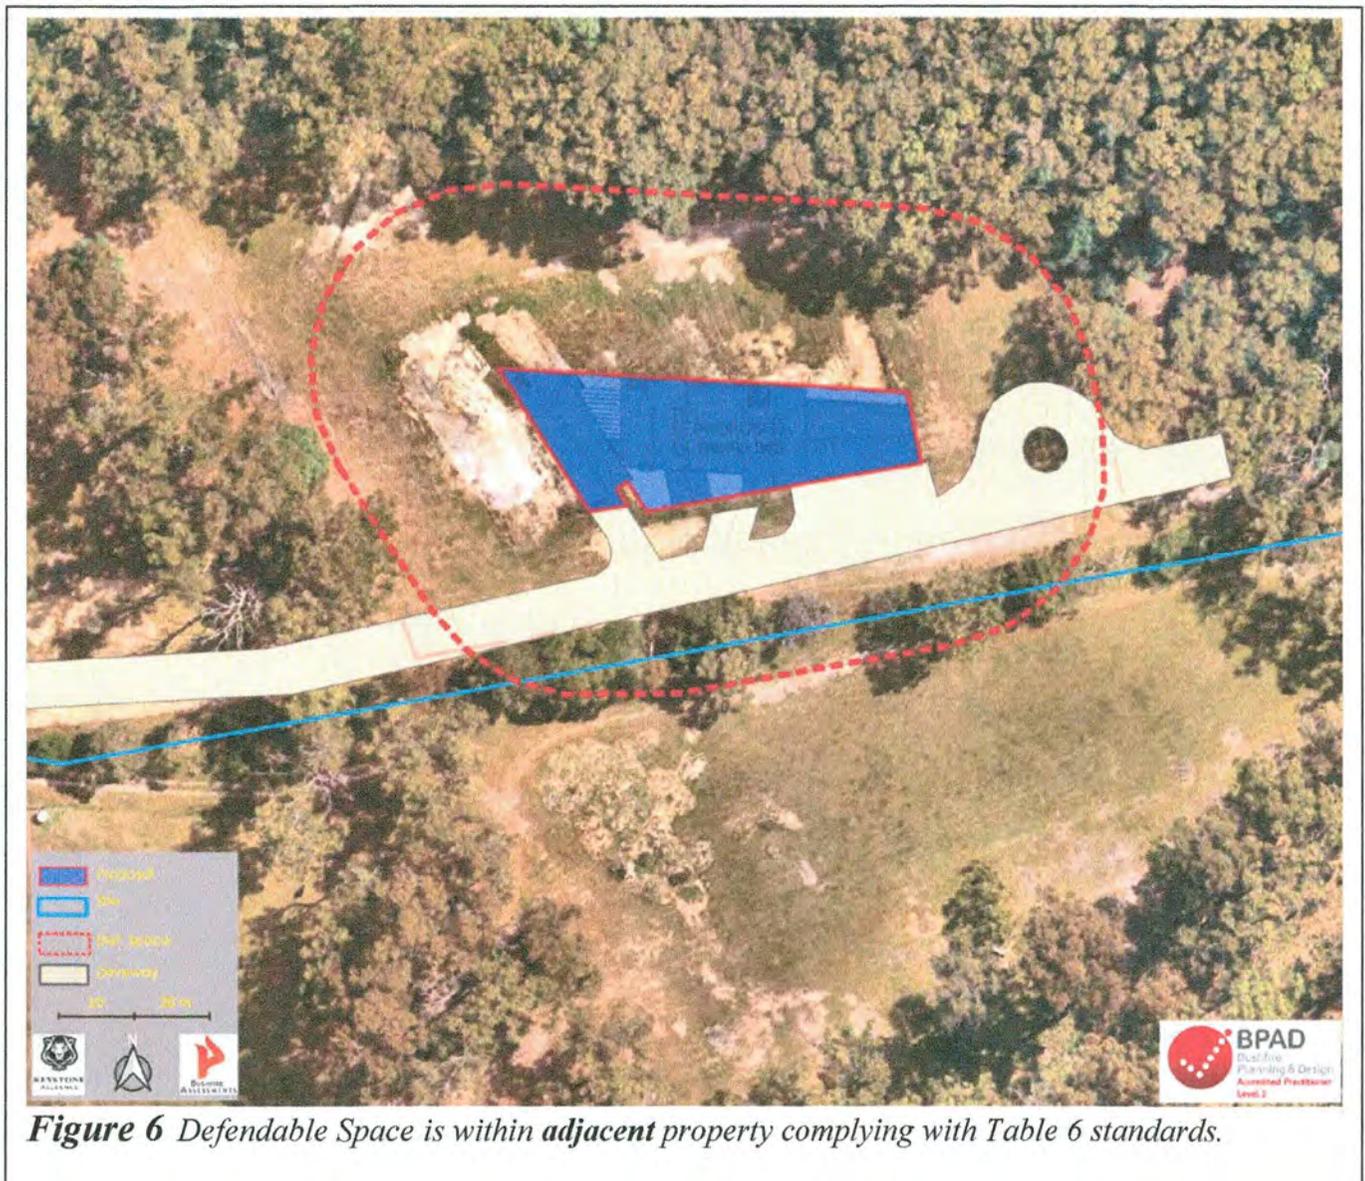
The habitable building will be constructed with a **BAL-29** vegetation classified as forest on an effective slope of flat/upslope, required defensible space is **25m or to the property boundary, whichever is lesser** from the edges of the proposal as shown in *Figure 6* corresponding to Clause 53.02-5 Table 2.

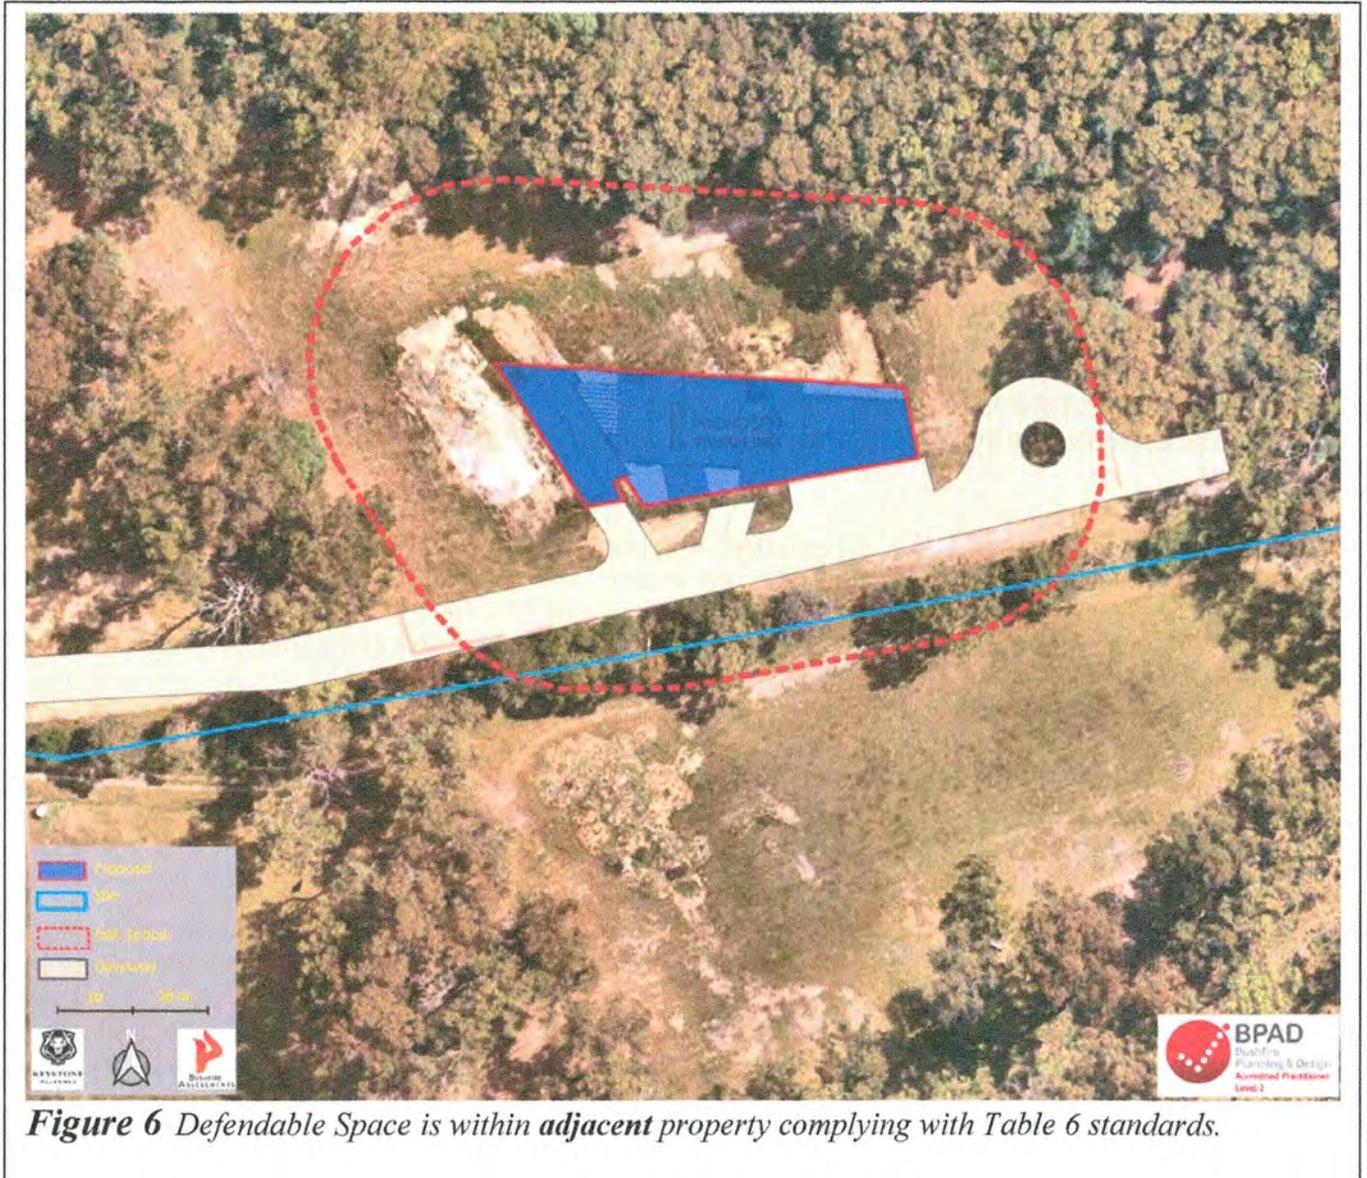
The habitable building will be constructed with a **BAL-29** vegetation classified as forest on an effective slope of flat/upslope, required defensible space is **25m or to the property boundary, whichever is lesser** from the edges of the proposal as shown in *Figure 6* corresponding to Clause 53.02-5 Table 2.

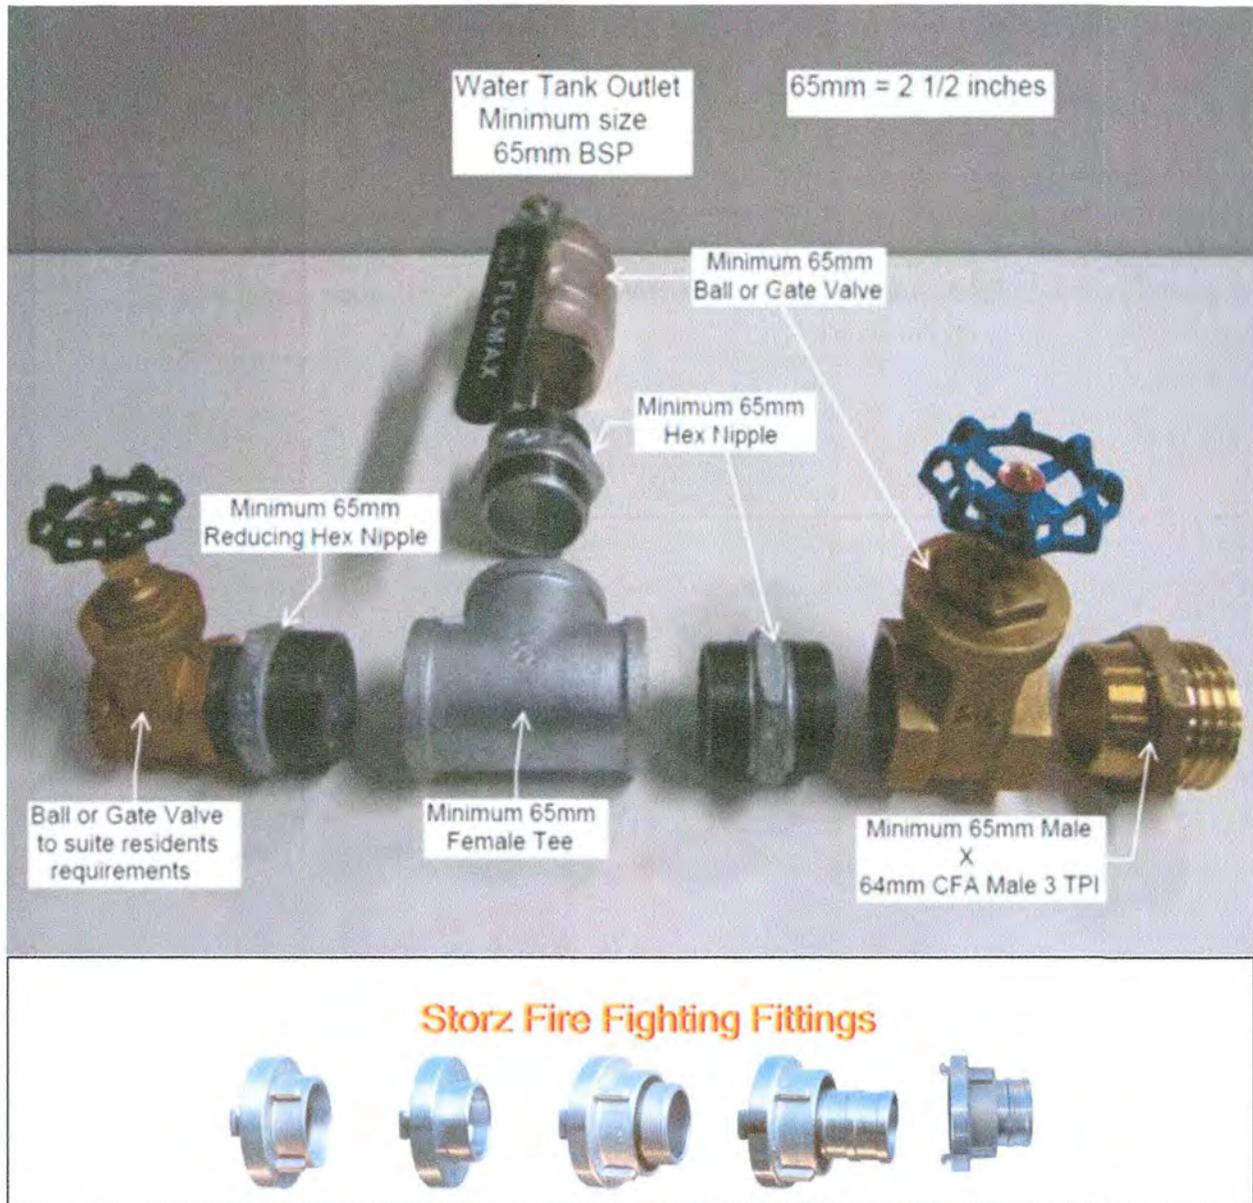
**Diagram 1 CFA Standard permit conditions for water supply, in FRV areas pls check if they use same fittings or Storz Fitting apply.**

Diagram 1 below shows some common tank fittings available at most plumbing suppliers which meet the connection requirements. It includes a 65mm tank outlet, two 65 mm ball or gate valves with a 65mm male to 64 mm CFA 3 threads per inch male coupling. This is a special fitting which allows the CFA fire truck to connect to the water supply. An additional ball or gate valve will provide access to the water supply for the resident of the dwelling'
