Notice of Application for a Planning Permit

The land affected by the application is located at:		L1 PS335048 V10188 F654 80 Gordon Road, Pakenham Upper VIC 3810	
The applicat	ion is for a permit to:	Buildings and works (Construction of a replacement dwelling) and removal of vegetation	
A permit is re	equired under the follo	wing clauses of the planning scheme:	
35.06-5	Construct a building or co	onstruct or carry out works	
42.01-2	Construct a building or construct or carry out works		
42.01-2	Remove, destroy or lop vegetation		
44.06-2	44.06-2 Construct a building or construct or carry out works associated with accommodation		
		APPLICATION DETAILS	
The applicar	nt for the permit is:	XWB Consulting	
Application r	number:	T240054

Supporting submission Planning permit application for a replacement dwelling 80 Gordon Road Pakenham Upper

Bushfire Assessment 80 Gordon Road Pakenham Upper

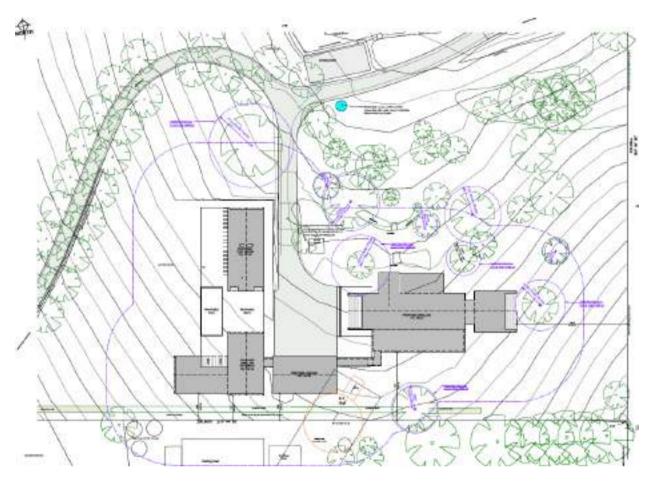
The application proposes the construction of a replacement dwelling as shown in the plan below. Detailed plans have been submitted with the application.

The dwelling is a large dwelling with a number of interconnected elements. The elements will include the main dwelling wing, guest wing, pool house wing, pool and deck, and garage. My client has mature age children who still live at home but seek a level of independence and has regularly has family and friend come to visit but are unable to stay within the existing dwelling. Details of the proposed development include:

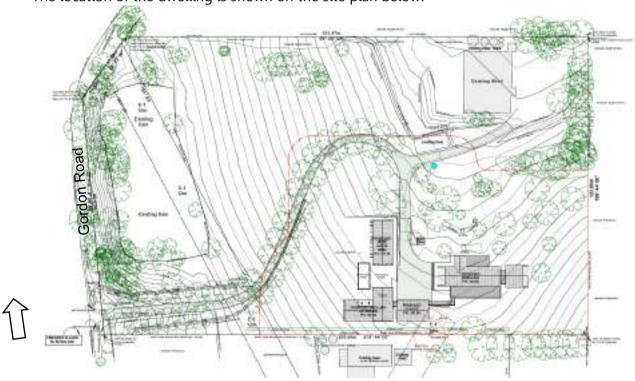
- of 2.35m. Filling is required for the main dwelling element and garage with a maximum depth of filling of 1m for the main dwelling element.
- No removal of native vegetation is required for the construction of the replacement dwelling. The removal of a limited number of planted garden species of trees and shrubs is required for the construction of the dwelling.
- It is proposed to stage construction with the initial construction of the guest wing and pool wing which the clients will live in while the existing dwelling is demolished and the main dwelling wing is constructed.

The location of the dwelling is shown on the site plan below:

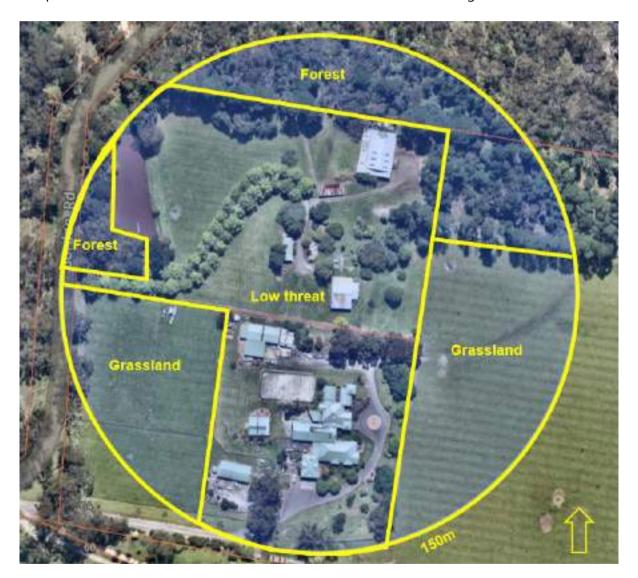
The plan below shows the bushfire hazard within 150m of the dwelling site:

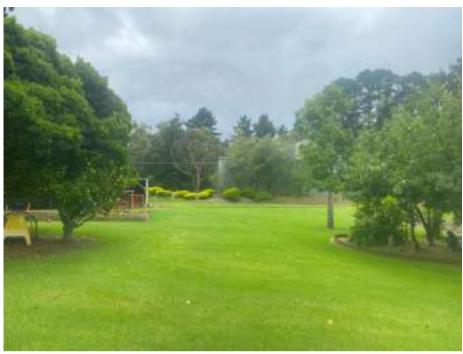
The land to the north comprises managed areas within the site which would be classified as low threat vegetation under AS3959. The adjoining property to the north contains remnant bushland which would be classified as forest under AS3959. The slope of the forest area is upslope from the proposed dwelling. The areas to the north are shown in the photographs below:

Managed gardens to the north

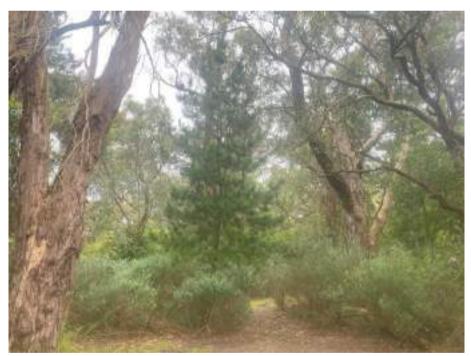
Bushland area to the north

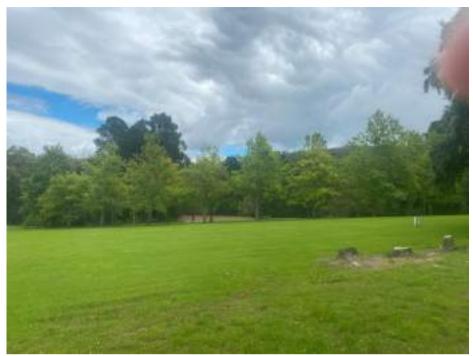
The land to the west comprises managed areas within the site which would be classified as low threat vegetation under AS3959. There is a small patch of bushland adjoining the dam which would be classified as forest under AS3959. The slope of the forest area is downslope from the proposed dwelling with a slope of 6°. There are areas of open paddock to the south west which would be classified as grassland under AS3959. The slope of the grassland area is downslope from the proposed dwelling with a slope of 6°. The areas to the west are shown in the photographs below:

Managed gardens to the west

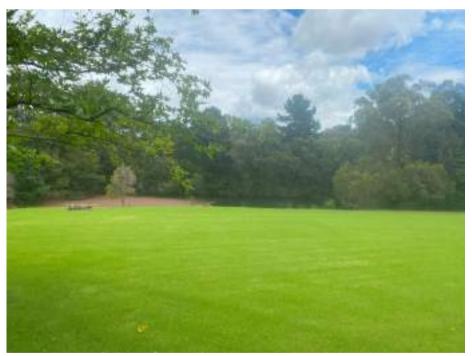
Managed gardens down to the dam

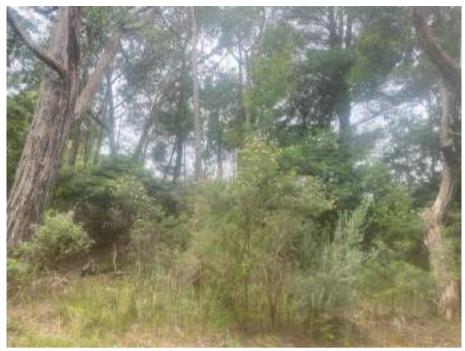
West side of dam adjoining Gordon Road

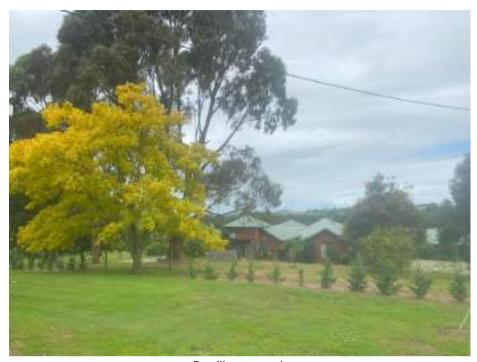
The land to the south comprises managed areas within the site and on the adjoining property to the south which would be classified as low threat vegetation under AS3959. There are areas of open paddock to the south west and south east which would be classified as grassland under AS3959. The slope of the grassland area is downslope from the proposed dwelling with a slope of 6° to the south west and 8° to the south east. The area to the south is shown in the photographs below:

Dwelling to south

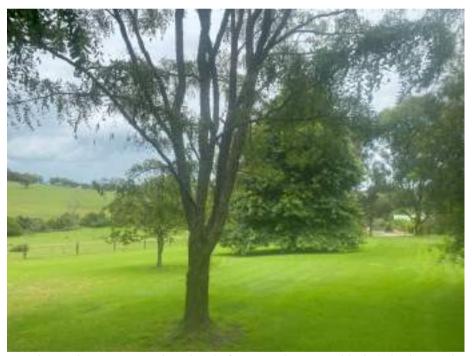
To the south east, managed gardens in foreground, open paddocks in background

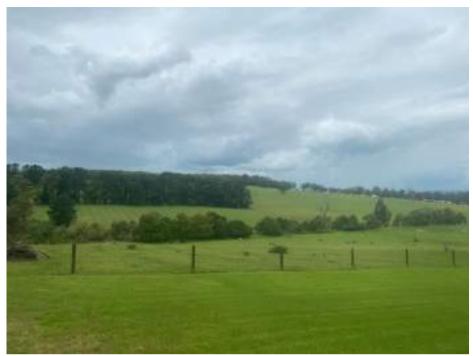
The land to the east comprises managed areas within the site which would be classified as low threat vegetation under AS3959. There are areas of open paddock to the east which would be classified as grassland under AS3959. The slope of the grassland area is downslope from the proposed dwelling with a slope of 9° to the south east. The areas to the east are shown in the photograph below:

To the east, managed gardens in foreground, open paddocks in background

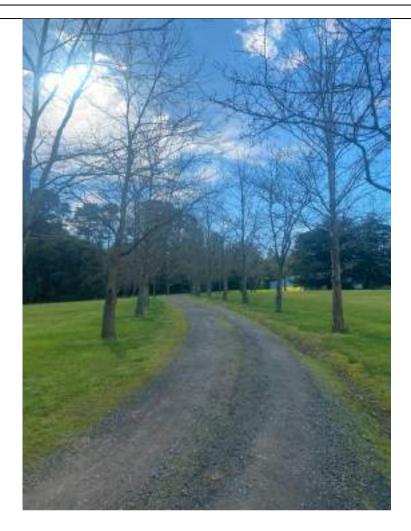
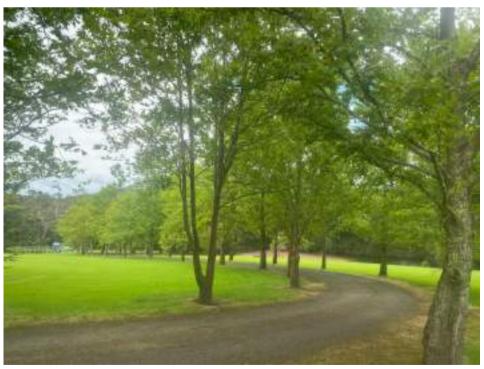
Two variations are sought to the defendable space requirements as alternative measures based on the managed nature of the gardens around the existing and proposed dwelling. Firstly it is proposed to retain the existing rows of plane trees either side of the driveway which would not meet the canopy separation requirements above on the basis that trees pose a low bushfire risk given they are exotic trees with tight smooth bark and are in a managed lawn environment as shown in the photographs below:

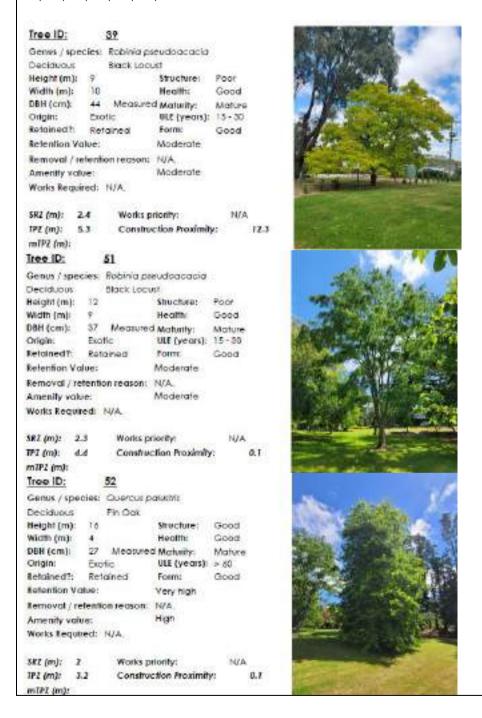
The second is the retention of a number of smaller exotic trees within the existing managed garden which would not meet the canopy separation requirements. The trees pose a low bushfire risk given their location within a managed exotic garden and includes trees 39, 51, 52, 56, 58, 61, 65, 66, 67 and 68.

Tree ID: Genus / species: Marus alba Deciduous Mulberry Height (m): 5 Shucture: Good Width (m): 5 Health: Good DBH (cm): 20 Measured Maturity: Mature Origin: Exotic title (years): > 60 Retained?: Retained Form: Good Retention Value: Moderate Removal / retention reason: N/A. Amenity value: Works Required: N/A 5RZ (m): 1.8 Works priority: N/A TPE (m): 2.4 Construction Proximity: mTPZ (m): Tree ID: Genus / species: Prunus semulata Deciduous Japanese Flowering Cherry Height (m): 6 Structure: Good Width (m): 12 Health:
DBH (cm): 54 Measured Mahrity:
Origin: Exotic BLE (vers Fore Over mature Origina Exotic ULE (years): 5 - 15 Retained?; Retained Form: Fair Retention Votue: Low Removal / retention reason: N/A. Moderate Amenity value: Works Required: N/A. 582 (m): 2.7 Works priority: N/A TPZ (m)z 6.5 Construction Proximity: mTPZ (m): Tree ID: Genus / species: Frunus semulata Deciduous Japanese Flowering Cherry ffeight (m): 3 Shuchire: Good Width (m): 5 Health: Good DBH (cm): 24 Measured Maturity: Mature Origin: Exotic ULE (years): 30 - 60 Retained?: Retained Form. Refertion Value: Very low Kemoval / retention reason: N/A. Very low Amenity value: Works Required: N/A. SRZ (m): 1.9 Works priority: TPZ (m): 2.9 Construction Proximity: mIPI (m): 65 Tree ID: Genus / species: Prunus semulata Japanese Rowering Cherry Decktuous Height (m): 4 Structure: Fair Width (m): 2 Health: Good 08H (cm): 10 Measured Maferity: Immature Origin: Exotic ME (years): 15-30

Retained?: Retained Form: Foor Retention Value: Very low Removal / retention reason: N/A. Amenity value: Very low Works Required: 11/A. SR2 (m): 1.6 Works priority: TPE (m): 2.0 Construction Proximity: mFPZ (m):

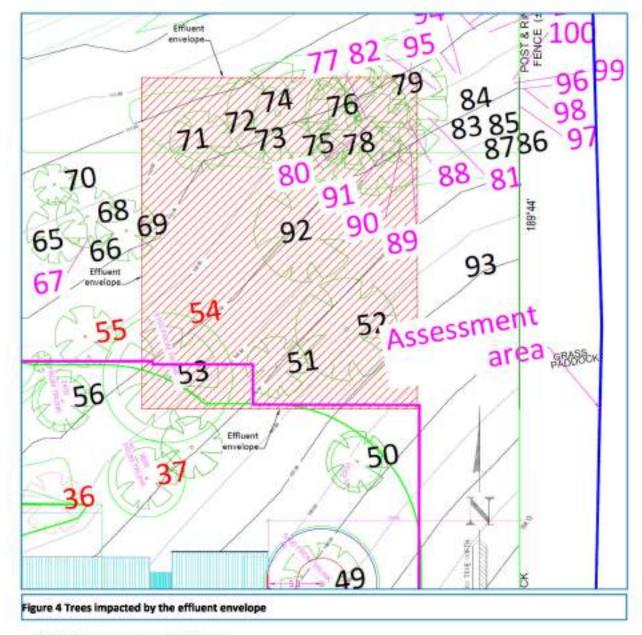
13.4. Trees 51, 52, 53, 71, 72, 73, 74, 75, 79, 80, 88, 89, 90, 91 & 92

These trees are located within the proposed subsoil effluent envelope (Figure 4).

These trees will remain viable within the proposed effluent envelope.

The Arborist Report notes that Trees 51, 52, 53, 71, 72, 73, 74, 75, 79, 80, 88, 89, 90, 91 & 92 are located within the proposed subsoil effluent envelope. In response to Council's concerns the effluent distribution system is proposed to be drip irrigation laid at grade within the specified area and covered with a layer of mulch. The Arborist Report notes the only impact of this system will be the delivery plumbing and the increased nutrient load of the effluent liquids. Given that the trees in this area are mostly exotic species and that it is likely that this soil has a good infiltration rate, it is likely that the increased nutrient load created by the effluent discharge will have little impact on the health or longevity of the affected trees. The location of the delivery plumbing for the effluent envelope is not specified and so its impact has not been calculated. However, provided that it is located outside the TPZ of retained trees, it will have little impact on the health and longevity of these trees.

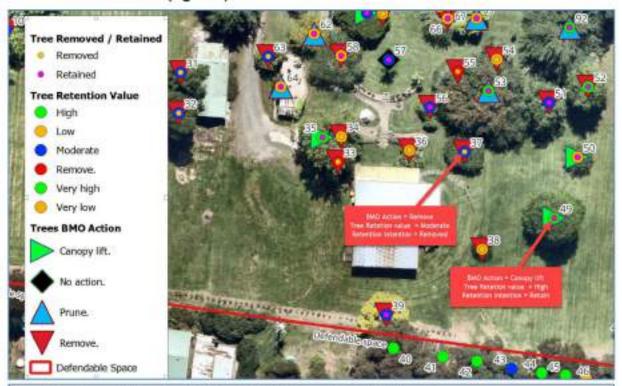
Figure 5 Tree Removal / Retention intention, Retention Value and BMO Action legend

- Where trees are required to be removed to achieve the requirements of the BMO an effort is made to retain those trees with the highest retention value and trees with lower retention values are generally preferentially removed.
- It is understood that the owners of this property wish to retain a number of trees that are listed below as removed.
 - This will not be in accordance with the CFA canopy separation guidelines and must be negotiated directly with the CFA.
 - b. The following site plans show the tree removal and pruning that is likely to be required to be in accordance with the CFA canopy separation specification.
- Tree Removal / Retention intention, Retention Value and BMO Action are illustrated as set out below (Figure 5).
