Notice of Application for a Planning Permit

The land affected by the application is located at:	L4B LP6442 V4968 F530 42 Payne Road, Beaconsfield VIC 3807
The application is for a permit to:	Construction of a Replacement Dwelling, Construction, Use and Illumination of a Private Tennis Court and Removal of Vegetation

Application No.: T240471 PA
Proposal: Construction of a Replacement Dwelling and Associated Works
Location: 42 Payne Road, Beaconsfield

Buildings & Works Associated with a Replacement Dwelling at 42 Payne Road, Beaconsfield.

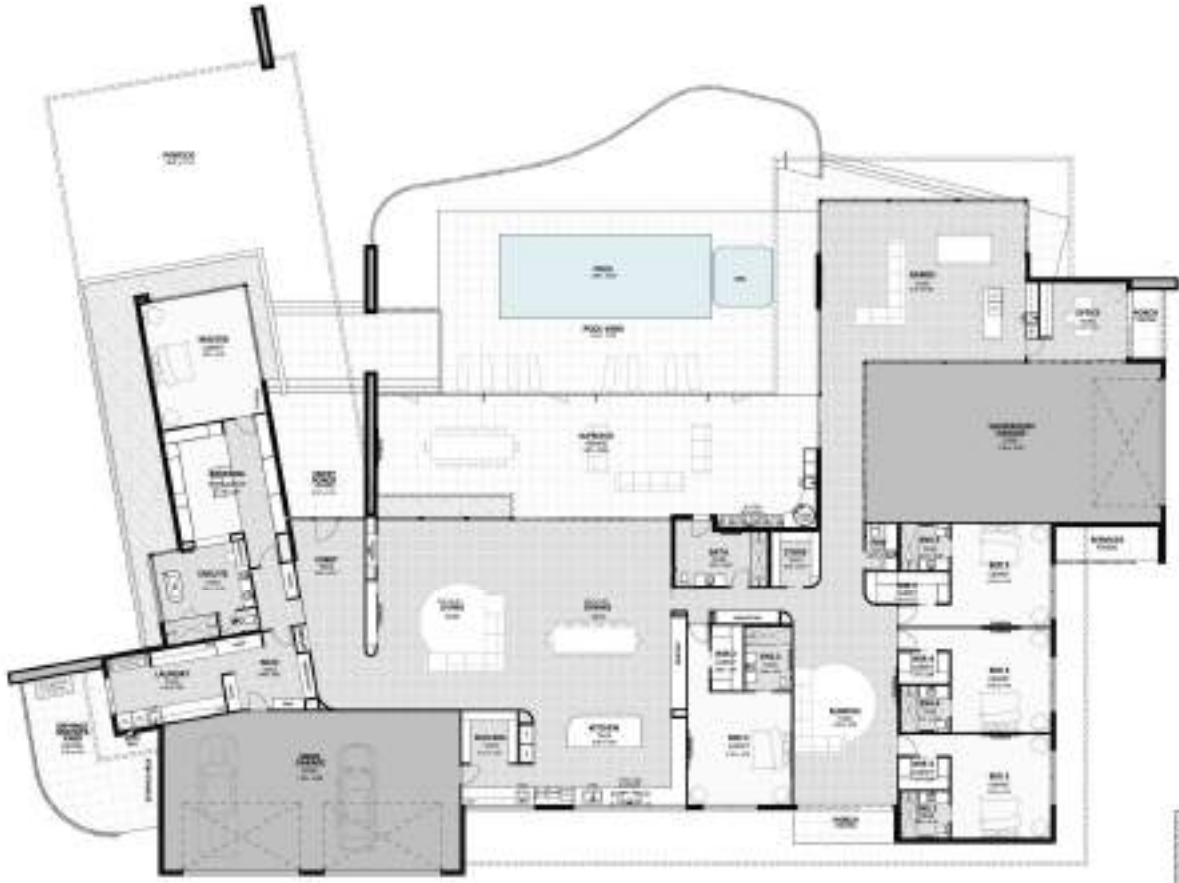
Figure 1 - Proposed Floor Plan

The application seeks approval for construction of a single storey replacement dwelling.

- A new septic system is proposed to service the new dwelling.
- It is proposed that the existing dwelling is to be decommissioned and used as a studio / rumpus area. Decommission plans can be provided if required.

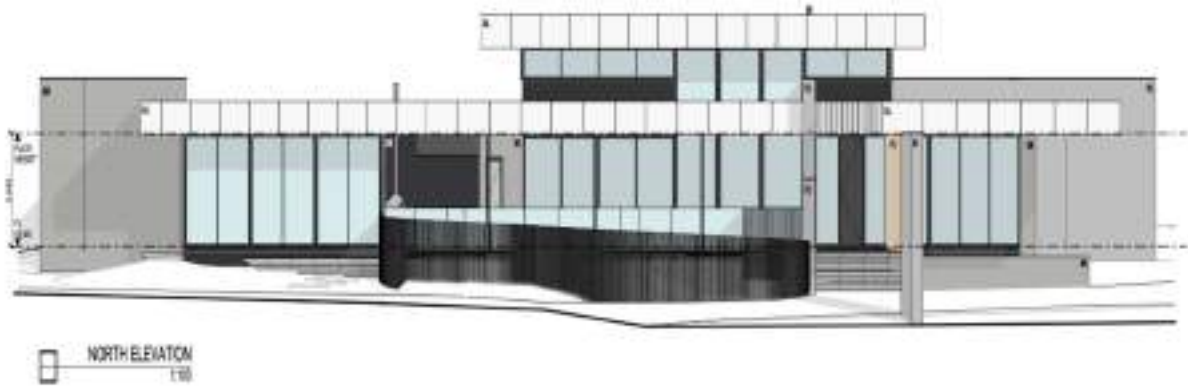
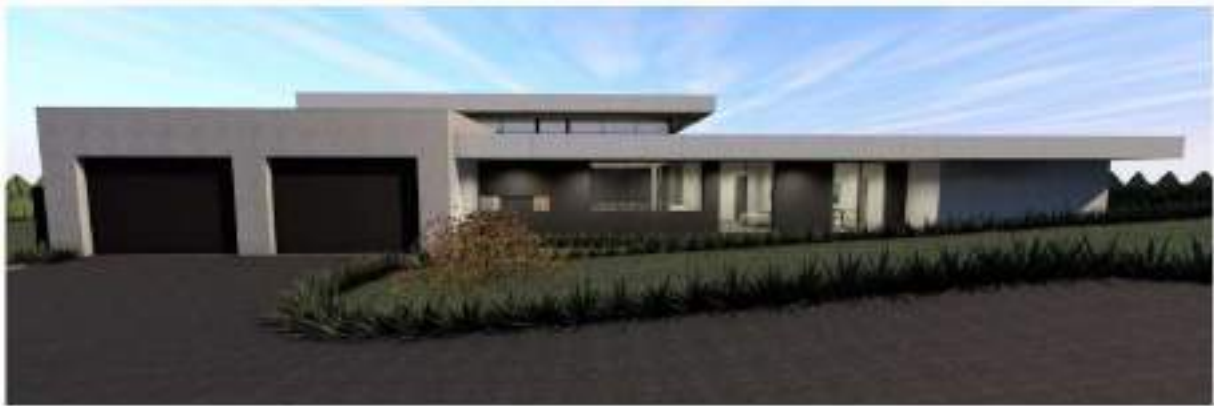
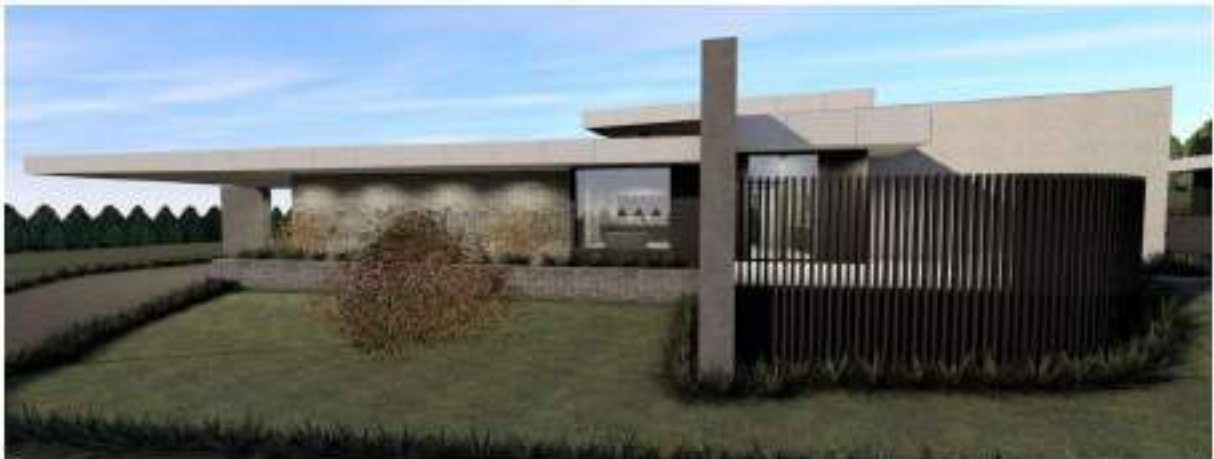
Figure 2 - Proposed Elevation Plans

Southern Perspective

Western Perspective

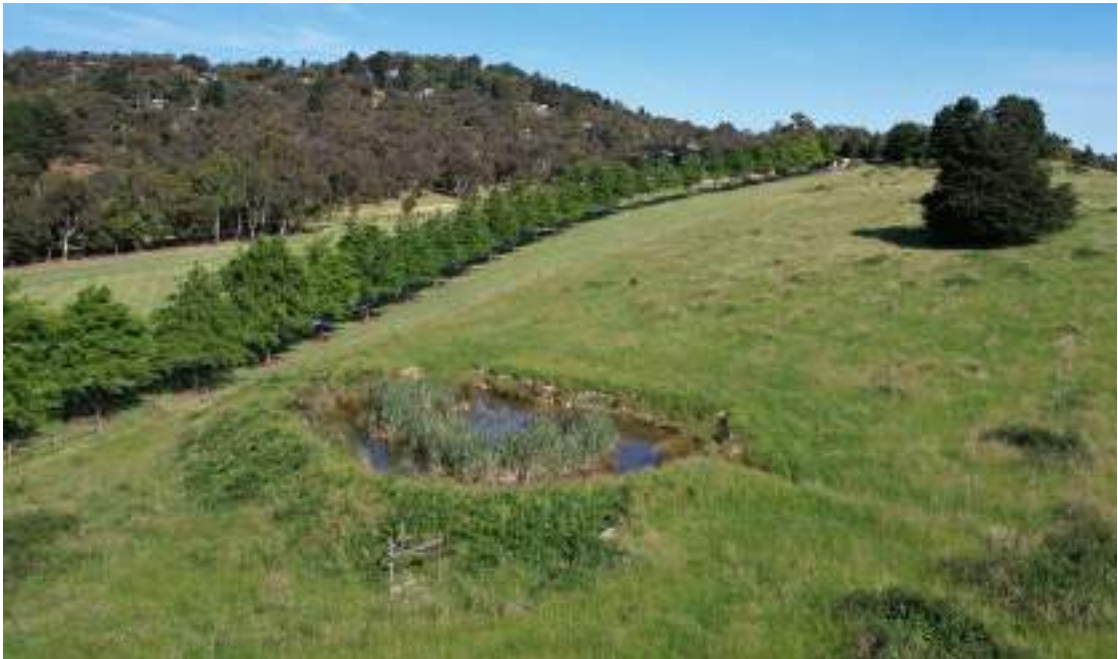
Figure 6 - view of the dam and location of development.

It is submitted that the proposed replacement dwelling is not in contrast to the requirements of this clause and will not cause any detrimental impact on the landscape value of the area. Some vegetation removal is required around the dam but this vegetation have been planted and mostly contains shrubs.

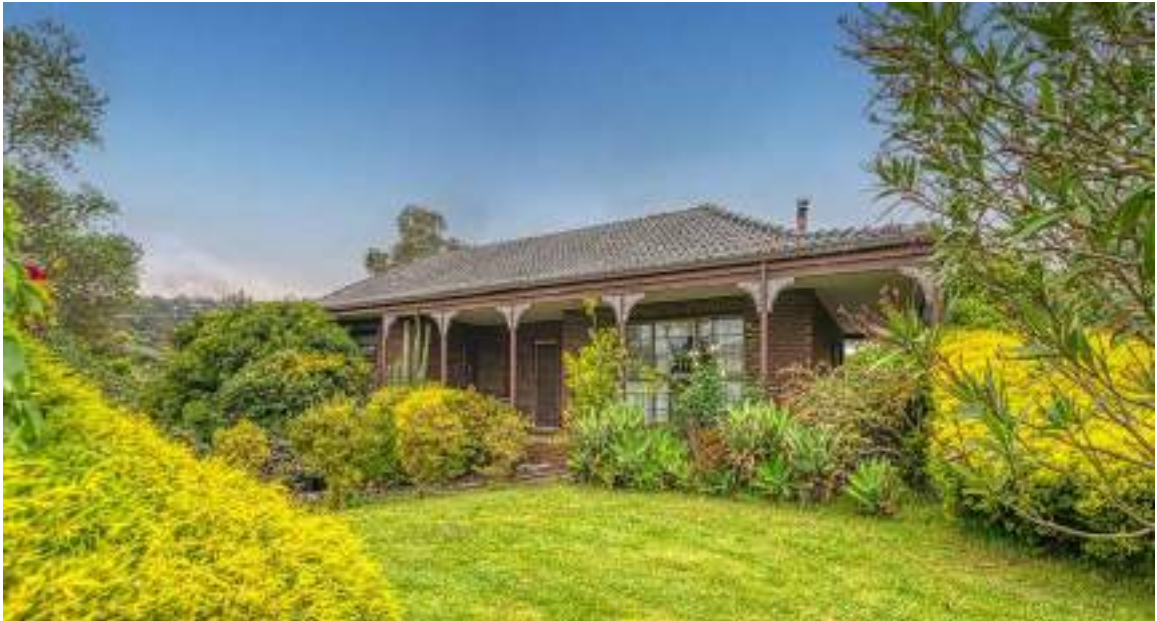
Figure 7 – Existing dwelling onsite to be decommissioned and retained.

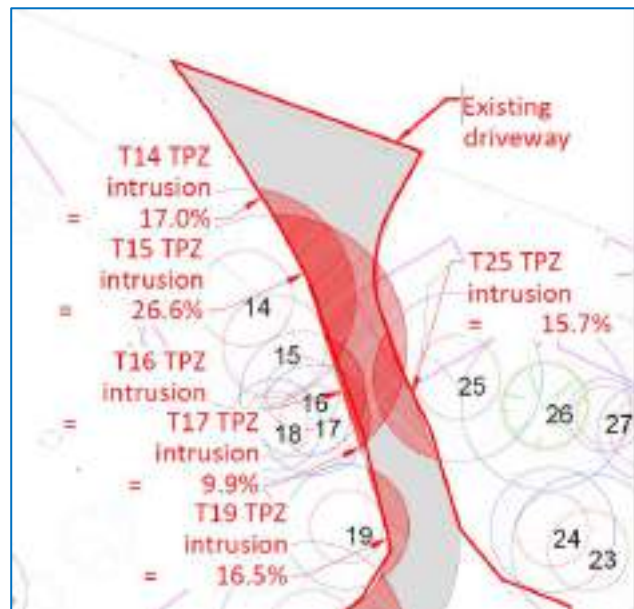
Figure 1 Trees 14 - 25 TPZ intrusions

The proposed driveway in the area of these trees is located largely over the existing driveway and, as such, will not significantly alter their growing conditions.

These trees will remain viable within the proposed development.

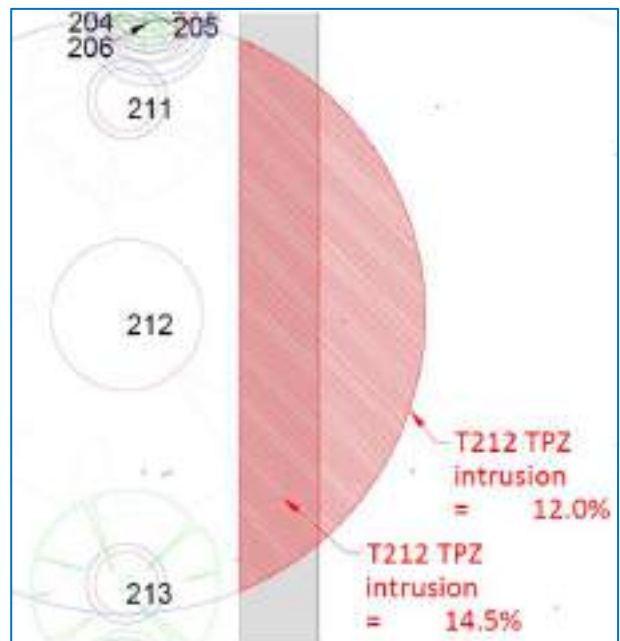
Figure 3 Tree 212 TPZ intrusion

Provided that one of these alternatives is adopted this tree will remain viable within the proposed development.

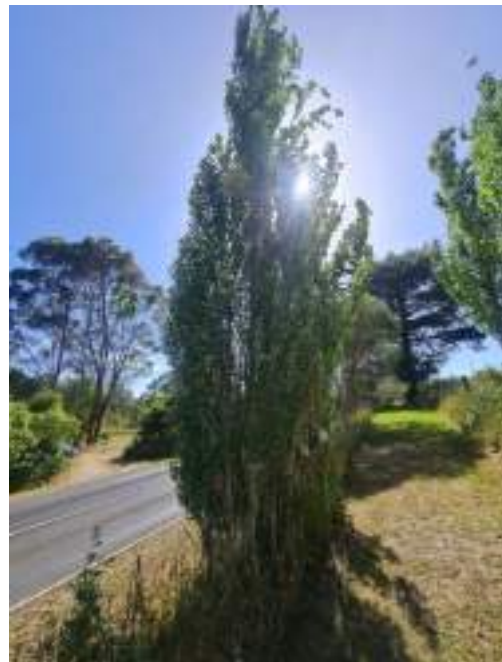
Tree ID: 1

Genus / species: *Populus alba*
 Deciduous White Poplar
Height (m): 9 **Structure:** Fair
Width (m): 2 **Health:** Good
DBH (cm): 15 Measured **Maturity:** Mature
Origin: Exotic **ULE (years):** 30 - 60
Retained?: Retained **Form:** Good
Retention Value: Moderate
Removal / retention reason: Road reserve.
Amenity value: Moderate
Works Required: N/A.

SRZ (m): 1.6 **Works priority:** N/A
TPZ (m): 2.0 **Construction Proximity:** 3
mTPZ (m): = TPZ

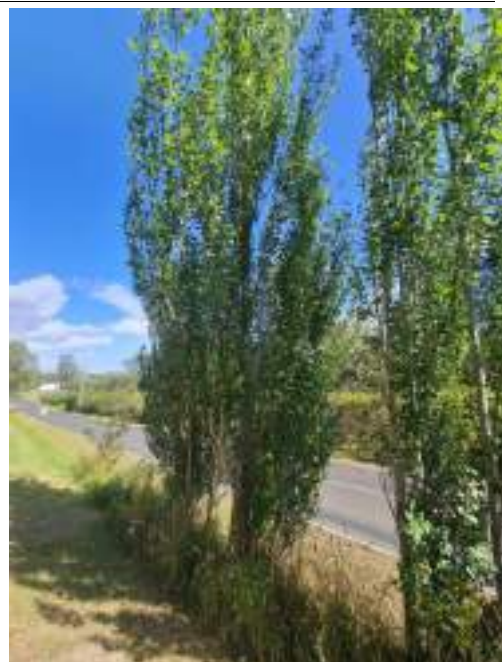
Tree ID: 2

Genus / species: *Populus alba*
 Deciduous White Poplar
Height (m): 12 **Structure:** Fair
Width (m): 3 **Health:** Good
DBH (cm): 28 Measured **Maturity:** Mature
Origin: Exotic **ULE (years):** 30 - 60
Retained?: Retained **Form:** Good
Retention Value: Moderate
Removal / retention reason: Road reserve.
Amenity value: Moderate
Works Required: N/A.

SRZ (m): 2 **Works priority:** N/A
TPZ (m): 3.4 **Construction Proximity:** 4.4
mTPZ (m): = TPZ

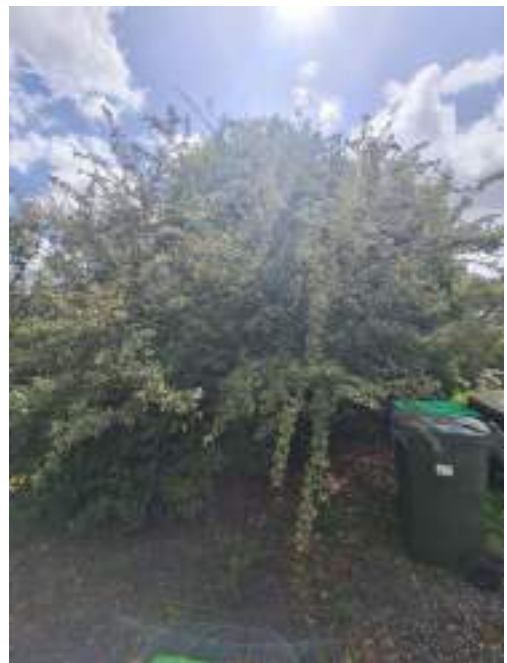
Tree ID: 24

Genus / species: *Cotoneaster glaucophyllus*
 Evergreen Cotoneaster
Height (m): 4 **Structure:** Fair
Width (m): 8 **Health:** Good
DBH (cm): 28 Estimated **Maturity:** Mature
Origin: Exotic **ULE (years):** 15 - 30
Retained?: Retained **Form:** Poor
Retention Value: Low
Removal / retention reason: N/A.
Amenity value: Low
Works Required: N/A.

SRZ (m): 2 **Works priority:** N/A
TPZ (m): 3.4 **Construction Proximity:** 4.4
mTPZ (m): = TPZ

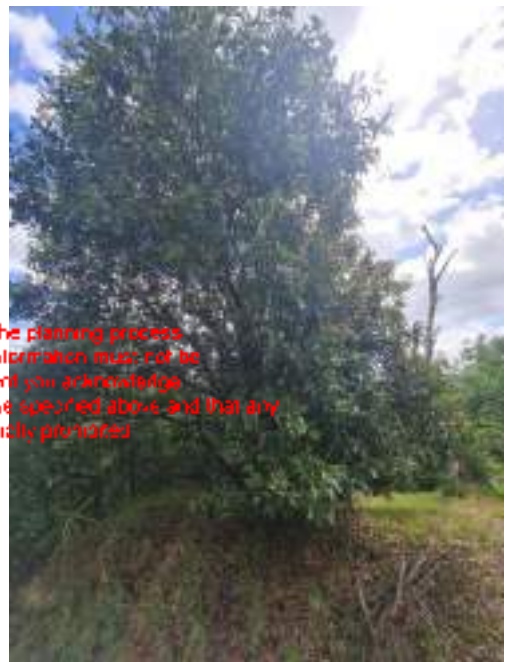
Tree ID: 25

Genus / species: *Photinia serrulata*
 Evergreen Chinese Hawthorn
Height (m): 6 **Structure:** Fair
Width (m): 7 **Health:** Good
DBH (cm): 38 Measured **Maturity:** Mature
Origin: Exotic **ULE (years):** 15 - 30
Retained?: Retained **Form:** Good
Retention Value: Low
Removal / retention reason: N/A
Amenity value: Low
Works Required: N/A.

SRZ (m): 2.3 **Works priority:** N/A
TPZ (m): 4.6 **Construction Proximity:** 2.6
mTPZ (m): = TPZ

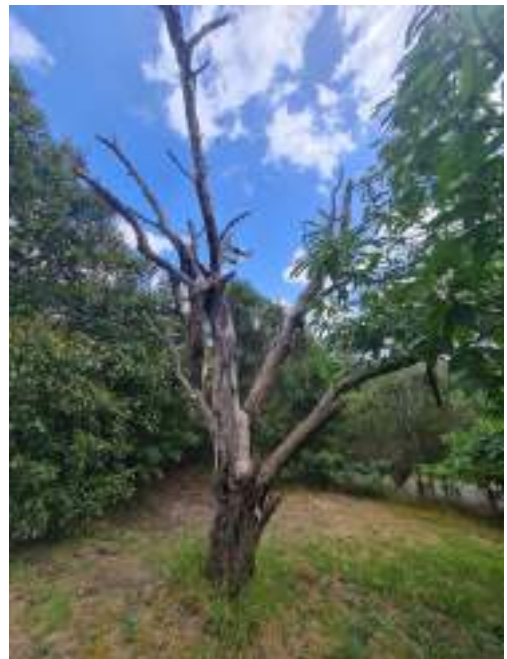
Tree ID: 26

Genus / species: *Unknown sp.*
 Unknown Unknown
Height (m): 6 **Structure:** Poor
Width (m): 6 **Health:** Dead
DBH (cm): 38 Measured **Maturity:** Over mature
Origin: Unknown **ULE (years):** 0
Retained?: Retained **Form:** Poor
Retention Value: Remove.
Removal / retention reason: N/A.
Amenity value: Very low
Works Required: N/A.

SRZ (m): 2.3 **Works priority:** N/A
TPZ (m): 4.6 **Construction Proximity:** 5.6
mTPZ (m): = TPZ

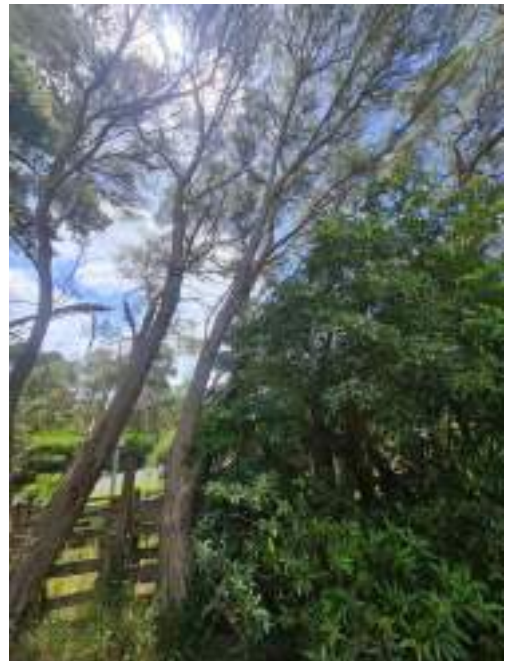
Tree ID: 33

Genus / species: *Melaleuca armillaris*
 Evergreen Giant Honey Myrtle
Height (m): 10 **Structure:** Poor
Width (m): 5 **Health:** Fair
DBH (cm): 48 Measured **Maturity:** Mature
Origin: Victorian **ULE (years):** 15 - 30
Retained?: Retained **Form:** Poor
Retention Value: Moderate
Removal / retention reason: N/A.
Amenity value: Moderate
Works Required: N/A.

SRZ (m): 2.5 **Works priority:** N/A
TPZ (m): 5.8 **Construction Proximity:** 6.8
mTPZ (m): = TPZ

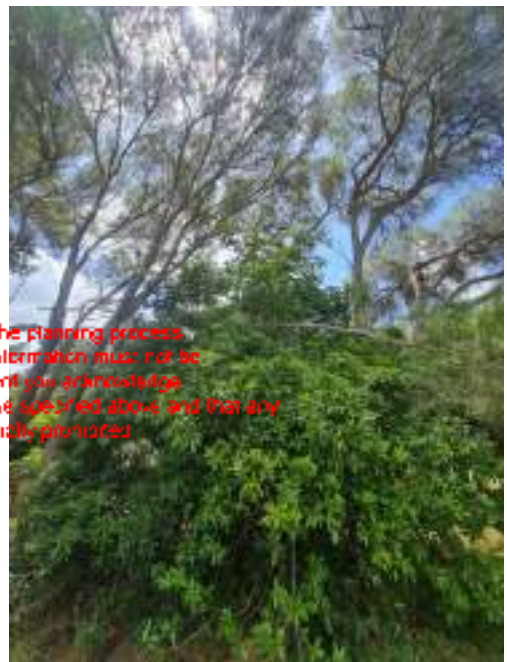
Tree ID: 34

Genus / species: *Melaleuca armillaris*
 Evergreen Giant Honey Myrtle
Height (m): 10 **Structure:** Poor
Width (m): 5 **Health:** Fair
DBH (cm): 34 Measured **Maturity:** Mature
Origin: Victorian **ULE (years):** 15 - 30
Retained?: Retained **Form:** Poor
Retention Value: Moderate
Removal / retention reason: N/A
Amenity value: Moderate
Works Required: N/A.

SRZ (m): 2.2 **Works priority:** N/A
TPZ (m): 4.1 **Construction Proximity:** 5.1
mTPZ (m): = TPZ

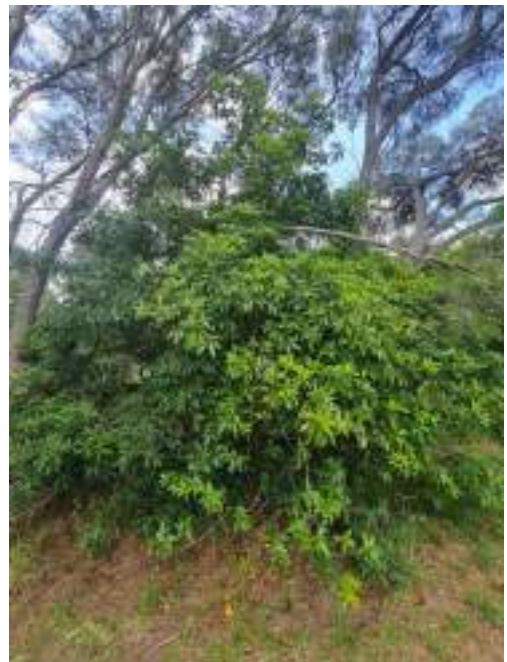
Tree ID: 35

Genus / species: *Pittosporum undulatum*
 Evergreen Sweet Pittosporum
Height (m): 5 **Structure:** Good
Width (m): 5 **Health:** Good
DBH (cm): 20 Estimated **Maturity:** Young
Origin: Victorian **ULE (years):** 15 - 30
Retained?: Retained **Form:** Fair
Retention Value: Low
Removal / retention reason: N/A.
Amenity value: Low
Works Required: N/A.

SRZ (m): 1.8 **Works priority:** N/A
TPZ (m): 2.4 **Construction Proximity:** 3.4
mTPZ (m): = TPZ

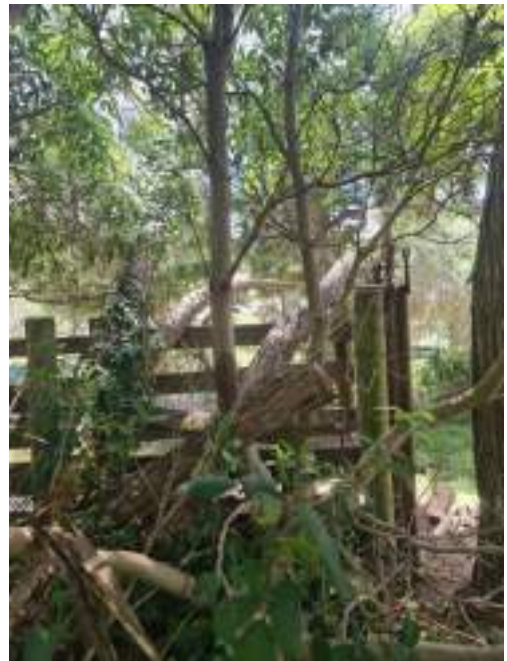
Tree ID: 36

Genus / species: *Melaleuca armillaris*
 Evergreen Giant Honey Myrtle
Height (m): 7 **Structure:** Poor
Width (m): 6 **Health:** Good
DBH (cm): 39 Measured **Maturity:** Mature
Origin: Victorian **ULE (years):** 15 - 30
Retained?: Retained **Form:** Very poor
Retention Value: Low
Removal / retention reason: N/A.
Amenity value: Low
Works Required: N/A.

SRZ (m): 2.3 **Works priority:** N/A
TPZ (m): 4.7 **Construction Proximity:** 5.7
mTPZ (m): = TPZ

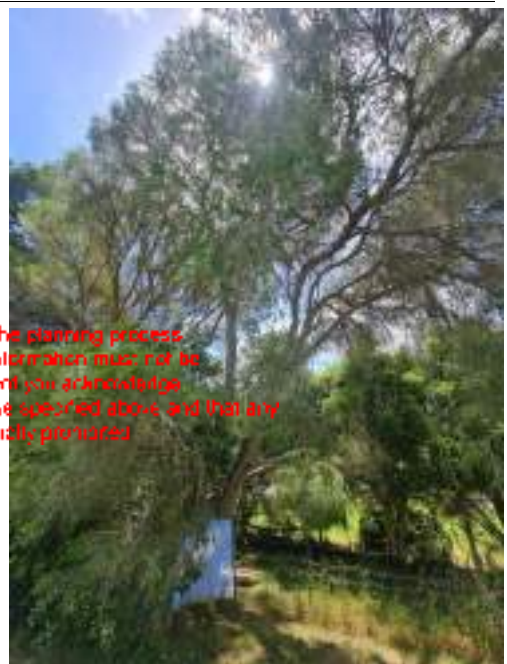
Tree ID: 37

Genus / species: *Melaleuca armillaris*
 Evergreen Giant Honey Myrtle
Height (m): 18 **Structure:** Fair
Width (m): 8 **Health:** Good
DBH (cm): 48 Measured **Maturity:** Mature
Origin: Victorian **ULE (years):** 15 - 30
Retained?: Retained **Form:** Fair
Retention Value: Moderate
Removal / retention reason: N/A
Amenity value: Moderate
Works Required: N/A.

SRZ (m): 2.5 **Works priority:** N/A
TPZ (m): 5.8 **Construction Proximity:** 6.8
mTPZ (m): = TPZ

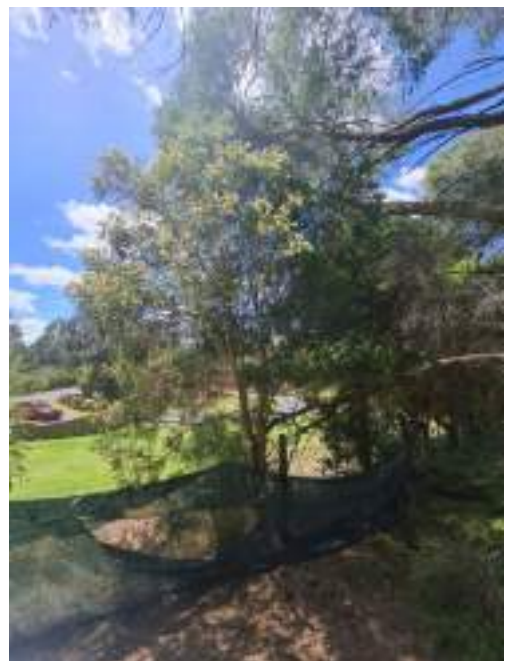
Tree ID: 38

Genus / species: *Melaleuca styphelioides*
 Evergreen Prickly Paperbark
Height (m): 5 **Structure:** Good
Width (m): 4 **Health:** Good
DBH (cm): 24 Measured **Maturity:** Mature
Origin: Australian **ULE (years):** 15 - 30
Retained?: Retained **Form:** Good
Retention Value: Low
Removal / retention reason: N/A.
Amenity value: Low
Works Required: N/A.

SRZ (m): 1.9 **Works priority:** N/A
TPZ (m): 2.9 **Construction Proximity:** 3.9
mTPZ (m): = TPZ

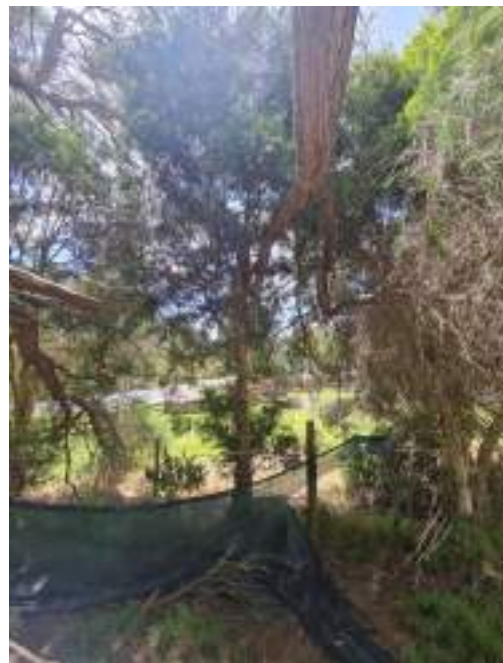
Tree ID: 39

Genus / species: *Melaleuca styphelioides*
 Evergreen Prickly Paperbark
Height (m): 5 **Structure:** Good
Width (m): 3 **Health:** Good
DBH (cm): 16 Measured **Maturity:** Mature
Origin: Australian **ULE (years):** 15 - 30
Retained?: Retained **Form:** Good
Retention Value: Low
Removal / retention reason: N/A.
Amenity value: Low
Works Required: N/A.

SRZ (m): 1.6 **Works priority:** N/A
TPZ (m): 2.0 **Construction Proximity:** 3
mTPZ (m): = TPZ

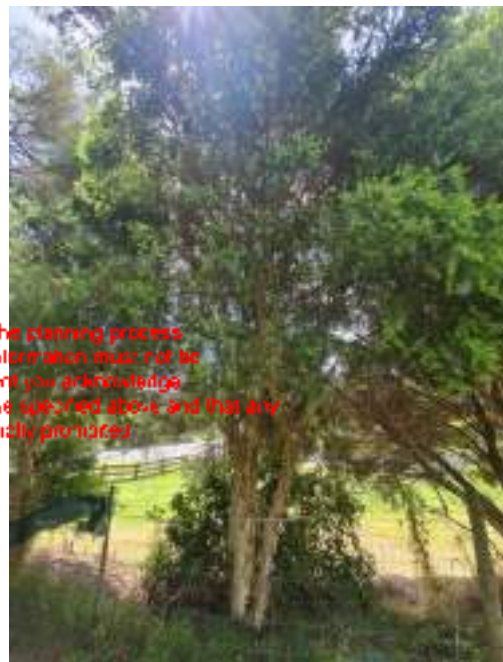
Tree ID: 40

Genus / species: *Melaleuca styphelioides*
 Evergreen Prickly Paperbark
Height (m): 6 **Structure:** Good
Width (m): 4 **Health:** Good
DBH (cm): 31 Measured **Maturity:** Mature
Origin: Australian **ULE (years):** 15 - 30
Retained?: Retained **Form:** Good
Retention Value: Low
Removal / retention reason: N/A.
Amenity value: Low
Works Required: N/A.

SRZ (m): 2.1 **Works priority:** N/A
TPZ (m): 3.7 **Construction Proximity:** 4.7
mTPZ (m): = TPZ

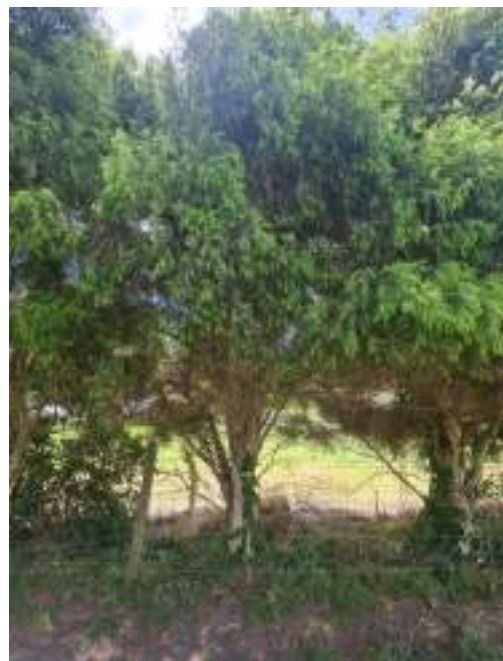
Tree ID: 41

Genus / species: *Melaleuca styphelioides*
 Evergreen Prickly Paperbark
Height (m): 6 **Structure:** Good
Width (m): 5 **Health:** Good
DBH (cm): 34 Measured **Maturity:** Mature
Origin: Australian **ULE (years):** 15 - 30
Retained?: Retained **Form:** Good
Retention Value: Low
Removal / retention reason: N/A.
Amenity value: Low
Works Required: N/A.

SRZ (m): 2.2 **Works priority:** N/A
TPZ (m): 4.1 **Construction Proximity:** 5.1
mTPZ (m): = TPZ

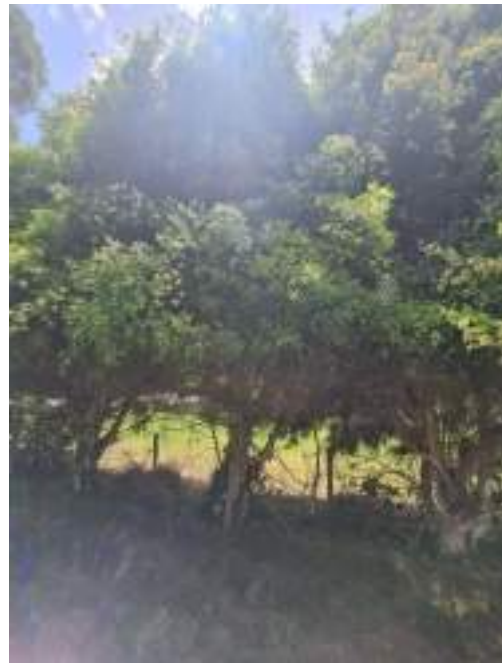
Tree ID: 42

Genus / species: *Melaleuca styphelioides*
 Evergreen Prickly Paperbark
Height (m): 7 **Structure:** Good
Width (m): 4 **Health:** Good
DBH (cm): 39 Measured **Maturity:** Mature
Origin: Australian **ULE (years):** 15 - 30
Retained?: Retained **Form:** Fair
Retention Value: Low
Removal / retention reason: N/A.
Amenity value: Low
Works Required: N/A.

SRZ (m): 2.3 **Works priority:** N/A
TPZ (m): 4.7 **Construction Proximity:** 5.7
mTPZ (m): = TPZ

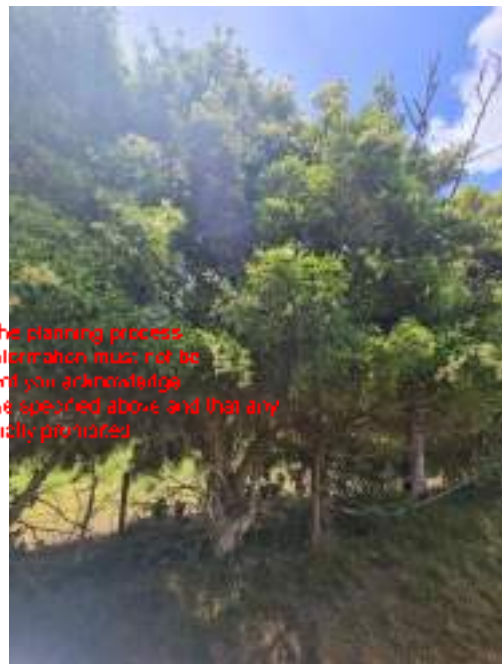
Tree ID: 43

Genus / species: *Melaleuca styphelioides*
 Evergreen Prickly Paperbark
Height (m): 7 **Structure:** Good
Width (m): 4 **Health:** Good
DBH (cm): 47 Estimated **Maturity:** Mature
Origin: Australian **ULE (years):** 15 - 30
Retained?: Retained **Form:** Fair
Retention Value: Low
Removal / retention reason: N/A
Amenity value: Low
Works Required: N/A.

SRZ (m): 2.5 **Works priority:** N/A
TPZ (m): 5.6 **Construction Proximity:** 6.6
mTPZ (m): = TPZ

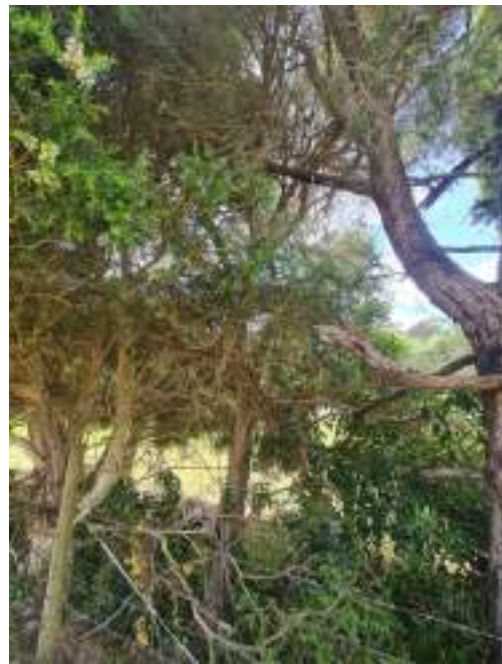
Tree ID: 44

Genus / species: *Melaleuca armillaris*
 Evergreen Giant Honey Myrtle
Height (m): 5 **Structure:** Good
Width (m): 4 **Health:** Good
DBH (cm): 22 Measured **Maturity:** Mature
Origin: Victorian **ULE (years):** 15 - 30
Retained?: Retained **Form:** Poor
Retention Value: Low
Removal / retention reason: N/A.
Amenity value: Low
Works Required: N/A.

SRZ (m): 1.9 **Works priority:** N/A
TPZ (m): 2.6 **Construction Proximity:** 3.6
mTPZ (m): = TPZ

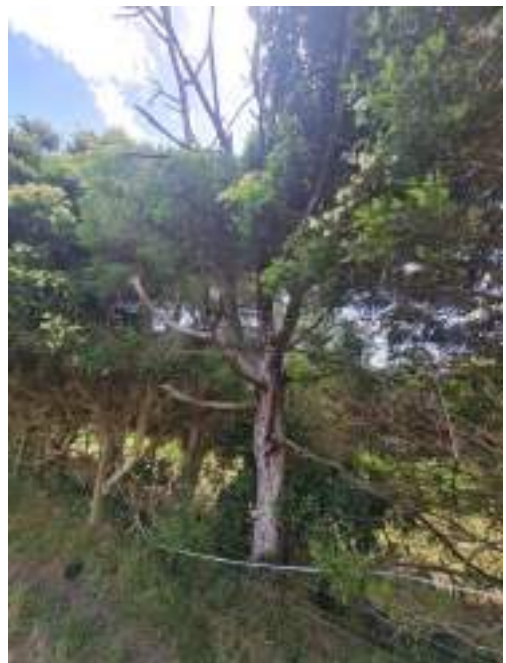
Tree ID: 45

Height (m): 7 **Structure:** Poor
Width (m): 4 **Health:** Dead
DBH (cm): 30 Measured **Maturity:** Over mature
Origin: Unknown **ULE (years):** 0
Retained?: Retained **Form:** Fair
Retention Value: Remove.
Removal / retention reason: N/A.
Amenity value: Very low
Works Required: N/A.

SRZ (m): 2.1 **Works priority:** N/A
TPZ (m): 3.6 **Construction Proximity:** 4.6
mTPZ (m): = TPZ

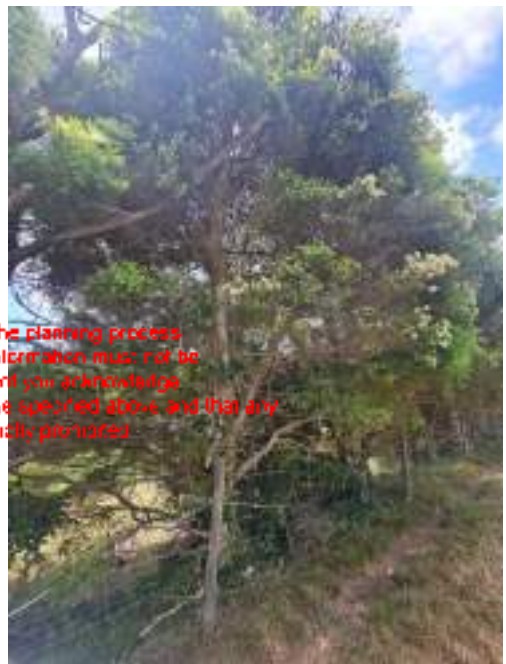
Tree ID: 46

Retention Value: Low
Removal / retention reason: N/A
Amenity value: Low
Works Required: N/A.

SRZ (m): 2.3 **Works priority:** N/A
TPZ (m): 4.7 **Construction Proximity:** 5.7
mTPZ (m): = TPZ

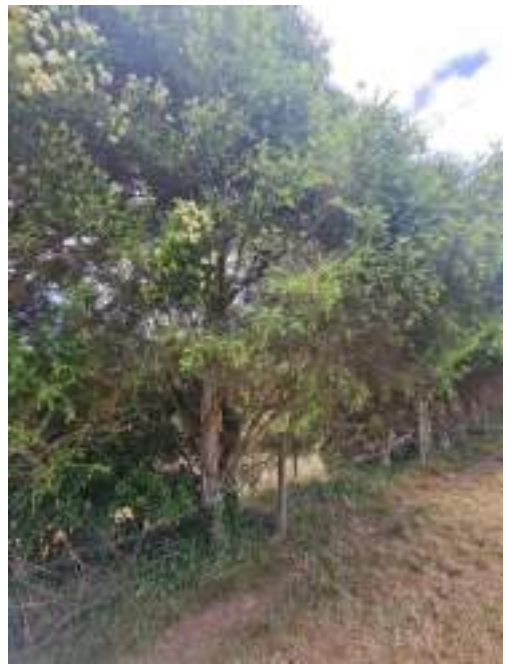
Tree ID: 47

Retention Value: Low
Removal / retention reason: N/A.
Amenity value: Low
Works Required: N/A.

SRZ (m): 2.5 **Works priority:** N/A
TPZ (m): 5.8 **Construction Proximity:** 6.8
mTPZ (m): = TPZ

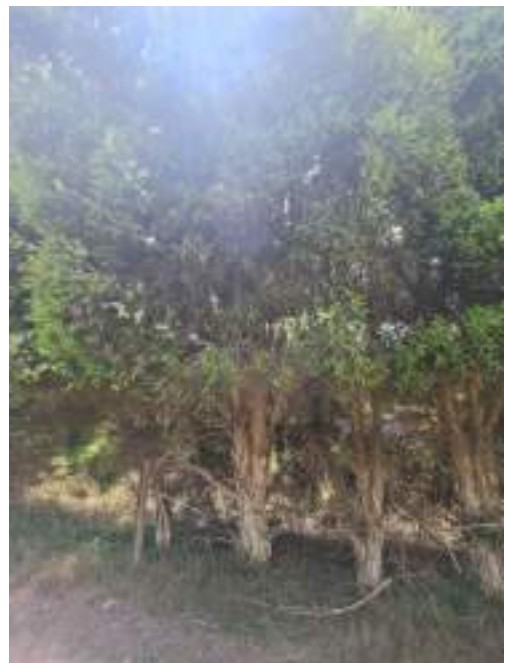
Tree ID: 48**Genus / species:** *Melaleuca styphelioides*

Height (m): 9	Structure: Fair
Width (m): 4	Health: Good
DBH (cm): 42 Measured	Maturity: Mature
Origin: Australian	ULE (years): 15 - 30
Retained?: Retained	Form: Fair

Retention Value: Low**Removal / retention reason:** N/A.**Amenity value:** Low**Works Required:** N/A.**SRZ (m): 2.4 Works priority:** N/A**TPZ (m): 5.0 Construction Proximity:** 6**mTPZ (m): = TPZ**

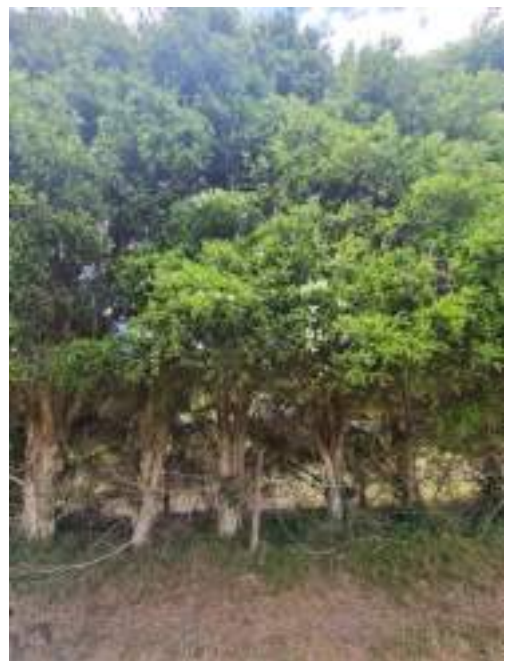
**Tree ID: 49****Genus / species:** *Melaleuca styphelioides*

Height (m): 9	Structure: Fair
Width (m): 4	Health: Good
DBH (cm): 41 Measured	Maturity: Mature
Origin: Australian	ULE (years): 15 - 30
Retained?: Retained	Form: Fair

Retention Value: Low**Removal / retention reason:** N/A.**Amenity value:** Low**Works Required:** N/A.**SRZ (m): 2.4 Works priority:** N/A**TPZ (m): 4.9 Construction Proximity:** 5.9**mTPZ (m): = TPZ**

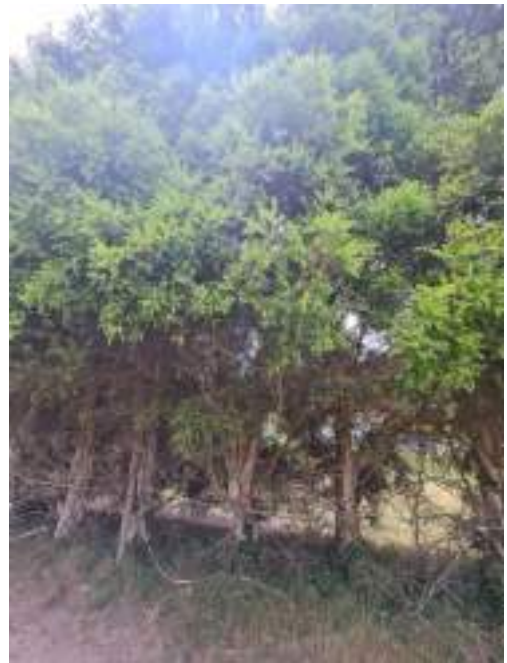
Tree ID: 51

TPZ (m): 3.8 **Construction Proximity:** 4.8

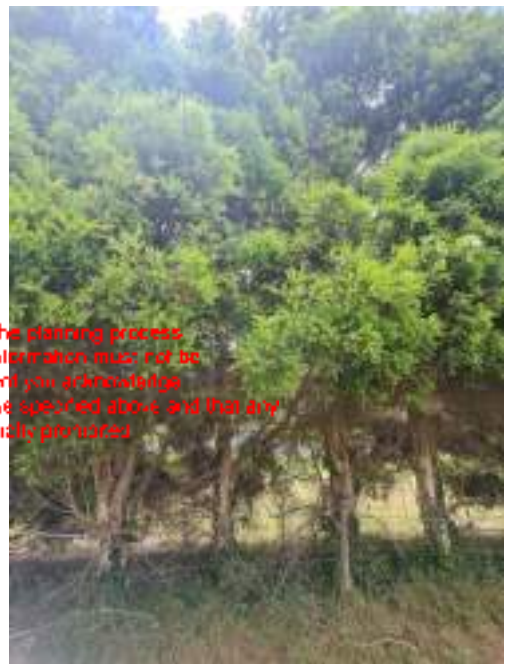
Tree ID: 52

TPZ (m): 3.2 **Construction Proximity:** 4.2

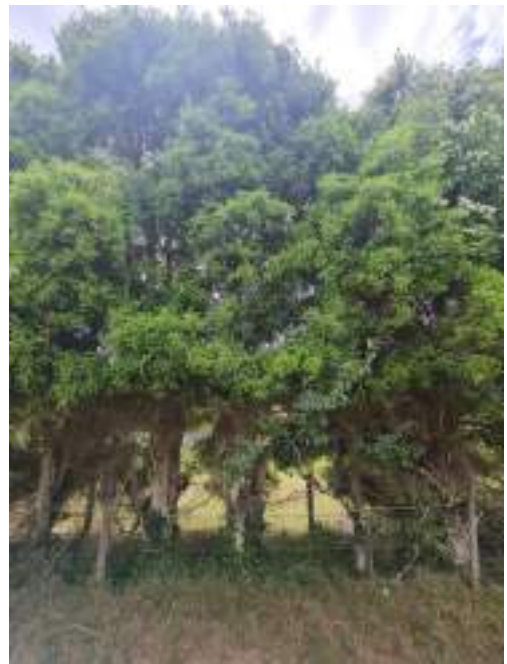
Tree ID: 53

TPZ (m): 3.5 **Construction Proximity:** 4.5

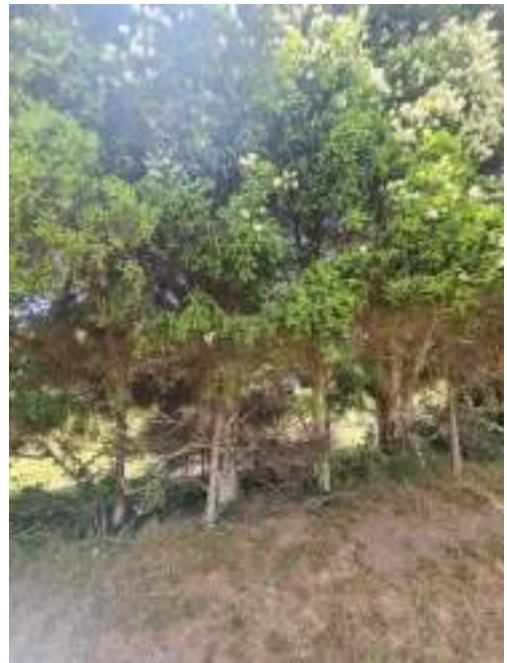
Tree ID: 54

Genus / species: *Melaleuca styphelioides*
 Evergreen Prickly Paperbark
Height (m): 8 **Structure:** Fair
Width (m): 4 **Health:** Good
DBH (cm): 29 Measured **Maturity:** Mature
Origin: Australian **ULE (years):** 15 - 30
Retained?: Retained **Form:** Fair
Retention Value: Low
Removal / retention reason: N/A.
Amenity value: Low
Works Required: N/A.

SRZ (m): 2.1 **Works priority:** N/A
TPZ (m): 3.5 **Construction Proximity:** 4.5
mTPZ (m): = TPZ

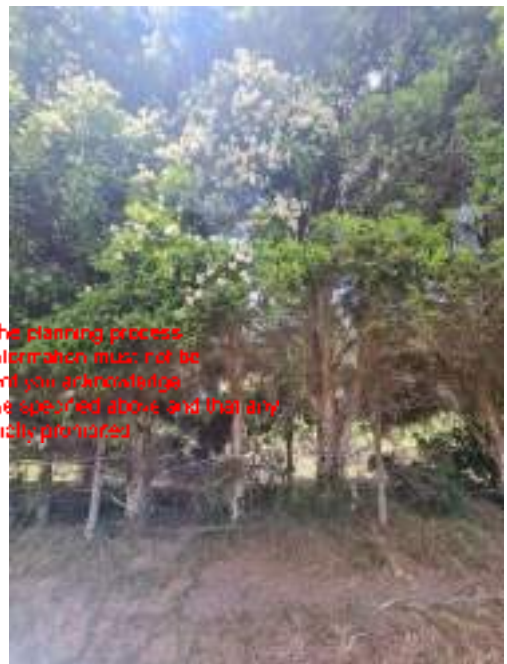
Tree ID: 55

Genus / species: *Melaleuca styphelioides*
 Evergreen Prickly Paperbark
Height (m): 8 **Structure:** Good
Width (m): 4 **Health:** Good
DBH (cm): 16 Measured **Maturity:** Mature
Origin: Australian **ULE (years):** 15 - 30
Retained?: Retained **Form:** Fair
Retention Value: Low
Removal / retention reason: N/A
Amenity value: Low
Works Required: N/A.

SRZ (m): 1.6 **Works priority:** N/A
TPZ (m): 2.0 **Construction Proximity:** 3
mTPZ (m): = TPZ

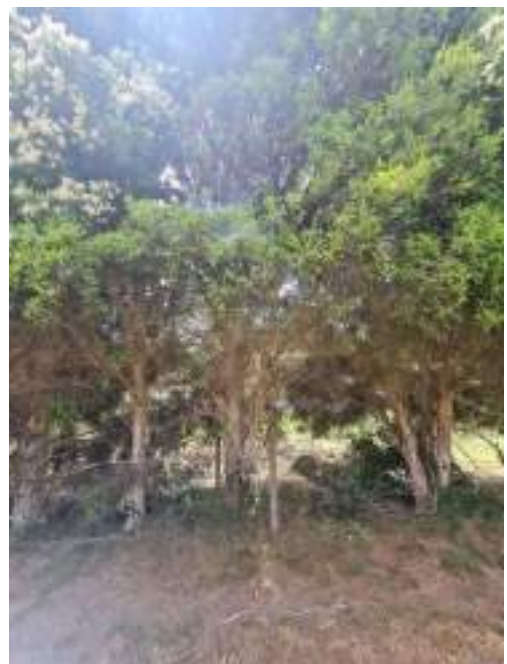
Tree ID: 56

Genus / species: *Melaleuca styphelioides*
 Evergreen Prickly Paperbark
Height (m): 9 **Structure:** Fair
Width (m): 4 **Health:** Good
DBH (cm): 40 Measured **Maturity:** Mature
Origin: Australian **ULE (years):** 15 - 30
Retained?: Retained **Form:** Fair
Retention Value: Low
Removal / retention reason: N/A.
Amenity value: Low
Works Required: N/A.

SRZ (m): 2.4 **Works priority:** N/A
TPZ (m): 4.8 **Construction Proximity:** 5.8
mTPZ (m): = TPZ

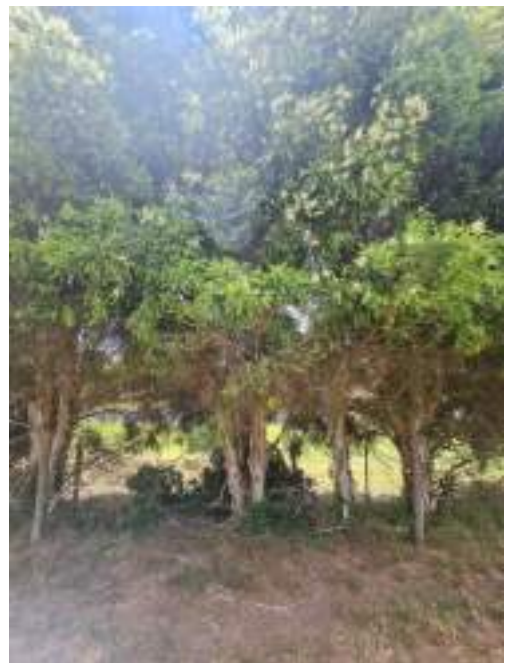
Tree ID: 57

TPZ (m): 3.2 **Construction Proximity:** 4.2

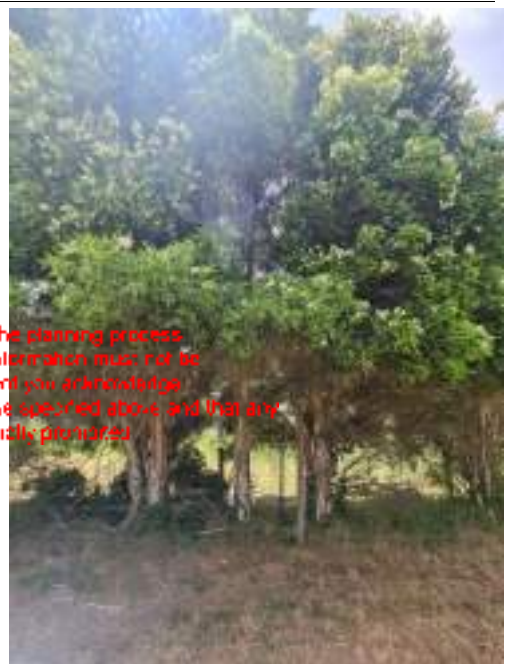
Tree ID: 58

TPZ (m): 2.6 **Construction Proximity:** 3.6

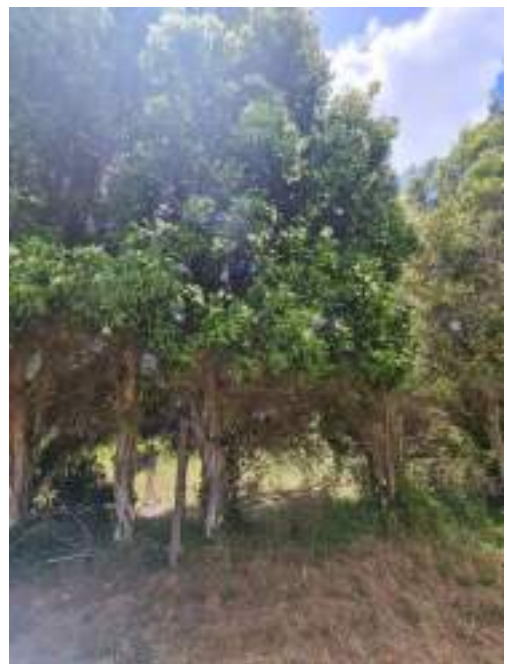
Tree ID: 59

TPZ (m): 4.3 **Construction Proximity:** 5.3

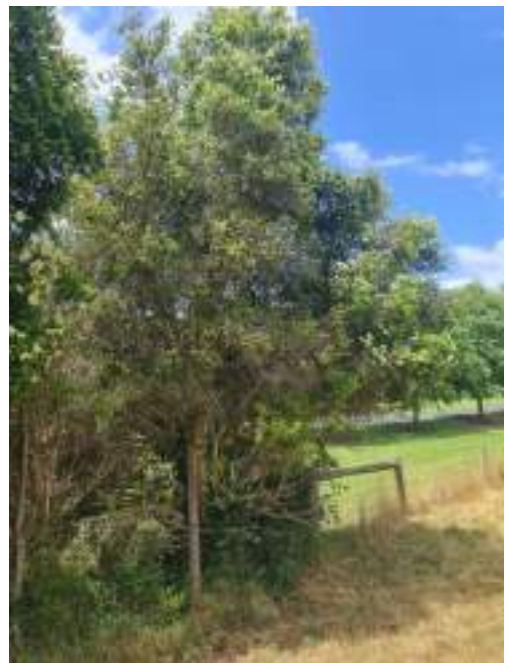
Tree ID: 60

TPZ (m): 5.6 **Construction Proximity:** 6.6

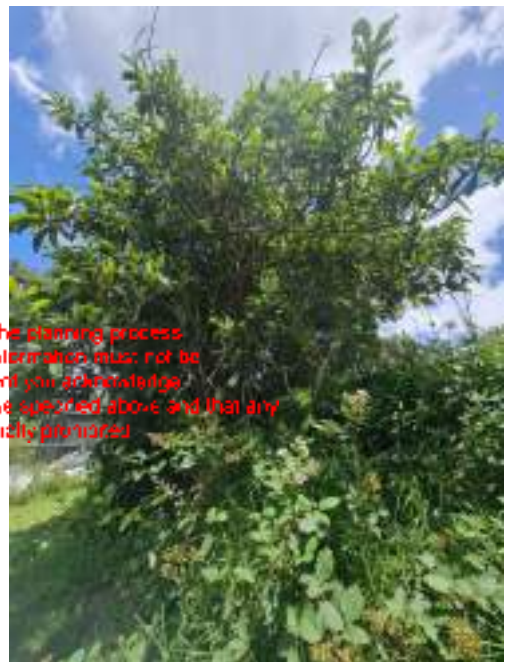
Tree ID: 61

TPZ (m): 3.0 **Construction Proximity:** 4

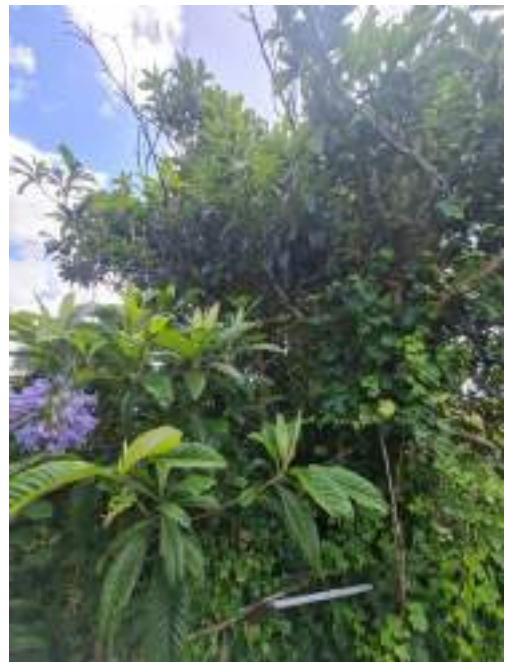
Tree ID: 62

TPZ (m): 2.9 **Construction Proximity:** 3.9

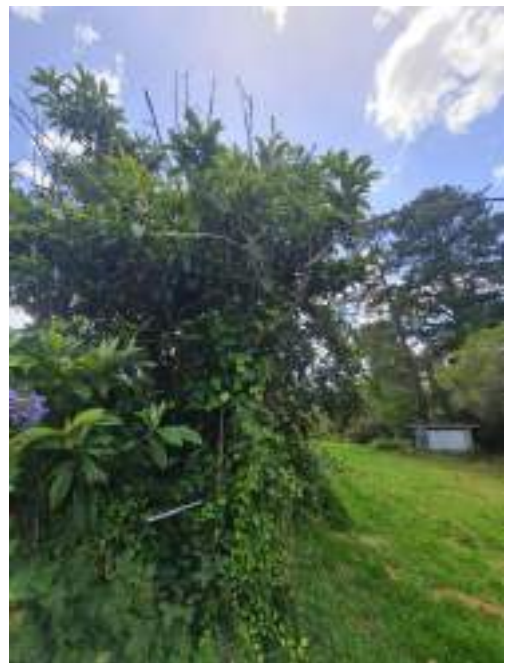
Tree ID: 63

Height (m): 4 **Structure:** Poor
Width (m): 4 **Health:** Fair
DBH (cm): 24 Estimated **Maturity:** Mature
Origin: Exotic **ULE (years):** 15 - 30
Retained?: Retained **Form:** Poor
Retention Value: Low
Removal / retention reason: N/A.
Amenity value: Low
Works Required: N/A.

SRZ (m): 1.9 **Works priority:** N/A
TPZ (m): 2.9 **Construction Proximity:** 3.9
mTPZ (m): = TPZ

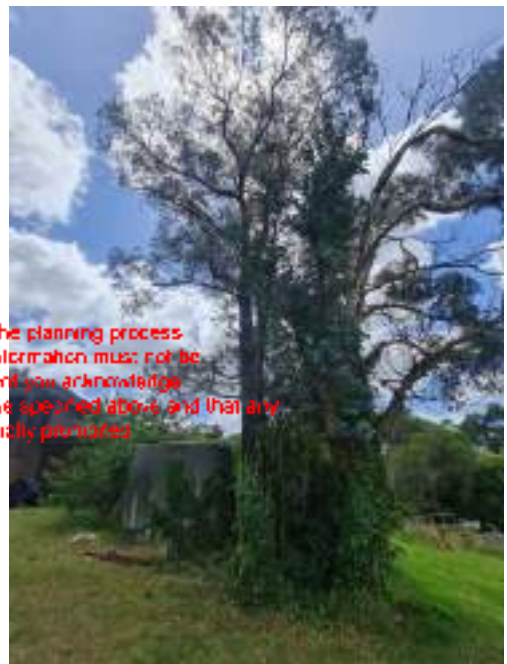
Tree ID: 64

Height (m): 14 **Structure:** Fair
Width (m): 9 **Health:** Good
DBH (cm): 59 Measured **Maturity:** Mature
Origin: Victorian **ULE (years):** 15 - 30
Retained?: Retained **Form:** Good
Retention Value: Moderate
Removal / retention reason: N/A
Amenity value: Moderate
Works Required: N/A.

SRZ (m): 2.8 **Works priority:** N/A
TPZ (m): 7.1 **Construction Proximity:** 8.1
mTPZ (m): = TPZ

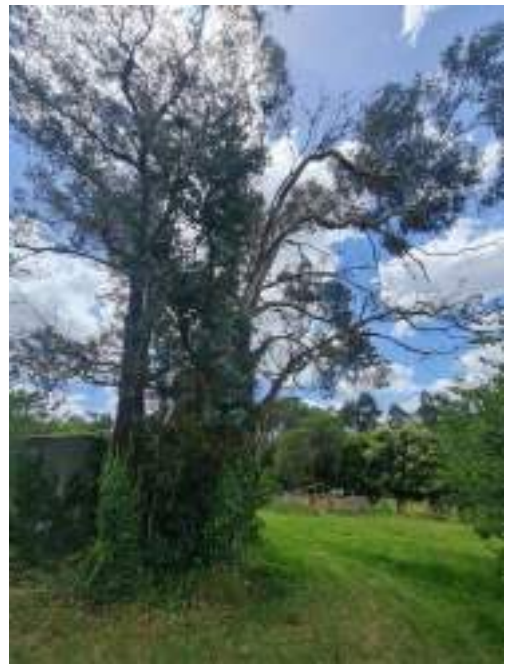
Tree ID: 65

Height (m): 11 **Structure:** Fair
Width (m): 12 **Health:** Fair
DBH (cm): 59 Measured **Maturity:** Mature
Origin: Victorian **ULE (years):** 15 - 30
Retained?: Retained **Form:** Poor
Retention Value: Moderate
Removal / retention reason: N/A.
Amenity value: Moderate
Works Required: N/A.

SRZ (m): 2.8 **Works priority:** N/A
TPZ (m): 7.1 **Construction Proximity:** 8.1
mTPZ (m): = TPZ

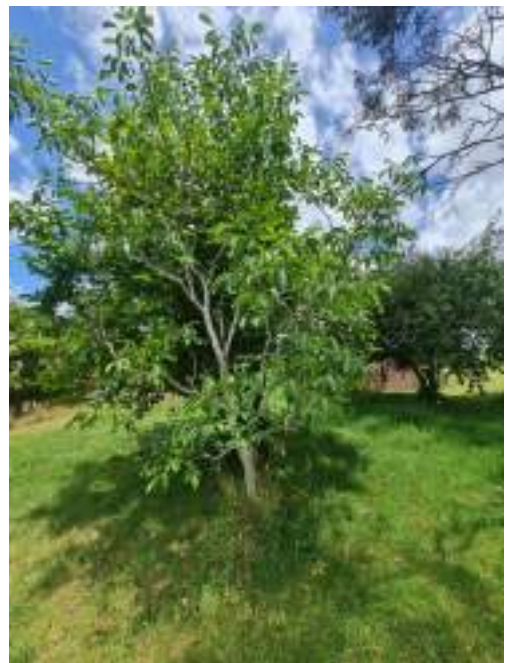
Tree ID: 66

TPZ (m): 2.0 **Construction Proximity:** 3

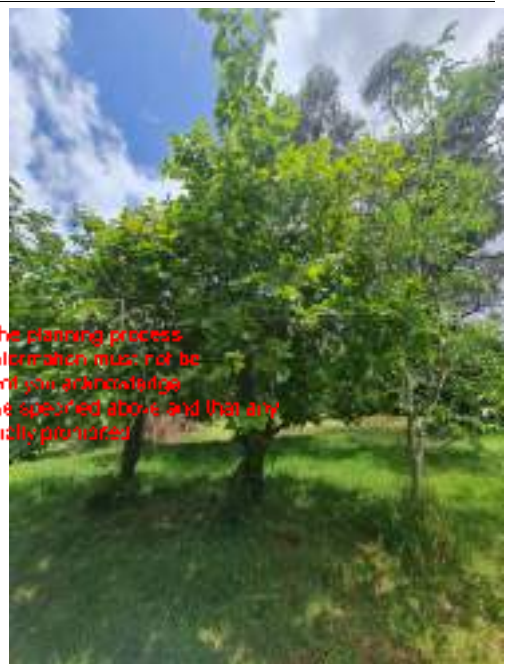
Tree ID: 67

TPZ (m): 2.0 **Construction Proximity:** 3

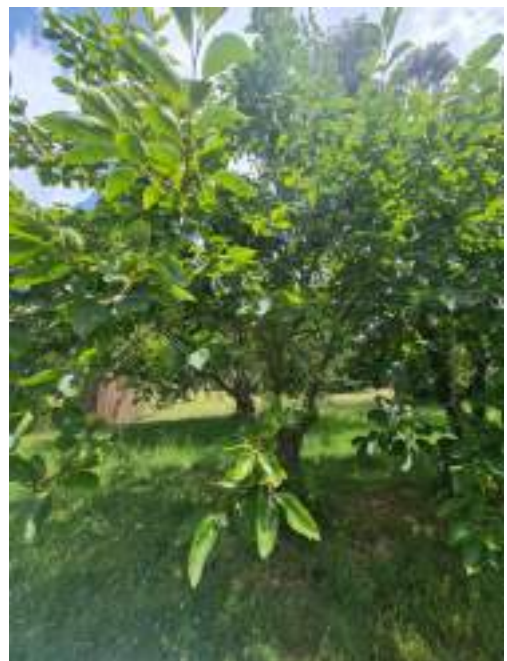
Tree ID: 68

TPZ (m): 2.5 **Construction Proximity:** 3.5

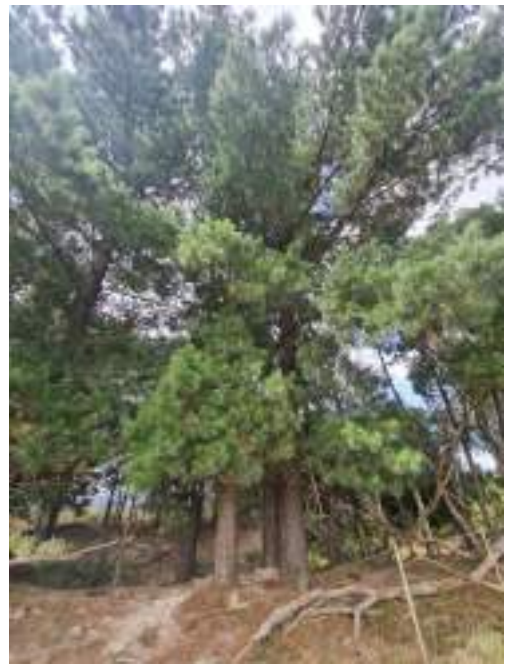
Tree ID: 111

Height (m): 18 **Structure:** Good
Width (m): 6 **Health:** Good
DBH (cm): 53 Measured **Maturity:** Mature
Origin: Exotic **ULE (years):** 30 - 60
Retained?: Retained **Form:** Fair
Retention Value: High
Removal / retention reason: N/A.
Amenity value: High
Works Required: N/A.

SRZ (m): 2.6 **Works priority:** N/A
TPZ (m): 6.4 **Construction Proximity:** 7.4
mTPZ (m): = TPZ
