Notice of Application for a Planning Permit

The land affected by the application is located at:	L4B LP6442 V4968 F530 42 Payne Road, Beaconsfield VIC 3807
The application is for a permit to:	Construction of a Replacement Dwelling, Construction, Use and Illumination of a Private Tennis Court and Removal of Vegetation

Application No.: T240471 PA
Proposal: Construction of a Replacement Dwelling and Associated Works
Location: 42 Payne Road, Beaconsfield

Buildings & Works Associated with a Replacement Dwelling at 42 Payne Road, Beaconsfield.

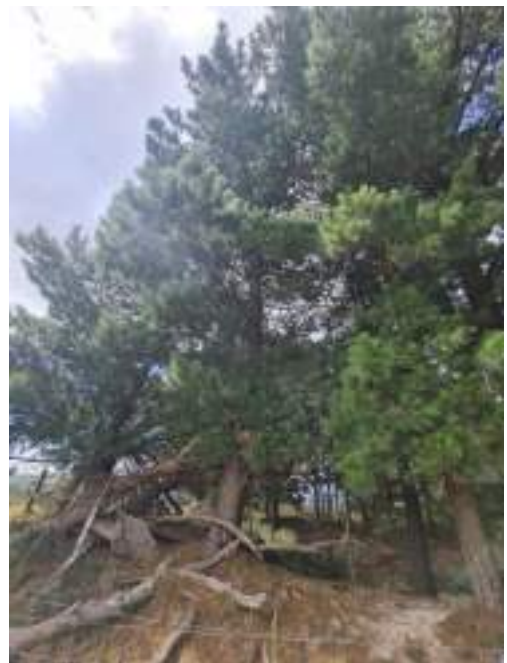
Tree ID: 112

Height (m): 18 **Structure:** Good
Width (m): 6 **Health:** Good
DBH (cm): 57 Measured **Maturity:** Mature
Origin: Exotic **ULE (years):** 30 - 60
Retained?: Retained **Form:** Fair
Retention Value: High
Removal / retention reason: N/A
Amenity value: High
Works Required: N/A.

SRZ (m): 2.7 **Works priority:** N/A
TPZ (m): 6.8 **Construction Proximity:** 7.8
mTPZ (m): = TPZ

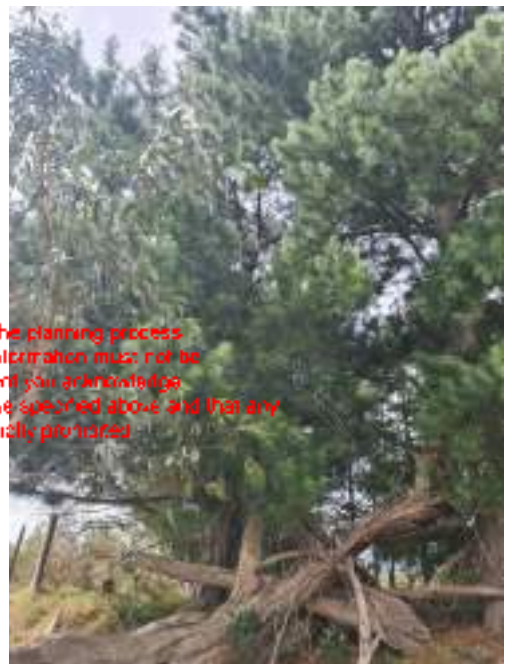
Tree ID: 113

Height (m): 15 **Structure:** Good
Width (m): 8 **Health:** Good
DBH (cm): 41 Measured **Maturity:** Mature
Origin: Exotic **ULE (years):** 30 - 60
Retained?: Retained **Form:** Fair
Retention Value: High
Removal / retention reason: N/A.
Amenity value: High
Works Required: N/A.

SRZ (m): 2.4 **Works priority:** N/A
TPZ (m): 4.9 **Construction Proximity:** 5.9
mTPZ (m): = TPZ

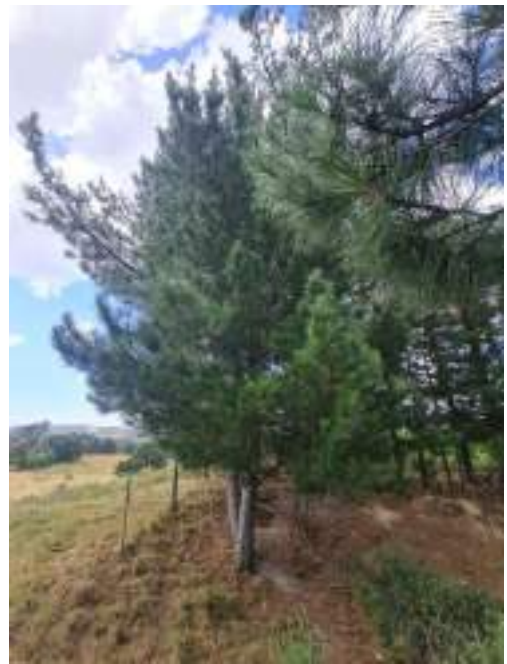
Tree ID: 114

Height (m): 15 **Structure:** Good
Width (m): 8 **Health:** Good
DBH (cm): 57 Measured **Maturity:** Mature
Origin: Exotic **ULE (years):** 30 - 60
Retained?: Retained **Form:** Fair
Retention Value: High
Removal / retention reason: N/A.
Amenity value: High
Works Required: N/A.

SRZ (m): 2.7 **Works priority:** N/A
TPZ (m): 6.8 **Construction Proximity:** 7.8
mTPZ (m): = TPZ

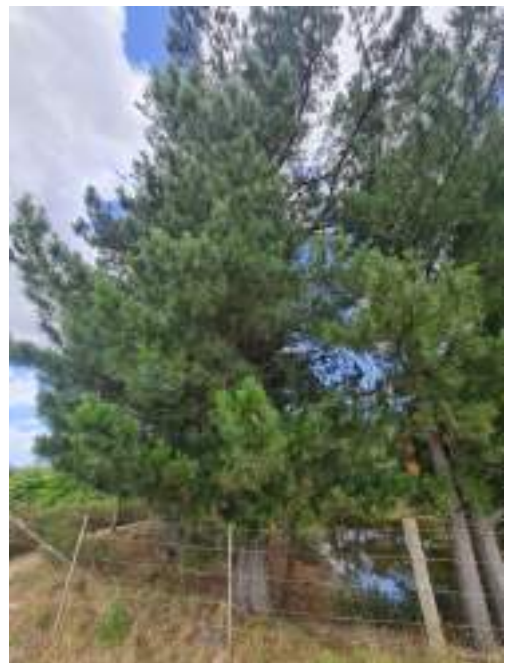
Tree ID: 115

Height (m): 18 **Structure:** Good
Width (m): 8 **Health:** Good
DBH (cm): 55 Measured **Maturity:** Mature
Origin: Exotic **ULE (years):** 30 - 60
Retained?: Retained **Form:** Fair
Retention Value: High
Removal / retention reason: N/A
Amenity value: High
Works Required: N/A.

SRZ (m): 2.7 **Works priority:** N/A
TPZ (m): 6.6 **Construction Proximity:** 7.6
mTPZ (m): = TPZ

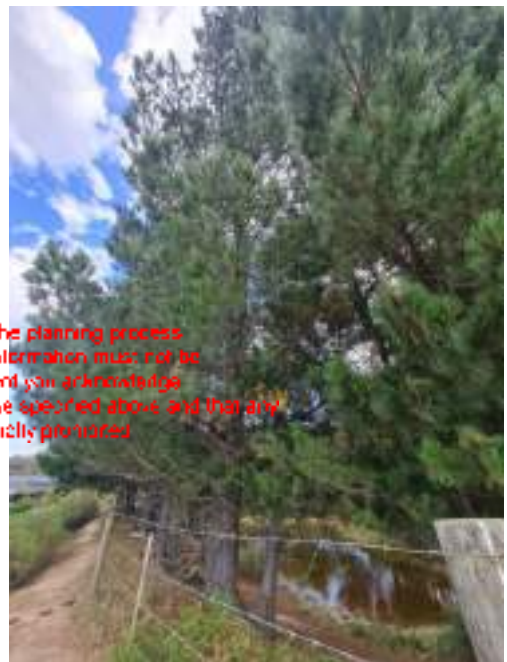
Tree ID: 116

Height (m): 14 **Structure:** Good
Width (m): 6 **Health:** Good
DBH (cm): 25 Measured **Maturity:** Mature
Origin: Exotic **ULE (years):** 30 - 60
Retained?: Retained **Form:** Fair
Retention Value: Moderate
Removal / retention reason: N/A.
Amenity value: Moderate
Works Required: N/A.

SRZ (m): 1.9 **Works priority:** N/A
TPZ (m): 3.0 **Construction Proximity:** 4
mTPZ (m): = TPZ

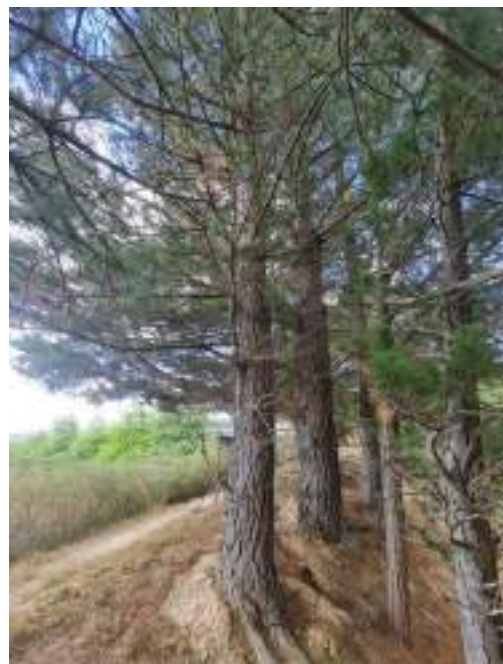
Tree ID: 120

Height (m): 18 **Structure:** Good
Width (m): 10 **Health:** Good
DBH (cm): 55 Measured **Maturity:** Mature
Origin: Exotic **ULE (years):** 30 - 60
Retained?: Retained **Form:** Fair
Retention Value: High
Removal / retention reason: N/A.
Amenity value: High
Works Required: N/A.

SRZ (m): 2.7 **Works priority:** N/A
TPZ (m): 6.6 **Construction Proximity:** 7.6
mTPZ (m): = TPZ

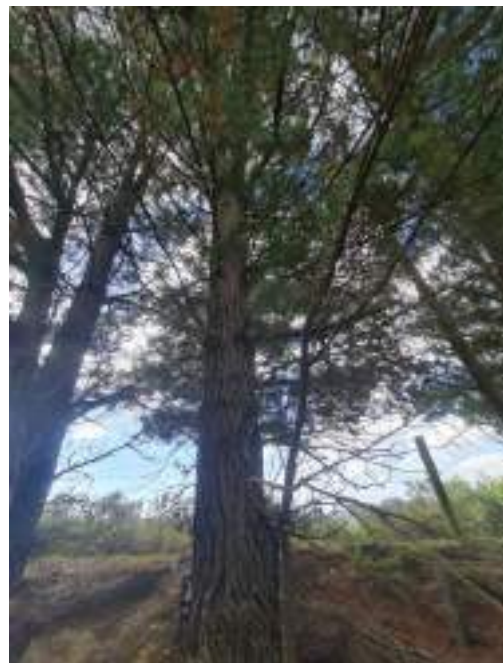
Tree ID: 121

Height (m): 7 **Structure:** Good
Width (m): 6 **Health:** Good
DBH (cm): 18 Measured **Maturity:** Mature
Origin: Exotic **ULE (years):** 30 - 60
Retained?: Retained **Form:** Poor
Retention Value: Low
Removal / retention reason: N/A
Amenity value: Low
Works Required: N/A.

SRZ (m): 1.7 **Works priority:** N/A
TPZ (m): 2.2 **Construction Proximity:** 3.2
mTPZ (m): = TPZ

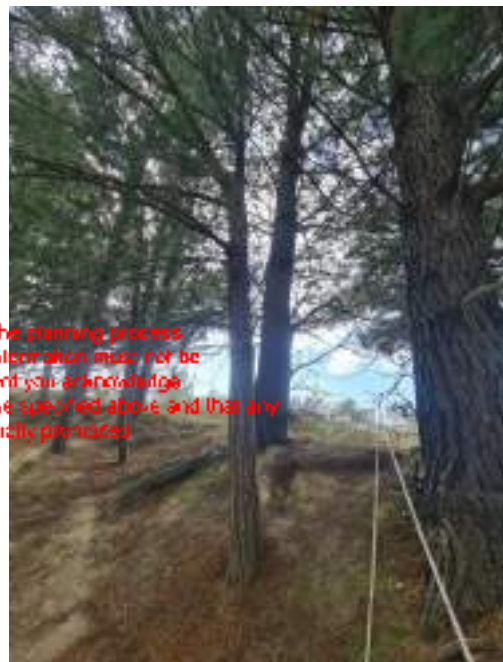
Tree ID: 122

Height (m): 15 **Structure:** Good
Width (m): 8 **Health:** Good
DBH (cm): 38 Measured **Maturity:** Mature
Origin: Exotic **ULE (years):** 30 - 60
Retained?: Retained **Form:** Fair
Retention Value: Moderate
Removal / retention reason: N/A.
Amenity value: Moderate
Works Required: N/A.

SRZ (m): 2.3 **Works priority:** N/A
TPZ (m): 4.6 **Construction Proximity:** 5.6
mTPZ (m): = TPZ

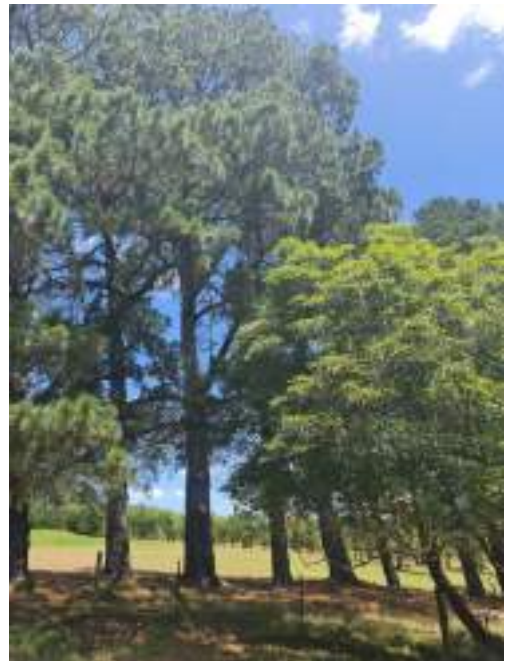
Tree ID: 151

Genus / species: *Pinus radiata*

Height (m): 20 **Structure:** Good
Width (m): 18 **Health:** Good
DBH (cm): 61 Measured **Maturity:** Mature
Origin: Exotic **ULE (years):** 30 - 60
Retained?: Retained **Form:** Fair
Retention Value: High
Removal / retention reason: Adjoining property.
Amenity value: High
Works Required: N/A.

SRZ (m): 2.8 **Works priority:** N/A
TPZ (m): 7.3 **Construction Proximity:** 8.3
mTPZ (m): = TPZ

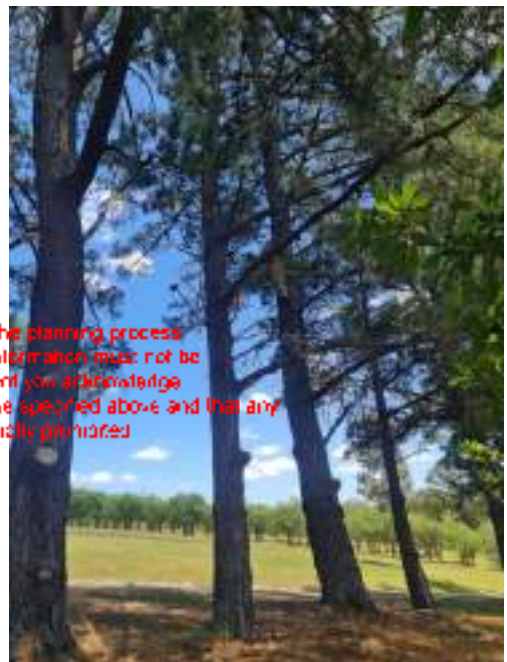
Tree ID: 152

Genus / species: *Hakea sp.*

Height (m): 5 **Structure:** Good
Width (m): 4 **Health:** Good
DBH (cm): 12 Measured **Maturity:** Mature
Origin: Australian **ULE (years):** 15 - 30
Retained?: Retained **Form:** Fair
Retention Value: Low
Removal / retention reason: N/A.
Amenity value: Low
Works Required: N/A.

SRZ (m): 1.6 **Works priority:** N/A
TPZ (m): 2.0 **Construction Proximity:** 3
mTPZ (m): = TPZ

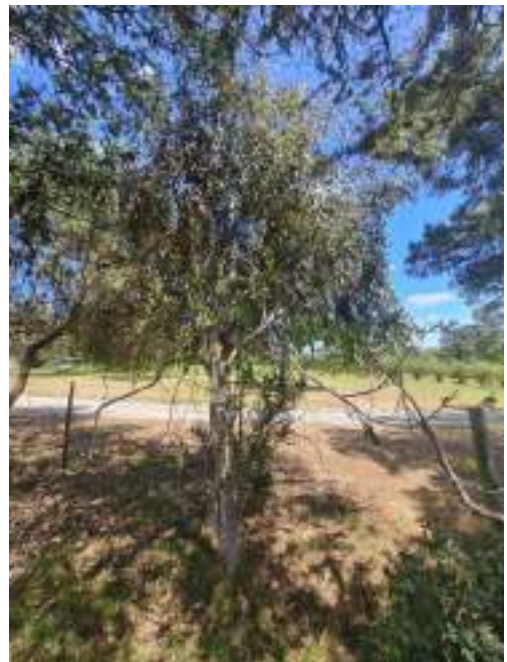
Tree ID: 153

Genus / species: *Acacia baileyana*
 Evergreen Cootamundra Wattle
Height (m): 5 **Structure:** Good
Width (m): 3 **Health:** Fair
DBH (cm): 11 Measured **Maturity:** Mature
Origin: Australian **ULE (years):** 5 - 15
Retained?: Retained **Form:** Poor
Retention Value: Low
Removal / retention reason: N/A.
Amenity value: Low
Works Required: N/A.

SRZ (m): 1.6 **Works priority:** N/A
TPZ (m): 2.0 **Construction Proximity:** 3
mTPZ (m): = TPZ

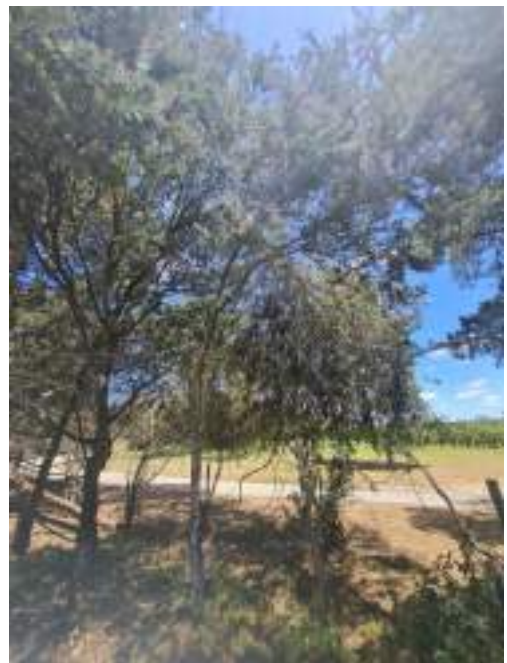
Tree ID: 154

Genus / species: *Acacia baileyana*
 Evergreen Cootamundra Wattle
Height (m): 8 **Structure:** Good
Width (m): 4 **Health:** Good
DBH (cm): 21 Measured **Maturity:** Mature
Origin: Australian **ULE (years):** 15 - 30
Retained?: Retained **Form:** Poor
Retention Value: Low
Removal / retention reason: N/A
Amenity value: Low
Works Required: N/A.

SRZ (m): 1.8 **Works priority:** N/A
TPZ (m): 2.5 **Construction Proximity:** 3.5
mTPZ (m): = TPZ

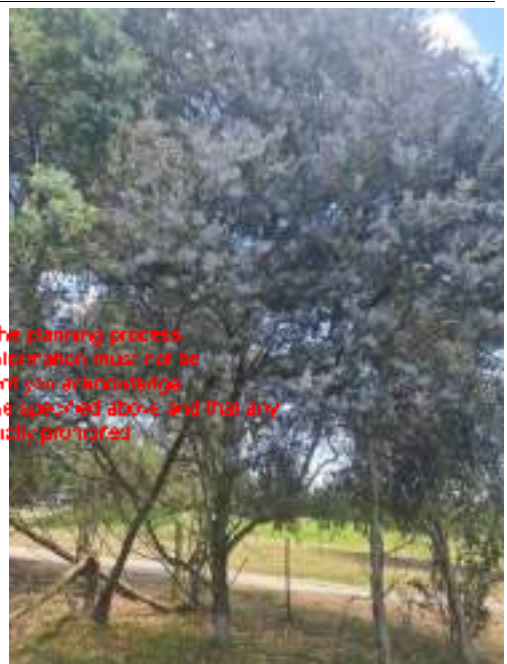
Tree ID: 155

Genus / species: *Acacia baileyana*
 Evergreen Cootamundra Wattle
Height (m): 8 **Structure:** Very poor
Width (m): 3 **Health:** Dead
DBH (cm): 17 Measured **Maturity:** Over mature
Origin: Australian **ULE (years):** 0
Retained?: Retained **Form:** Very poor
Retention Value: Remove.
Removal / retention reason: N/A.
Amenity value: Very low
Works Required: N/A.

SRZ (m): 1.7 **Works priority:** N/A
TPZ (m): 2.0 **Construction Proximity:** 3
mTPZ (m): = TPZ

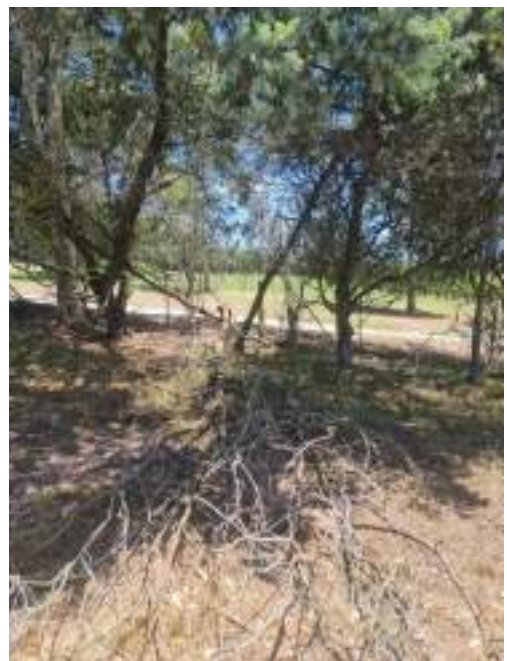
Tree ID: 156

Genus / species: *Acacia baileyana*
Evergreen Cootamundra Wattle
Height (m): 8 **Structure:** Good
Width (m): 9 **Health:** Good
DBH (cm): 33 Measured **Maturity:** Mature
Origin: Australian **ULE (years):** 15 - 30
Retained?: Retained **Form:** Poor
Retention Value: Low
Removal / retention reason: N/A.
Amenity value: Low
Works Required: N/A.

SRZ (m): 2.2 **Works priority:** N/A
TPZ (m): 4.0 **Construction Proximity:** 5
mTPZ (m): = TPZ

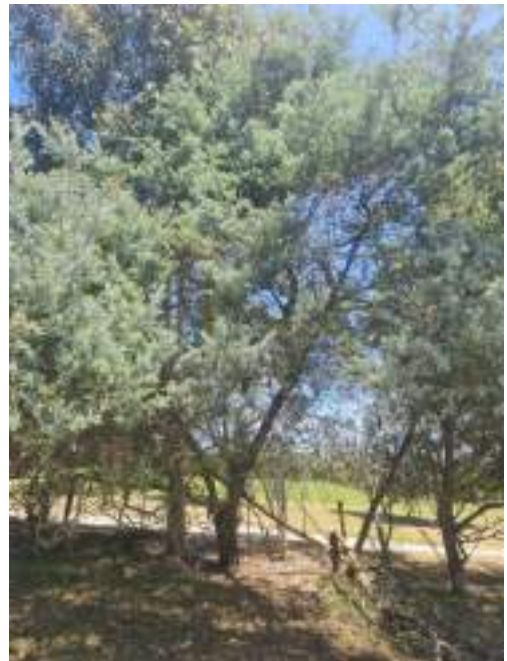
Tree ID: 157

Genus / species: *Corymbia maculata*
Evergreen Spotted Gum
Height (m): 12 **Structure:** Good
Width (m): 8 **Health:** Good
DBH (cm): 37 Measured **Maturity:** Mature
Origin: Victorian **ULE (years):** 30 - 60
Retained?: Retained **Form:** Good
Retention Value: Moderate
Removal / retention reason: N/A
Amenity value: Moderate
Works Required: N/A.

SRZ (m): 2.3 **Works priority:** N/A
TPZ (m): 4.4 **Construction Proximity:** 5.4
mTPZ (m): = TPZ

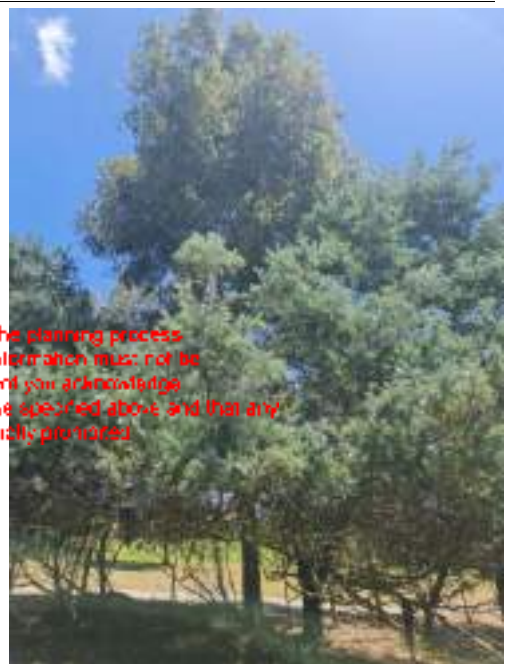
Tree ID: 158

Genus / species: *Acacia baileyana*
Evergreen Cootamundra Wattle
Height (m): 5 **Structure:** Good
Width (m): 4 **Health:** Fair
DBH (cm): 10 Measured **Maturity:** Mature
Origin: Australian **ULE (years):** 15 - 30
Retained?: Retained **Form:** Poor
Retention Value: Low
Removal / retention reason: N/A.
Amenity value: Low
Works Required: N/A.

SRZ (m): 1.6 **Works priority:** N/A
TPZ (m): 2.0 **Construction Proximity:** 3
mTPZ (m): = TPZ

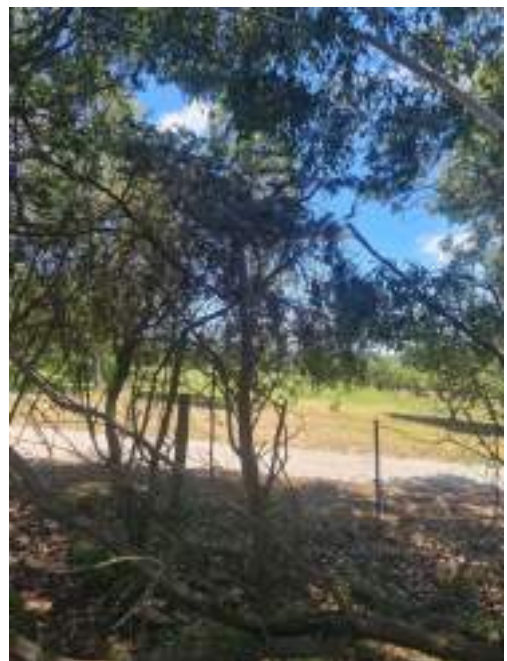
Tree ID: 159

Genus / species: *Acacia baileyana*
Evergreen Cootamundra Wattle
Height (m): 8 **Structure:** Fair
Width (m): 4 **Health:** Good
DBH (cm): 17 Measured **Maturity:** Mature
Origin: Australian **ULE (years):** 15 - 30
Retained?: Retained **Form:** Fair
Retention Value: Low
Removal / retention reason: N/A.
Amenity value: Low
Works Required: N/A.

SRZ (m): 1.7 **Works priority:** N/A
TPZ (m): 2.0 **Construction Proximity:** 3
mTPZ (m): = TPZ

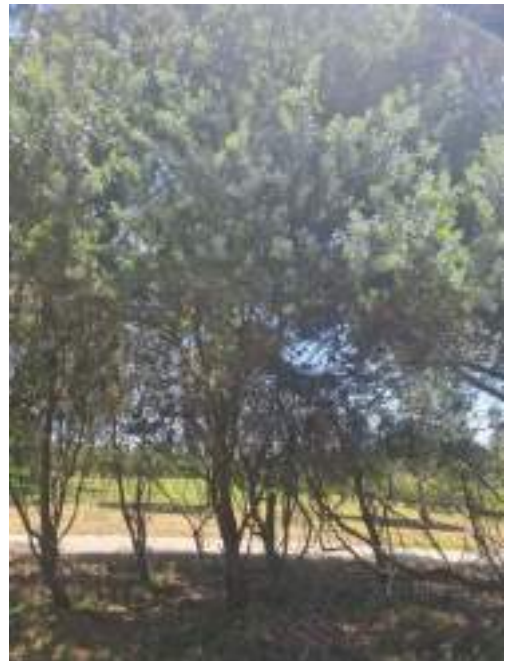
Tree ID: 160

Genus / species: *Acacia baileyana*
Evergreen Cootamundra Wattle
Height (m): 7 **Structure:** Good
Width (m): 3 **Health:** Fair
DBH (cm): 11 Measured **Maturity:** Mature
Origin: Australian **ULE (years):** 15 - 30
Retained?: Retained **Form:** Poor
Retention Value: Low
Removal / retention reason: N/A
Amenity value: Low
Works Required: N/A.

SRZ (m): 1.6 **Works priority:** N/A
TPZ (m): 2.0 **Construction Proximity:** 3
mTPZ (m): = TPZ

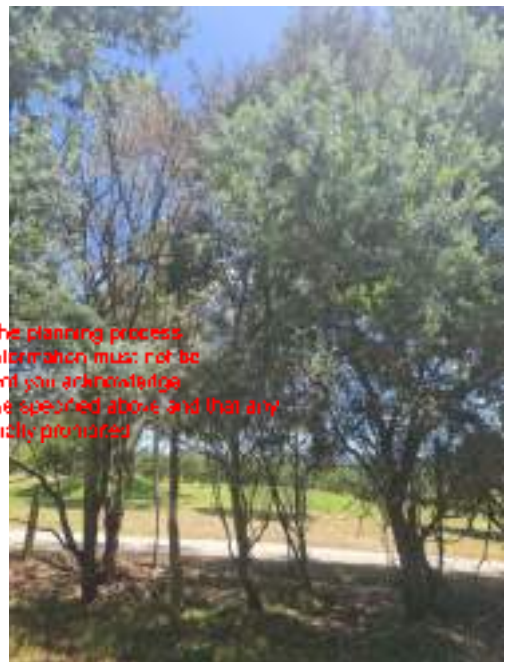
Tree ID: 161

Genus / species: *Acacia baileyana*
Evergreen Cootamundra Wattle
Height (m): 6 **Structure:** Fair
Width (m): 5 **Health:** Poor
DBH (cm): 11 Measured **Maturity:** Mature
Origin: Australian **ULE (years):** 5 - 15
Retained?: Retained **Form:** Poor
Retention Value: Low
Removal / retention reason: N/A.
Amenity value: Low
Works Required: N/A.

SRZ (m): 1.6 **Works priority:** N/A
TPZ (m): 2.0 **Construction Proximity:** 3
mTPZ (m): = TPZ

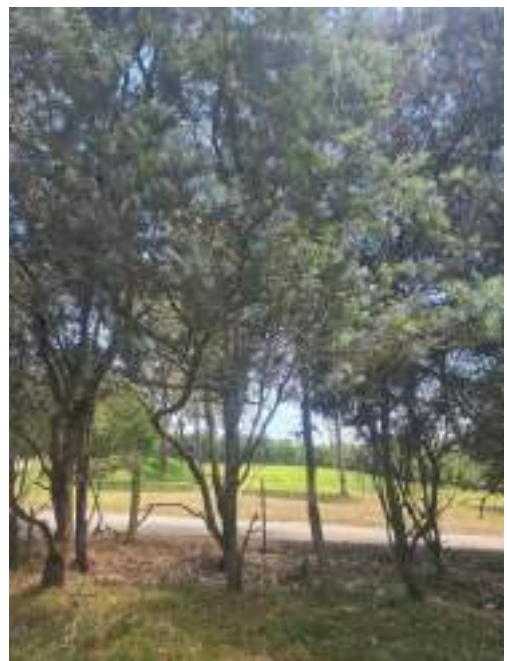
Tree ID: 162

Genus / species: *Acacia pycnantha*
Evergreen Golden Wattle
Height (m): 8 **Structure:** Good
Width (m): 6 **Health:** Fair
DBH (cm): 22 Measured **Maturity:** Mature
Origin: Melbourne **ULE (years):** 15 - 30
Retained?: Retained **Form:** Fair
Retention Value: Low
Removal / retention reason: N/A.
Amenity value: Low
Works Required: N/A.

SRZ (m): 1.9 **Works priority:** N/A
TPZ (m): 2.6 **Construction Proximity:** 3.6
mTPZ (m): = TPZ

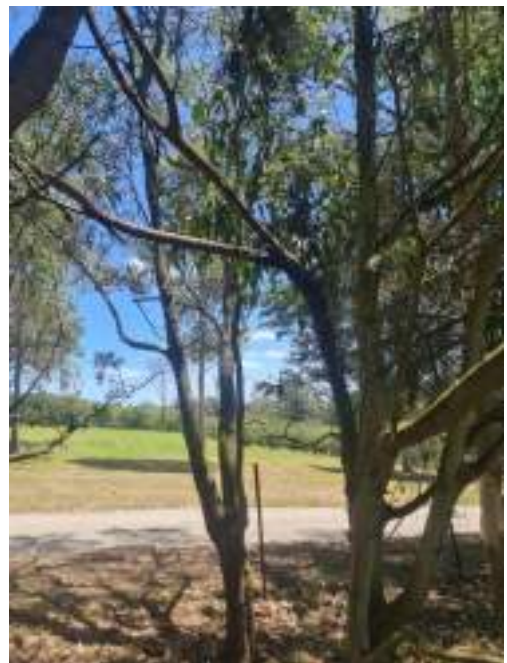
Tree ID: 163

Genus / species: *Acacia baileyana*
Evergreen Cootamundra Wattle
Height (m): 7 **Structure:** Poor
Width (m): 5 **Health:** Good
DBH (cm): 23 Measured **Maturity:** Mature
Origin: Australian **ULE (years):** 5 - 15
Retained?: Retained **Form:** Poor
Retention Value: Low
Removal / retention reason: N/A
Amenity value: Low
Works Required: N/A.

SRZ (m): 1.9 **Works priority:** N/A
TPZ (m): 2.8 **Construction Proximity:** 3.8
mTPZ (m): = TPZ

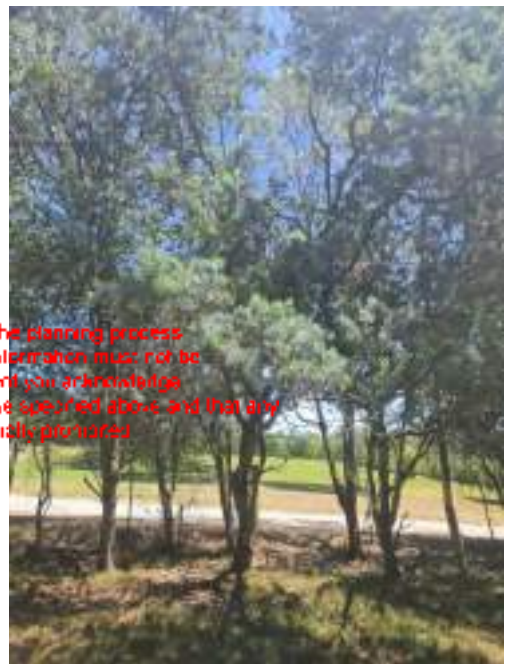
Tree ID: 164

Genus / species: *Acacia baileyana*
Evergreen Cootamundra Wattle
Height (m): 7 **Structure:** Fair
Width (m): 3 **Health:** Good
DBH (cm): 20 Measured **Maturity:** Mature
Origin: Australian **ULE (years):** 15 - 30
Retained?: Retained **Form:** Fair
Retention Value: Low
Removal / retention reason: N/A.
Amenity value: Low
Works Required: N/A.

SRZ (m): 1.8 **Works priority:** N/A
TPZ (m): 2.4 **Construction Proximity:** 3.4
mTPZ (m): = TPZ

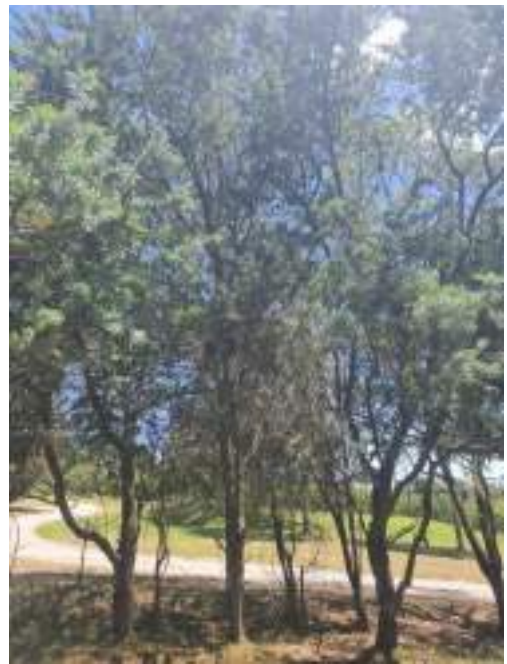
Tree ID: 165

Genus / species: *Acacia baileyana*
Evergreen Cootamundra Wattle
Height (m): 7 **Structure:** Good
Width (m): 3 **Health:** Good
DBH (cm): 19 Measured **Maturity:** Mature
Origin: Australian **ULE (years):** 15 - 30
Retained?: Retained **Form:** Fair
Retention Value: Low
Removal / retention reason: N/A.
Amenity value: Low
Works Required: N/A.

SRZ (m): 1.7 **Works priority:** N/A
TPZ (m): 2.3 **Construction Proximity:** 3.3
mTPZ (m): = TPZ

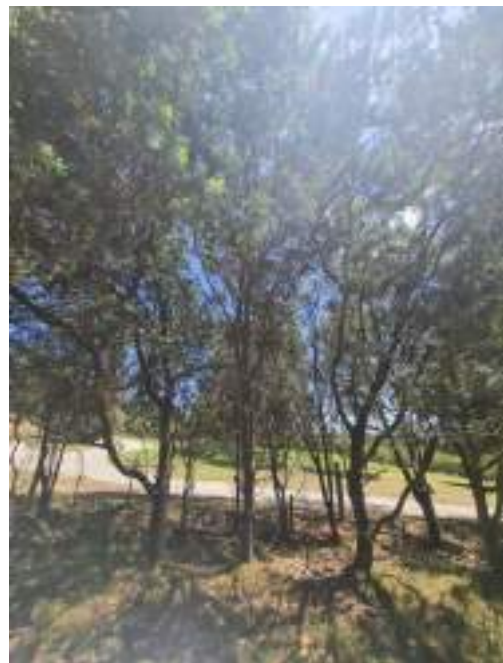
Tree ID: 166

Genus / species: *Hakea sp.*
Evergreen Hakea
Height (m): 5 **Structure:** Good
Width (m): 4 **Health:** Good
DBH (cm): 12 Estimated **Maturity:** Mature
Origin: Australian **ULE (years):** 15 - 30
Retained?: Retained **Form:** Fair
Retention Value: Low
Removal / retention reason: N/A
Amenity value: Low
Works Required: N/A.

SRZ (m): 1.6 **Works priority:** N/A
TPZ (m): 2.0 **Construction Proximity:** 3
mTPZ (m): = TPZ

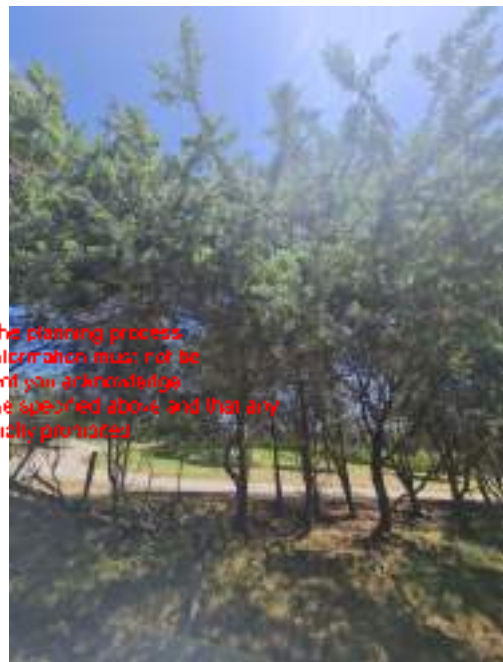
Tree ID: 167

Genus / species: *Acacia baileyana*
Evergreen Cootamundra Wattle
Height (m): 6 **Structure:** Good
Width (m): 5 **Health:** Good
DBH (cm): 16 Measured **Maturity:** Mature
Origin: Australian **ULE (years):** 15 - 30
Retained?: Retained **Form:** Poor
Retention Value: Low
Removal / retention reason: N/A.
Amenity value: Low
Works Required: N/A.

SRZ (m): 1.6 **Works priority:** N/A
TPZ (m): 2.0 **Construction Proximity:** 3
mTPZ (m): = TPZ

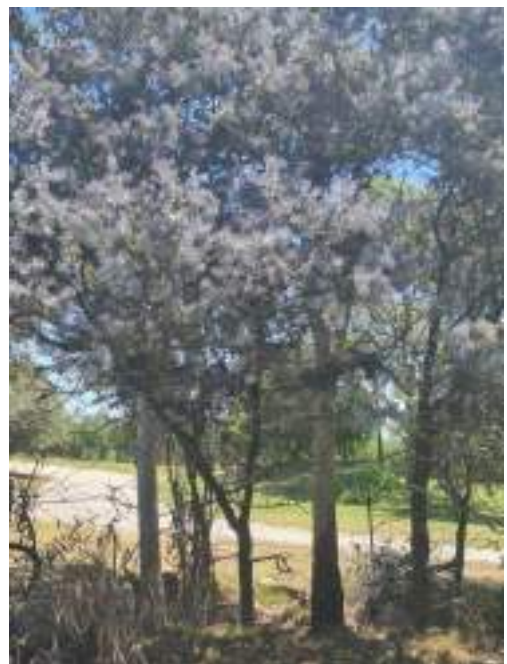
Tree ID: 171

Genus / species: *Eucalyptus sp.*

Height (m): 6 **Structure:** Good
Width (m): 5 **Health:** Good
DBH (cm): 18 Measured **Maturity:** Mature
Origin: Australian **ULE (years):** 30 - 60
Retained?: Retained **Form:** Poor
Retention Value: Low
Removal / retention reason: N/A.
Amenity value: Low
Works Required: N/A.

SRZ (m): 1.7 **Works priority:** N/A
TPZ (m): 2.2 **Construction Proximity:** 3.2
mTPZ (m): = TPZ

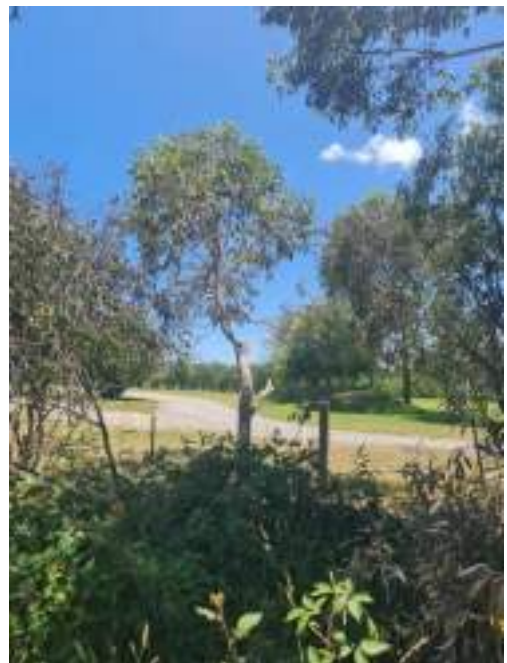
Tree ID: 172

Genus / species: *Corymbia maculata*

Height (m): 12 **Structure:** Good
Width (m): 5 **Health:** Good
DBH (cm): 19 Measured **Maturity:** Mature
Origin: Victorian **ULE (years):** 30 - 60
Retained?: Retained **Form:** Good
Retention Value: Moderate
Removal / retention reason: N/A
Amenity value: Moderate
Works Required: N/A.

SRZ (m): 1.7 **Works priority:** N/A
TPZ (m): 2.3 **Construction Proximity:** 3.3
mTPZ (m): = TPZ

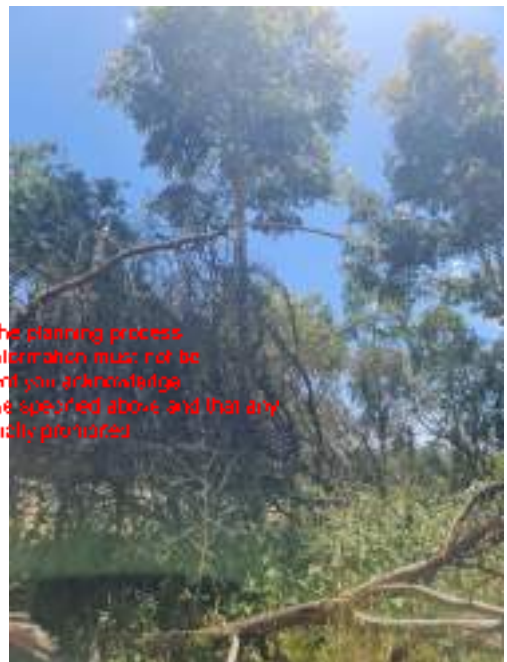
Tree ID: 173

Genus / species: *Acacia baileyana*

Height (m): 5 **Structure:** Fair
Width (m): 3 **Health:** Good
DBH (cm): 5 Measured **Maturity:** Mature
Origin: Australian **ULE (years):** 15 - 30
Retained?: Retained **Form:** Fair
Retention Value: Low
Removal / retention reason: N/A.
Amenity value: Low
Works Required: N/A.

SRZ (m): 1.6 **Works priority:** N/A
TPZ (m): 2.0 **Construction Proximity:** 3
mTPZ (m): = TPZ

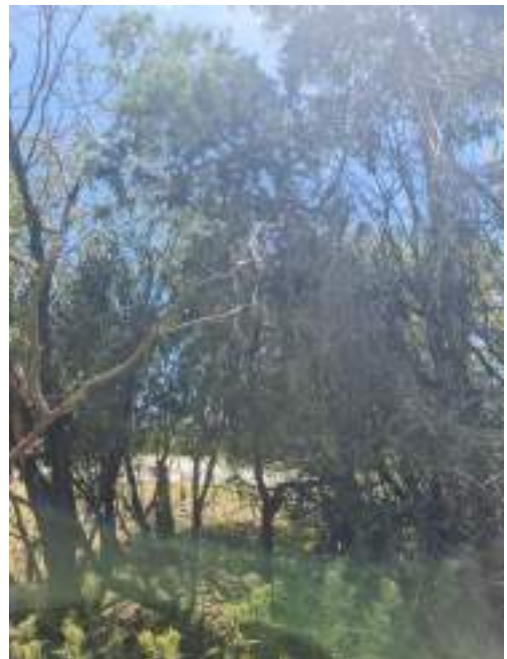
Tree ID: 174

Genus / species: *Unknown sp.*

Height (m): 5 **Structure:** Poor
Width (m): 6 **Health:** Dead
DBH (cm): 23 Measured **Maturity:** Over mature
Origin: Unknown **ULE (years):** 0
Retained?: Retained **Form:** Fair
Retention Value: Remove.
Removal / retention reason: N/A.
Amenity value: Very low
Works Required: N/A.

SRZ (m): 1.9 **Works priority:** N/A
TPZ (m): 2.8 **Construction Proximity:** 3.8
mTPZ (m): = TPZ

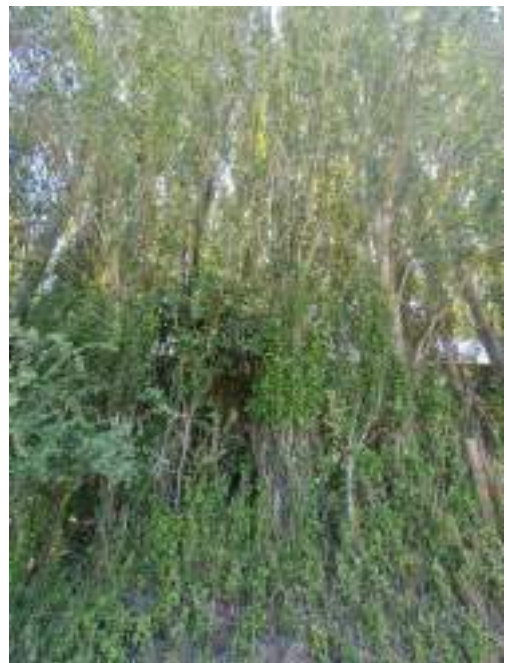
Tree ID: 198

Height (m): 15 **Structure:** Good
Width (m): 3 **Health:** Good
DBH (cm): 27 Estimated **Maturity:** Mature
Origin: Exotic **ULE (years):** 30 - 60
Retained?: Retained **Form:** Fair
Retention Value: Moderate
Removal / retention reason: Adjoining property.
Amenity value: Moderate
Works Required: N/A.

SRZ (m): 2 **Works priority:** N/A
TPZ (m): 3.2 **Construction Proximity:** 4.2
mTPZ (m): = TPZ

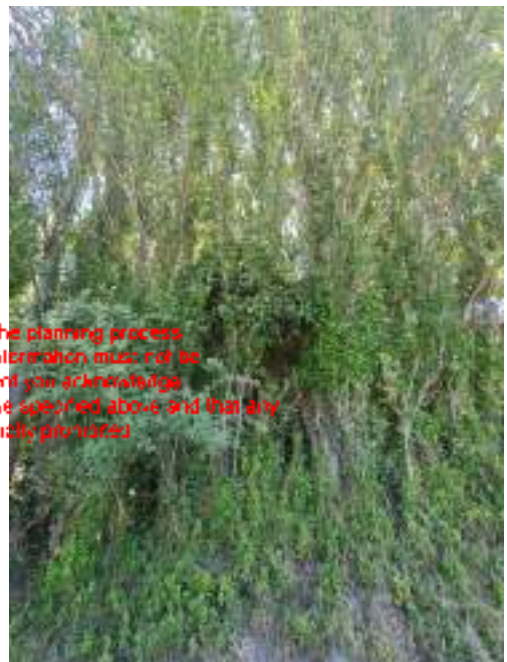
Tree ID: 199

Height (m): 15 **Structure:** Good
Width (m): 3 **Health:** Good
DBH (cm): 27 Estimated **Maturity:** Mature
Origin: Exotic **ULE (years):** 30 - 60
Retained?: Retained **Form:** Fair
Retention Value: Moderate
Removal / retention reason: Adjoining property.
Amenity value: Moderate
Works Required: N/A.

SRZ (m): 2 **Works priority:** N/A
TPZ (m): 3.2 **Construction Proximity:** 4.2
mTPZ (m): = TPZ

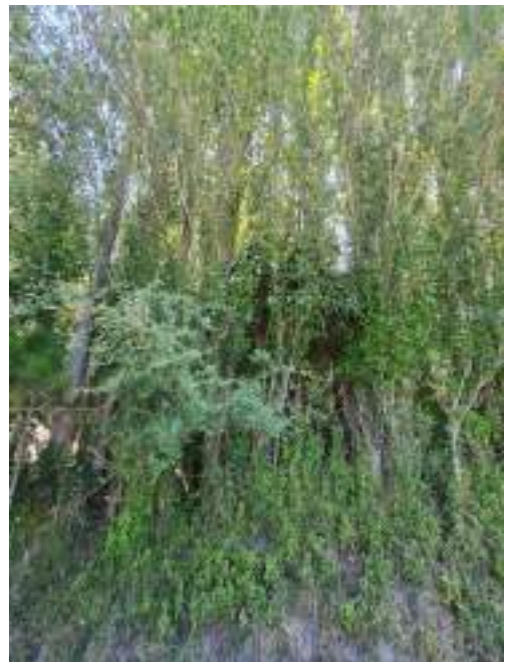
Tree ID: 200

Height (m): 15 **Structure:** Good
Width (m): 3 **Health:** Good
DBH (cm): 27 Estimated **Maturity:** Mature
Origin: Exotic **ULE (years):** 30 - 60
Retained?: Retained **Form:** Fair
Retention Value: Moderate
Removal / retention reason: Adjoining property.
Amenity value: Moderate
Works Required: N/A.

SRZ (m): 2 **Works priority:** N/A
TPZ (m): 3.2 **Construction Proximity:** 4.2
mTPZ (m): = TPZ

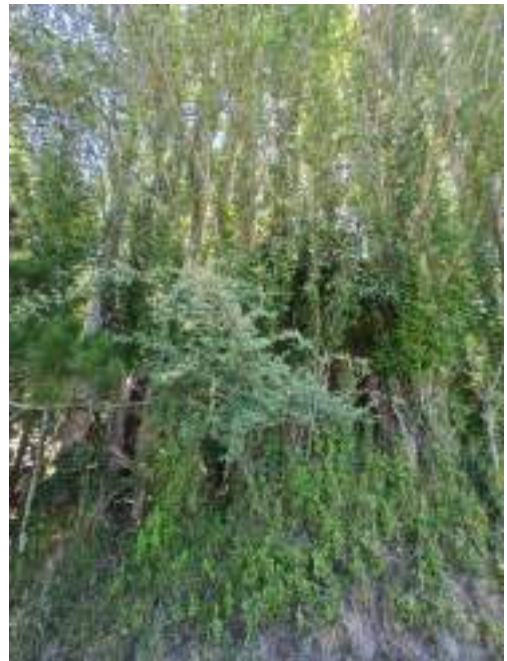
Tree ID: 201

Height (m): 15 **Structure:** Good
Width (m): 3 **Health:** Good
DBH (cm): 27 Estimated **Maturity:** Mature
Origin: Exotic **ULE (years):** 30 - 60
Retained?: Retained **Form:** Fair
Retention Value: Moderate
Removal / retention reason: Adjoining property.
Amenity value: Moderate
Works Required: N/A.

SRZ (m): 2 **Works priority:** N/A
TPZ (m): 3.2 **Construction Proximity:** 4.2
mTPZ (m): = TPZ

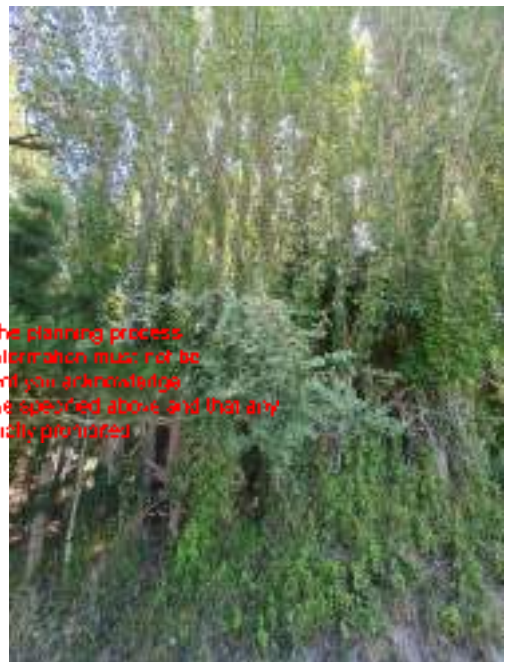
Tree ID: 202

Height (m): 15 **Structure:** Good
Width (m): 3 **Health:** Good
DBH (cm): 27 Estimated **Maturity:** Mature
Origin: Exotic **ULE (years):** 30 - 60
Retained?: Retained **Form:** Fair
Retention Value: Moderate
Removal / retention reason: Adjoining property.
Amenity value: Moderate
Works Required: N/A.

SRZ (m): 2 **Works priority:** N/A
TPZ (m): 3.2 **Construction Proximity:** 4.2
mTPZ (m): = TPZ

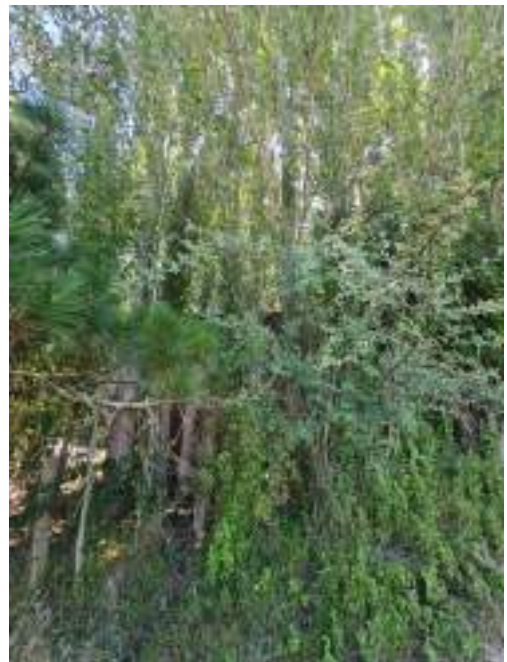
Tree ID: 203

Height (m): 15 **Structure:** Good
Width (m): 3 **Health:** Good
DBH (cm): 27 Estimated **Maturity:** Mature
Origin: Exotic **ULE (years):** 30 - 60
Retained?: Retained **Form:** Fair
Retention Value: Moderate
Removal / retention reason: Adjoining property.
Amenity value: Moderate
Works Required: N/A.

SRZ (m): 2 **Works priority:** N/A
TPZ (m): 3.2 **Construction Proximity:** 4.2
mTPZ (m): = TPZ

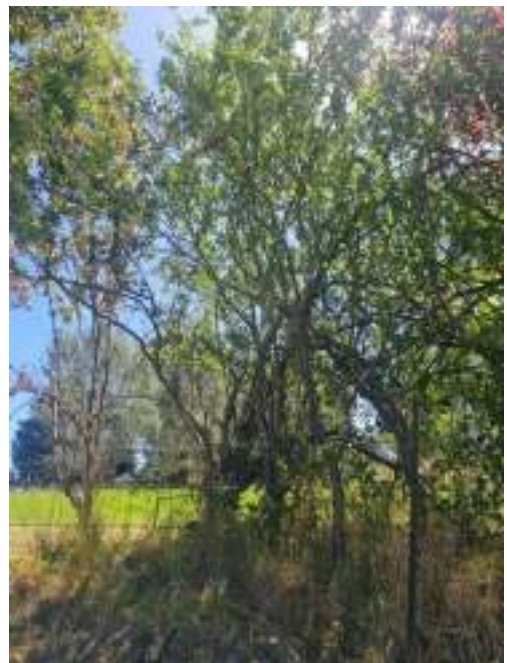
Tree ID: 222

Height (m): 4 **Structure:** Fair
Width (m): 5 **Health:** Fair
DBH (cm): 17 Estimated **Maturity:** Mature
Origin: Exotic **ULE (years):** 15 - 30
Retained?: Retained **Form:** Poor
Retention Value: Low
Removal / retention reason: Adjoining property.
Amenity value: Low
Works Required: N/A.

SRZ (m): 1.7 **Works priority:** N/A
TPZ (m): 2.0 **Construction Proximity:** 3
mTPZ (m): = TPZ

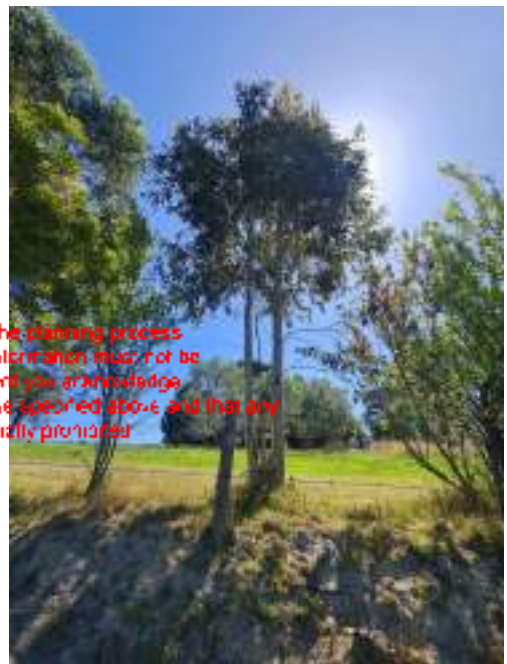
Tree ID: 223

Height (m): 8 **Structure:** Fair
Width (m): 6 **Health:** Good
DBH (cm): 25 Estimated **Maturity:** Mature
Origin: Victorian **ULE (years):** 15 - 30
Retained?: Retained **Form:** Good
Retention Value: Moderate
Removal / retention reason: Adjoining property
Amenity value: Moderate
Works Required: N/A.

SRZ (m): 1.9 **Works priority:** N/A
TPZ (m): 3.0 **Construction Proximity:** 4
mTPZ (m): = TPZ

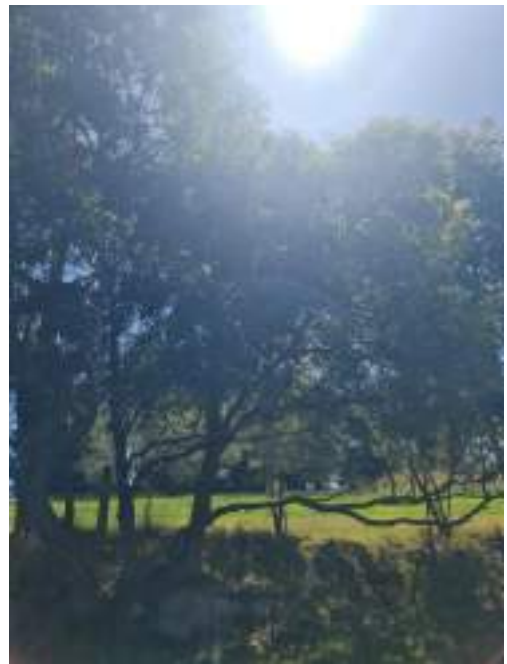
Tree ID: 224

Height (m): 6 **Structure:** Fair
Width (m): 6 **Health:** Good
DBH (cm): 28 Measured **Maturity:** Mature
Origin: Victorian **ULE (years):** 15 - 30
Retained?: Retained **Form:** Fair
Retention Value: Low
Removal / retention reason: N/A.
Amenity value: Low
Works Required: N/A.

SRZ (m): 2 **Works priority:** N/A
TPZ (m): 3.4 **Construction Proximity:** 4.4
mTPZ (m): = TPZ

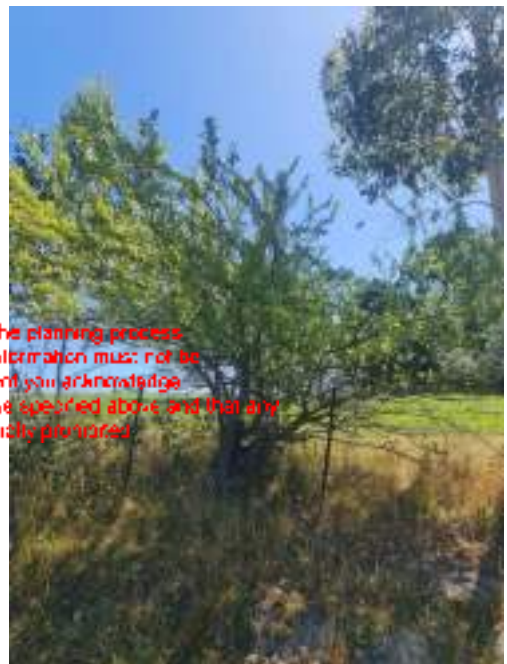
Tree ID: 230

Genus / species: *Corymbia maculata*

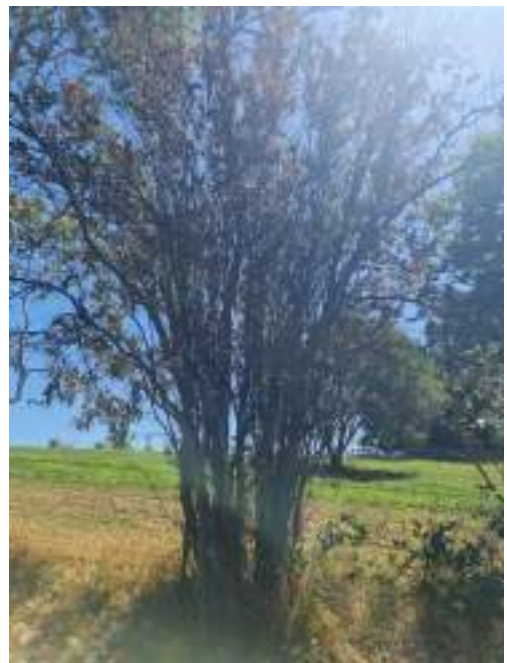
Tree ID: 232

Genus / species: *Corymbia maculata*

Height (m): 10 **Structure:** Good
Width (m): 6 **Health:** Good
DBH (cm): 29 Estimated **Maturity:** Mature
Origin: Victorian **ULE (years):** 30 - 60
Retained?: Retained **Form:** Good
Retention Value: Moderate
Removal / retention reason: Adjoining property.
Amenity value: Moderate
Works Required: N/A.

SRZ (m): 2.1 **Works priority:** N/A
TPZ (m): 3.5 **Construction Proximity:** 4.5
mTPZ (m): = TPZ

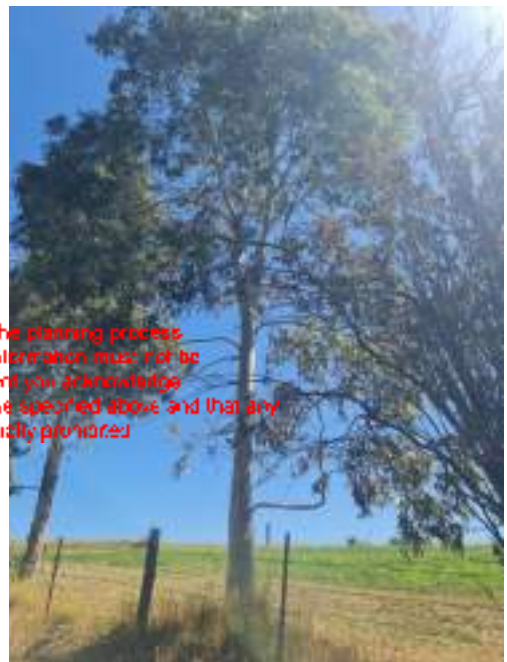
Tree ID: 233

Genus / species: *Corymbia maculata*

Height (m): 9 **Structure:** Good
Width (m): 7 **Health:** Good
DBH (cm): 21 Estimated **Maturity:** Mature
Origin: Victorian **ULE (years):** 30 - 60
Retained?: Retained **Form:** Good
Retention Value: Moderate
Removal / retention reason: Adjoining property.
Amenity value: Moderate
Works Required: N/A.

SRZ (m): 1.8 **Works priority:** N/A
TPZ (m): 2.5 **Construction Proximity:** 3.5
mTPZ (m): = TPZ

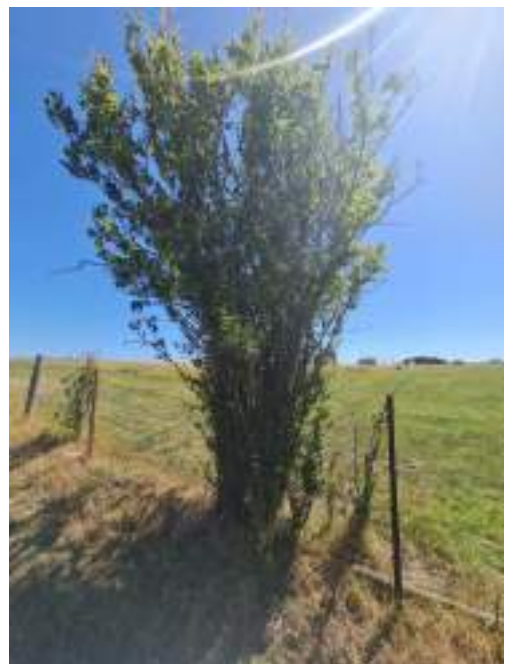
Tree ID: 237

Genus / species: *Prunus sp.*

Height (m): 3 **Structure:** Fair
Width (m): 5 **Health:** Good
DBH (cm): 25 Estimated **Maturity:** Mature
Origin: Exotic **ULE (years):** 15 - 30
Retained?: Retained **Form:** Fair
Retention Value: Low
Removal / retention reason: Adjoining property.
Amenity value: Low
Works Required: N/A.

SRZ (m): 1.9 **Works priority:** N/A
TPZ (m): 3.0 **Construction Proximity:** 4
mTPZ (m): = TPZ

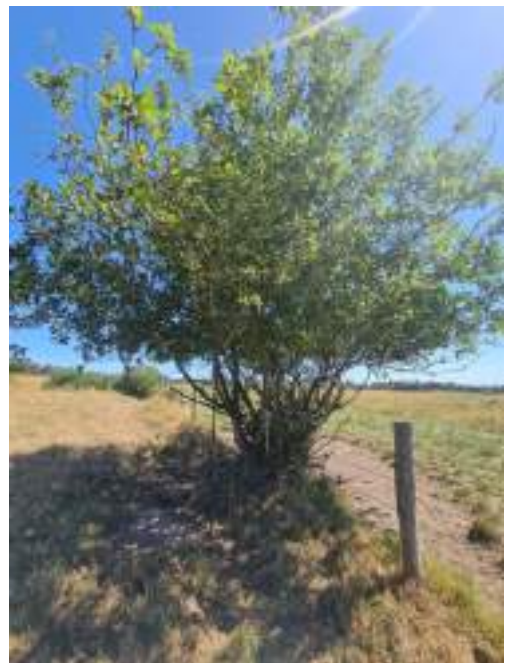
Tree ID: 238

Genus / species: *Unknown sp.*

Height (m): 2 **Structure:** Good
Width (m): 3 **Health:** Good
DBH (cm): 14 Estimated **Maturity:** Mature
Origin: Unknown **ULE (years):** 15 - 30
Retained?: Retained **Form:** Good
Retention Value: Low
Removal / retention reason: N/A
Amenity value: Low
Works Required: N/A.

SRZ (m): 1.6 **Works priority:** N/A
TPZ (m): 2.0 **Construction Proximity:** 3
mTPZ (m): = TPZ

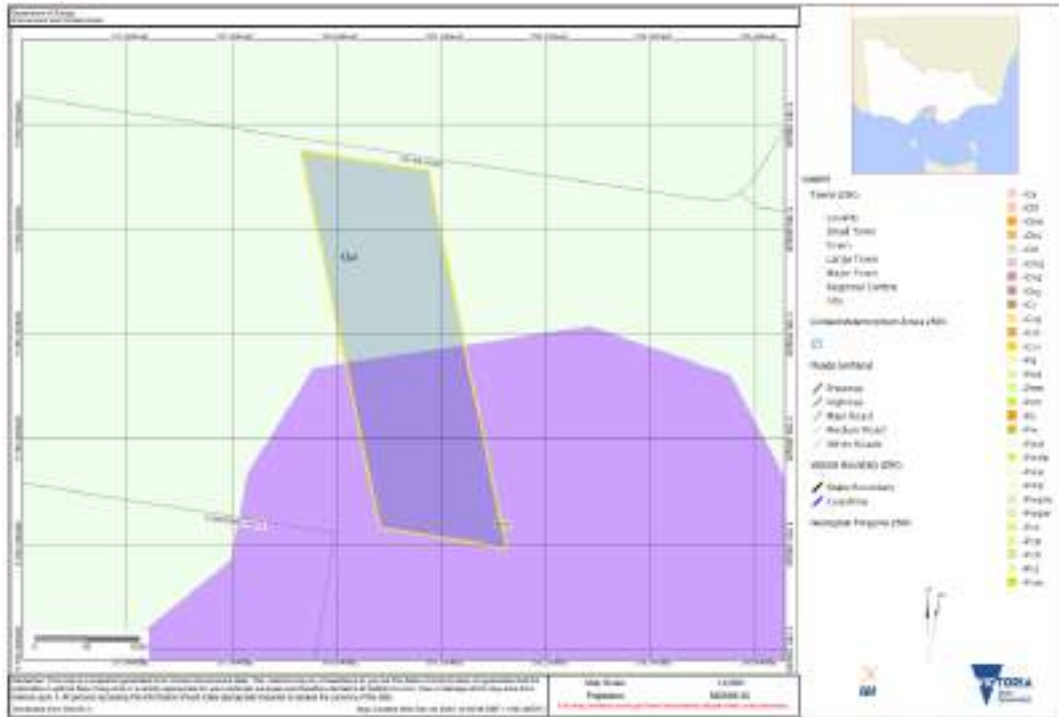
Figure 3.4 Extract of Geological from GeoVic 3

According to the Geological Survey of Victoria, the site is in an area of Devonian aged Marine sediments belonging to Murrindindi Supergroup overlain by Quaternary aged Alluvial deposits. An extract from GeoVic 3 is included in **Figure 3.4**.

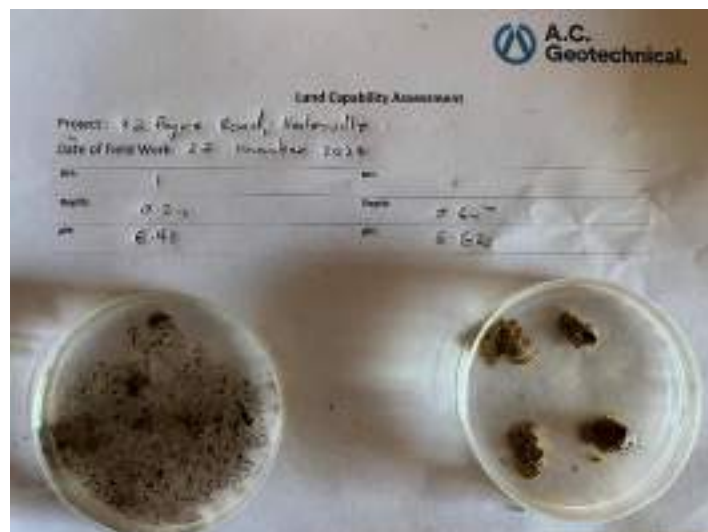
Figure 4.3 Laboratory Analysis

BORE HOLE 1	SAMPLE DEPTH: 200mm	SAMPLE DEPTH: 600mm
<u>SOIL ASSESSMENT</u> <u>(AS1547-2012)</u>	<u>SOIL HORIZON: A</u>	<u>SOIL HORIZON: B</u>
Soil Colour	Pale brown	Orange/brown
Soil Texture	Sandy Loam	Light clay
Coarse Fragments (%)	None	None
Soil Structure	Weak	Moderate
Soil Dispersion	Non-dispersive	Non-dispersive
Soil Permeability	1.4-3.0 mm/d	0.06-0.12 mm/d
Soil Category	2b	5b
pH 1:5 Ratio Electronic Method	6.41	6.62
Electrical Conductivity	0.05 dS/m	0.07 dS/m
Salinity Hazard	Non-saline	Non-saline
