Notice of Application for a Planning Permit

The land affected by the application is located at:	PC370839 V11086 F820 50 Lilliput Lane, Pakenham VIC 3810
The application is for a permit to:	Earthworks and Vegetation Removal
A permit is required under the following clauses of the planning scheme:

Proposed Use	Proposed Landscape Works including Vegetation Removal & Site Works, proposed Pool & in-ground trampoline
Current Use	Single storey dwelling with associated outbuildings
Cost of Works	\$95,000
Site Address	50 Lilliput Lane Pakenham 3810

This report was commissioned by 3D Design Group to assess the condition of 104 trees located on or adjacent to 50 Lilliput Lane, Pakenham and to evaluate the impacts on these trees arising from the proposed development on this site.

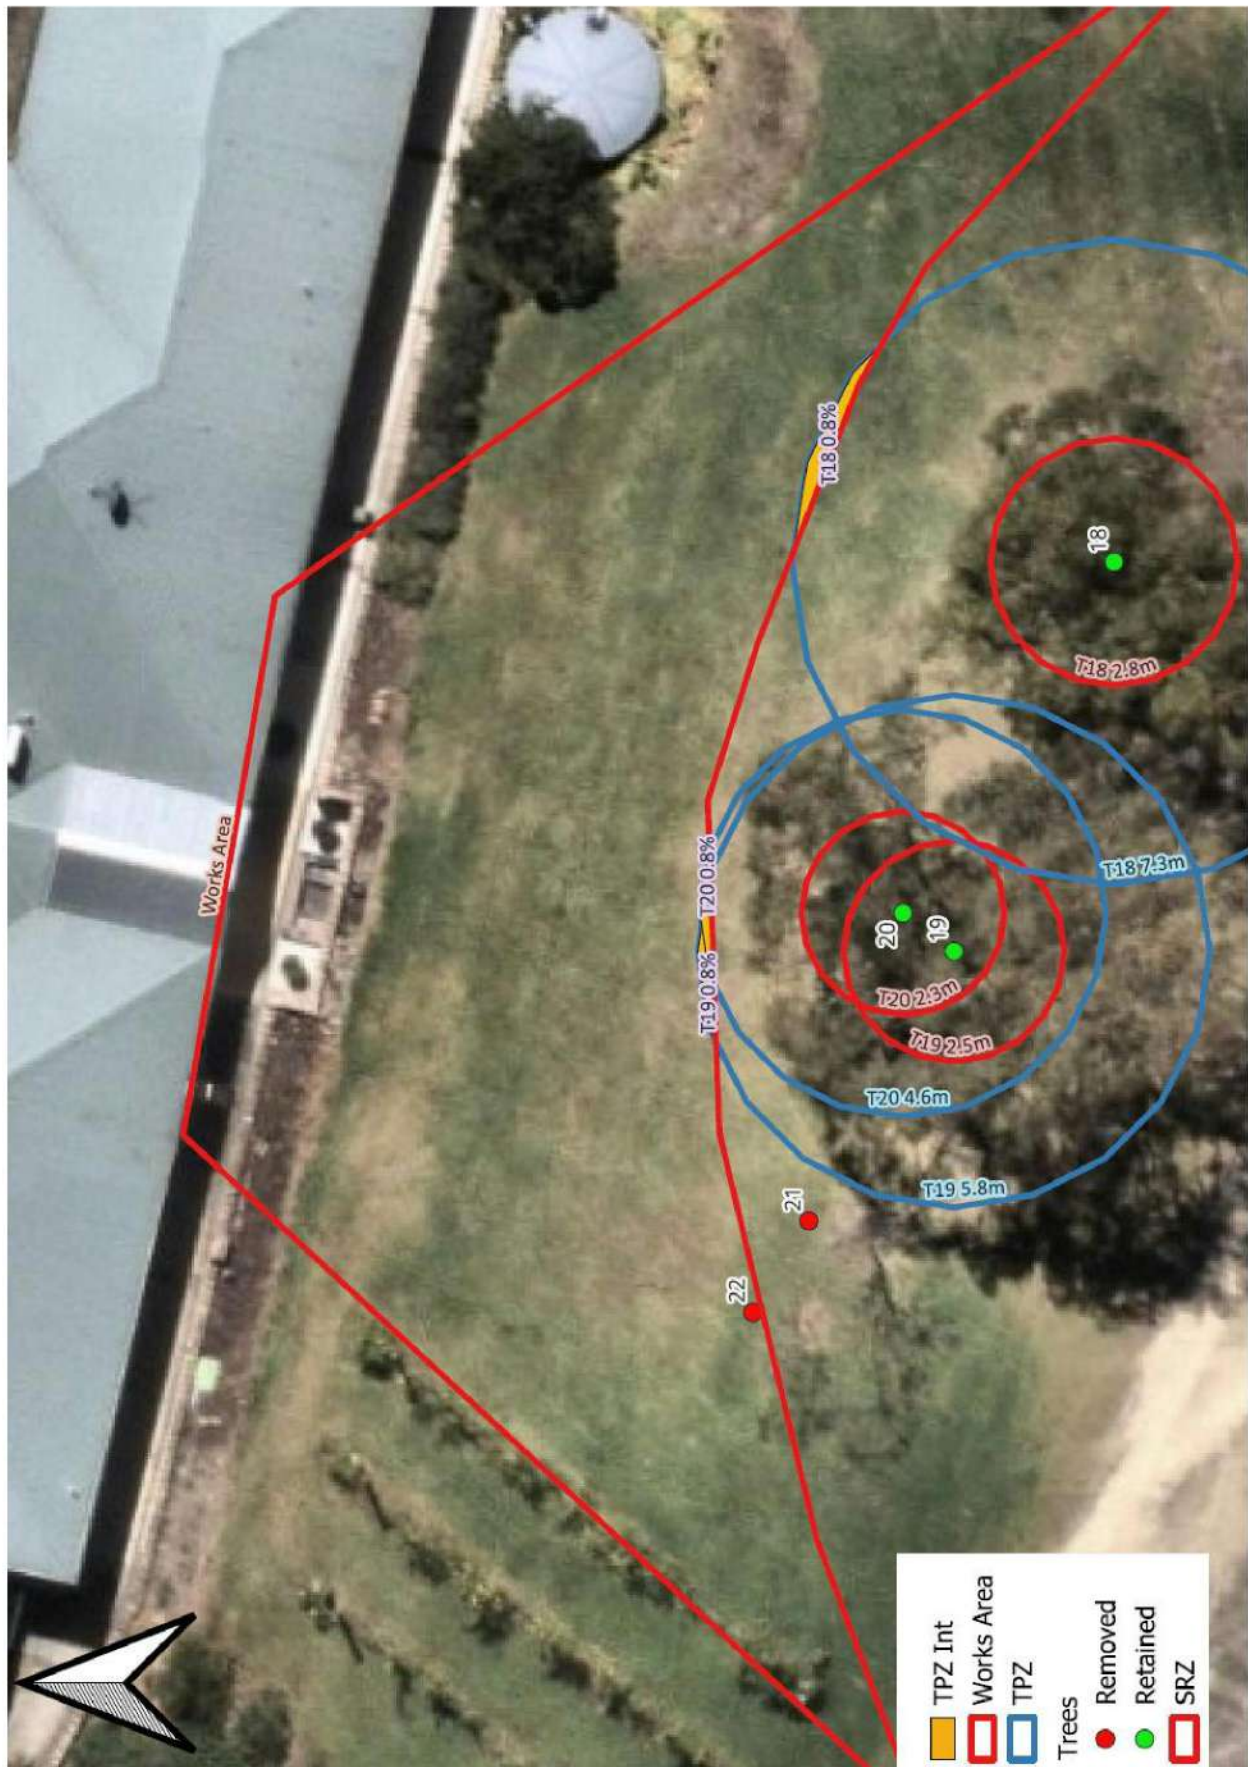
11.1. Trees 18 - 20

The following trees are regarded as being suitable for retention and are located within close proximity to elements of the proposed development. The successful retention of those trees that are proposed to be retained may require additional care and the adoption of the following recommendations.

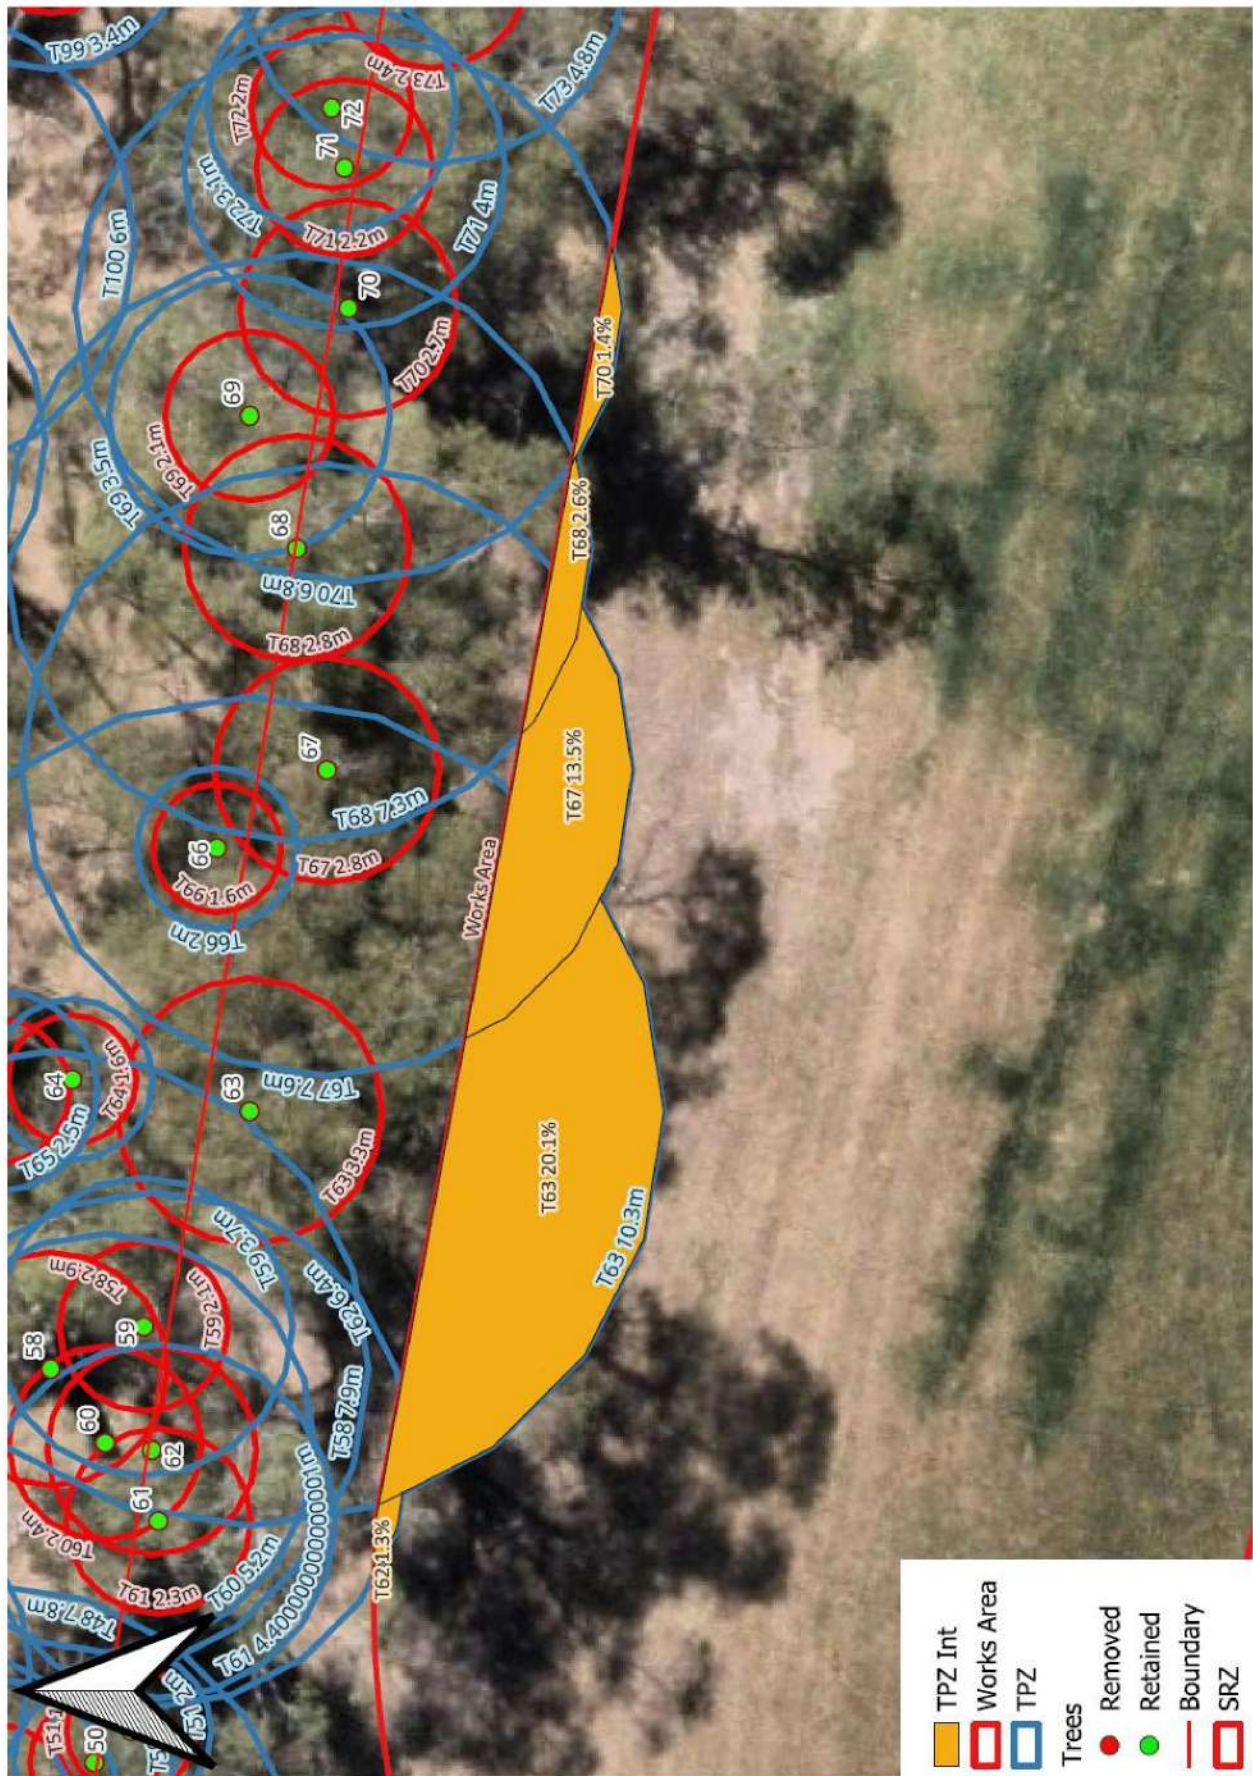
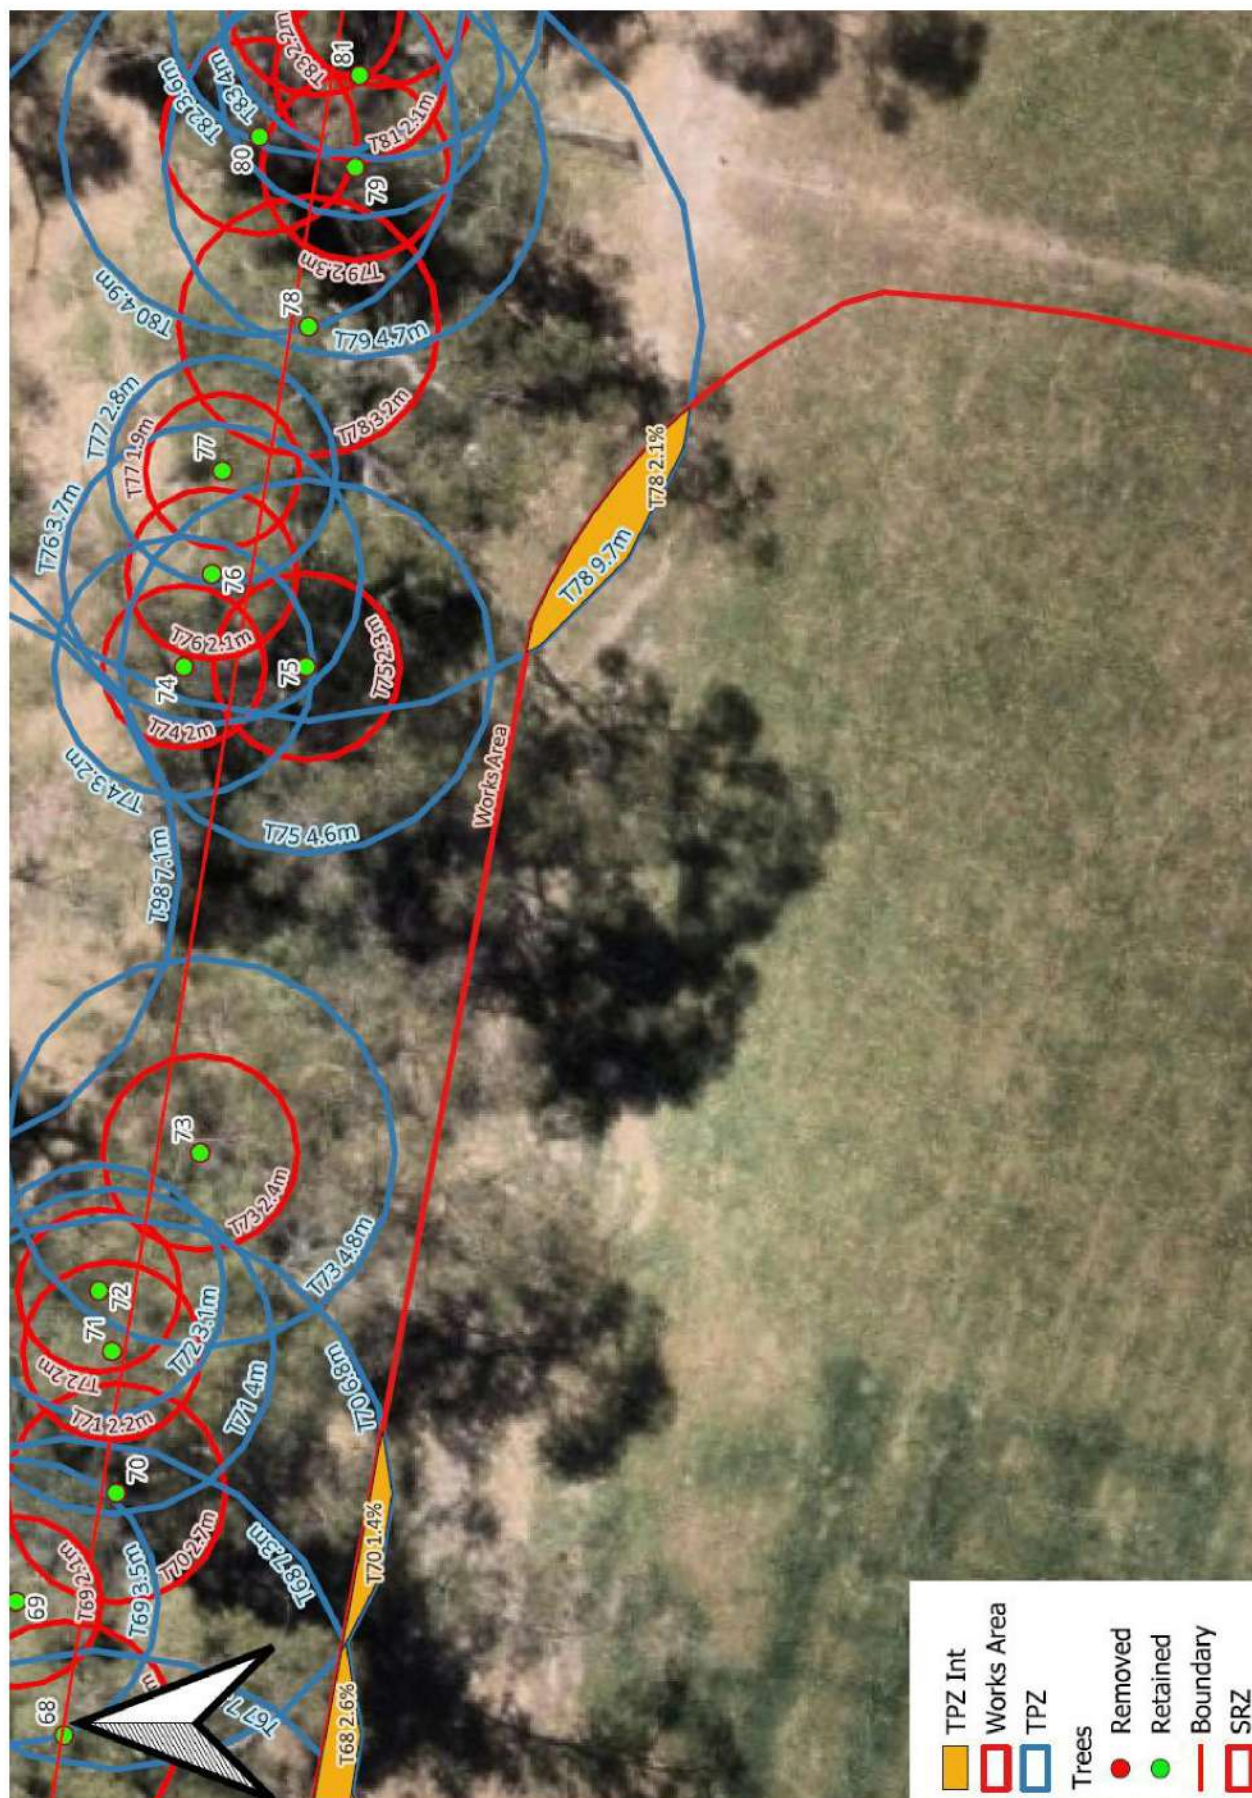
11.3. Trees 62, 63, 67, 68, 70 & 78

The proposed fill will encroach onto the TPZ of the following trees on the north side of the

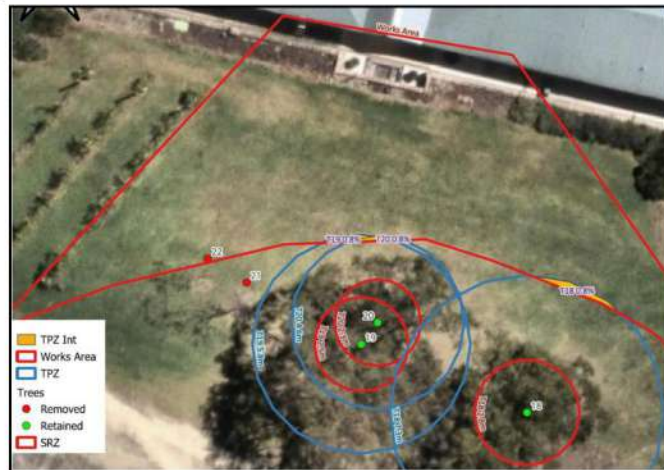
The TPZ intrusion for the proposed earthworks for these trees has been calculated at less than 10% (Figure 3, 4 and 5).

Under the AS 4970 this is considered to be a minor intrusion, therefore these trees are likely to remain viable from the proposed development.

Figure 3: Trees 18-20 TPZ intrusion less than 10%

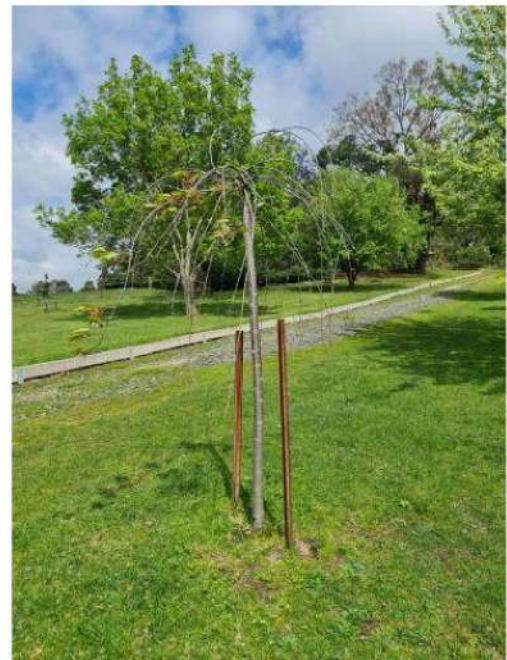
Tree ID: 2

Genus / species: *Pyrus calleryana*

Height (m): 7 **Structure:** Good
Width (m): 6 **Health:** Good
DBH (cm): 29 Measured **Maturity:** Mature
Origin: Exotic **ULE (years):** 15 - 30
Retained?: Removed **Form:** Good
Retention Value: Moderate
Removal / retention reason: N/A.
Amenity value: Moderate
Works Required: N/A.

SRZ (m): 2.1 **Works priority:** N/A
TPZ (m): 3.5 **Construction Impact:** High
mTPZ (m): = TPZ

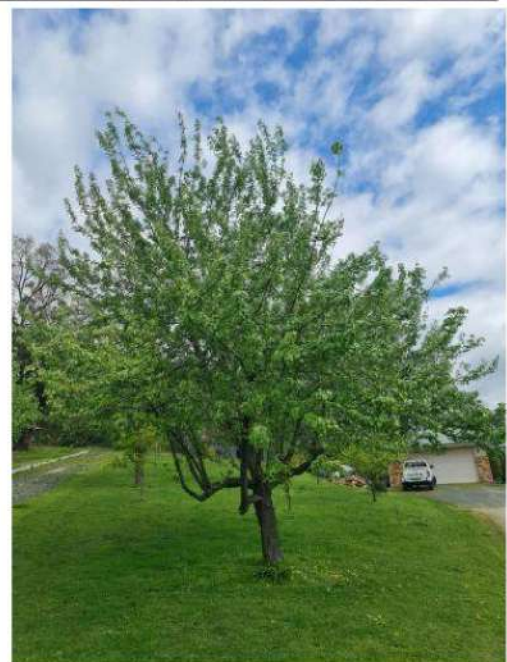
Tree ID: 3**Genus / species:** *Prunus persica*

Deciduous Peach

Height (m): 2 **Structure:** Fair
Width (m): 2 **Health:** Fair
DBH (cm): 4 Measured **Maturity:** Young
Origin: Exotic **ULE (years):** 5 - 15
Retained?: Removed **Form:** Fair

Retention Value: Very low**Removal / retention reason:** N/A.**Amenity value:** Very low**Works Required:** N/A.**SRZ (m):** 1.6 **Works priority:** N/A**TPZ (m):** 2.0 **Construction Impact:** High**mTPZ (m):** = TPZ

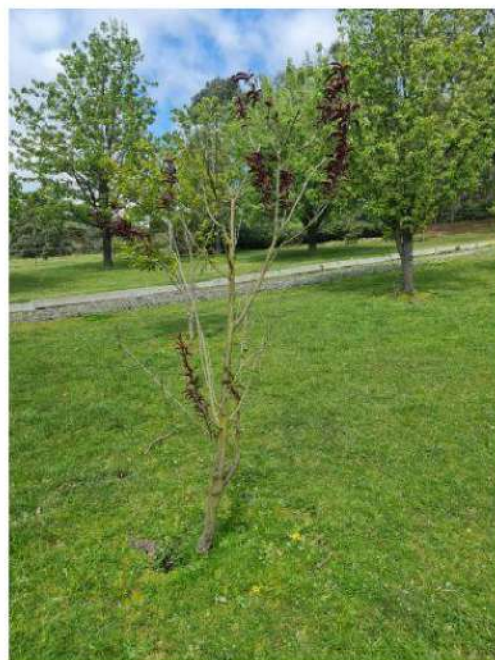
**Tree ID: 4****Genus / species:** *Morus alba*

Deciduous Mulberry

Retention Value: Very low
Removal / retention reason: N/A
Amenity value: Very low

Works Required: N/A.**SRZ (m):** 1.6 **Works priority:** N/A**TPZ (m):** 2.0 **Construction Impact:** High**mTPZ (m):** = TPZ

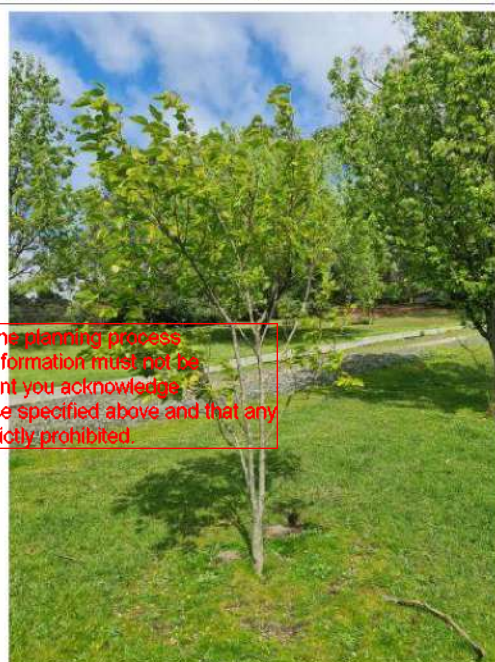
**Tree ID: 5****Genus / species:** *Malus sp.*

Deciduous Apple

Height (m): 2 **Structure:** Good
Width (m): 2 **Health:** Good
DBH (cm): 11 Measured **Maturity:** Young
Origin: Exotic **ULE (years):** 15 - 30
Retained?: Removed **Form:** Good

Retention Value: Very low**Removal / retention reason:** N/A.**Amenity value:** Very low**Works Required:** N/A.**SRZ (m):** 1.6 **Works priority:** N/A**TPZ (m):** 2.0 **Construction Impact:** High**mTPZ (m):** = TPZ

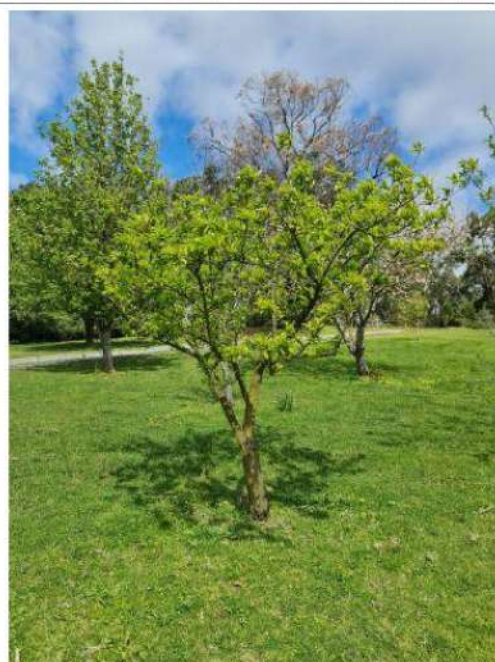
Tree ID: 6**Genus / species:** *Malus domestica*

Deciduous Apple

Height (m): 3 **Structure:** Fair**Width (m):** 2 **Health:** Good**DBH (cm):** 11 Measured **Maturity:** Young**Origin:** Exotic **ULE (years):** 15 - 30**Retained?:** Removed **Form:** Good**Retention Value:** Very low**Removal / retention reason:** N/A.**Amenity value:** Very low**Works Required:** N/A.**SRZ (m):** 1.6 **Works priority:** N/A**TPZ (m):** 2.0 **Construction Impact:** High**mTPZ (m):** = TPZ

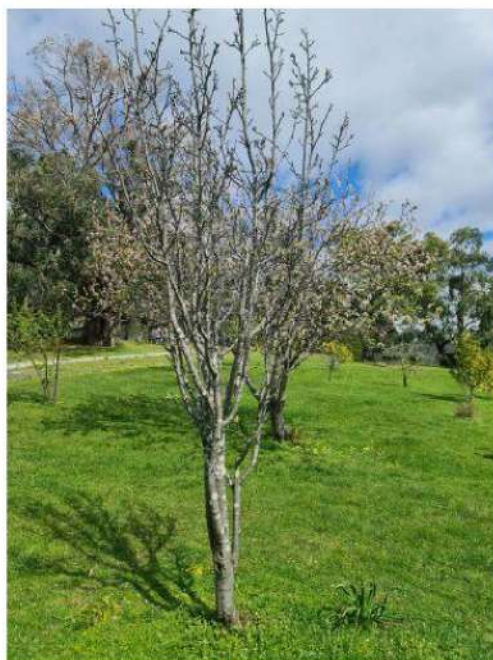
**Tree ID: 7****Genus / species:** *Pyrus communis*

Deciduous Common Pear

Retention Value: Moderate
Removal / retention reason: N/A
Amenity value: Moderate

Works Required: N/A.**SRZ (m):** 1.8 **Works priority:** N/A**TPZ (m):** 2.5 **Construction Impact:** High**mTPZ (m):** = TPZ

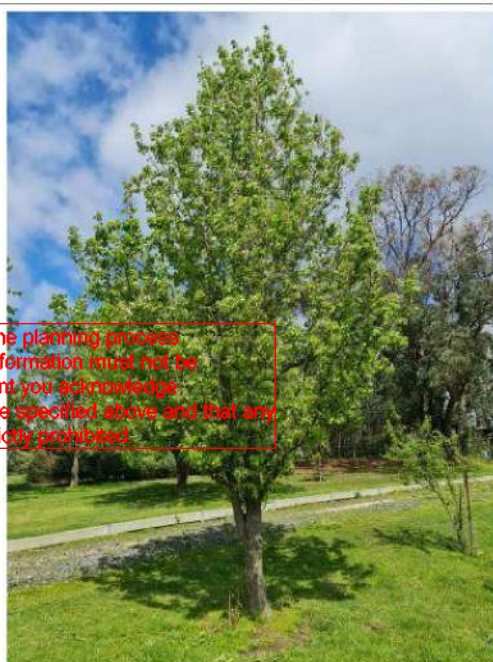
**Tree ID: 8****Genus / species:** *Prunus persica*

Deciduous Peach

Height (m): 2 **Structure:** Good**Width (m):** 4 **Health:** Good**DBH (cm):** 12 Measured **Maturity:** Young**Origin:** Exotic **ULE (years):** 15 - 30**Retained?:** Removed **Form:** Good**Retention Value:** Very low**Removal / retention reason:** N/A.**Amenity value:** Very low**Works Required:** N/A.**SRZ (m):** 1.6 **Works priority:** N/A**TPZ (m):** 2.0 **Construction Impact:** High**mTPZ (m):** = TPZ

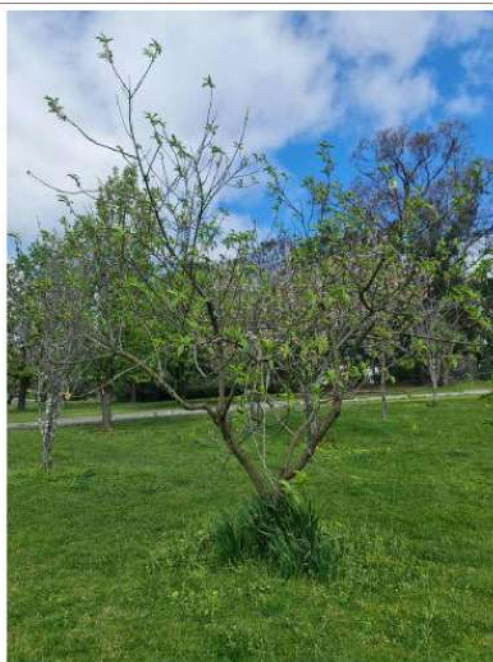
Tree ID: 9**Genus / species:** *Malus sargentii*

Deciduous Crab Apple

Height (m): 3 **Structure:** Good**Width (m):** 5 **Health:** Good**DBH (cm):** 17 Measured **Maturity:** Mature**Origin:** Exotic **ULE (years):** 15 - 30**Retained?:** Removed **Form:** Good**Retention Value:** Low**Removal / retention reason:** N/A.**Amenity value:** Low**Works Required:** N/A.**SRZ (m):** 1.7 **Works priority:** N/A**TPZ (m):** 2.0 **Construction Impact:** High**mTPZ (m):** = TPZ

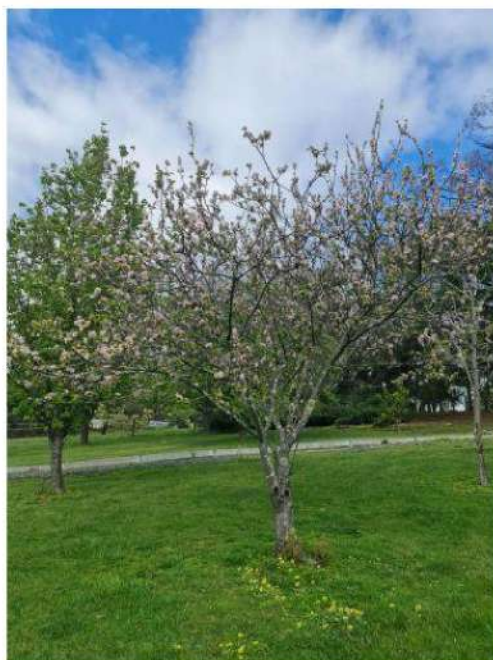
**Tree ID: 10****Genus / species:** *Ginkgo biloba*

Deciduous Maidenhair Tree

SRZ (m): 1.6 **Works priority:** N/A**TPZ (m):** 2.0 **Construction Impact:** High**mTPZ (m):** = TPZ

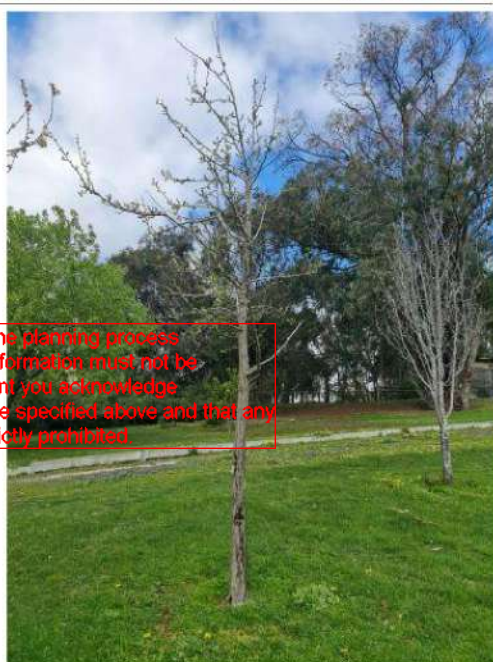
**Tree ID: 11****Genus / species:** *Malus domestica*

Deciduous Apple

Height (m): 3 **Structure:** Good**Width (m):** 2 **Health:** Good**DBH (cm):** 11 Measured **Maturity:** Mature**Origin:** Exotic **ULE (years):** 15 - 30**Retained?:** Removed **Form:** Good**Retention Value:** Low**Removal / retention reason:** N/A.**Amenity value:** Low**Works Required:** N/A.**SRZ (m):** 1.6 **Works priority:** N/A**TPZ (m):** 2.0 **Construction Impact:** High**mTPZ (m):** = TPZ

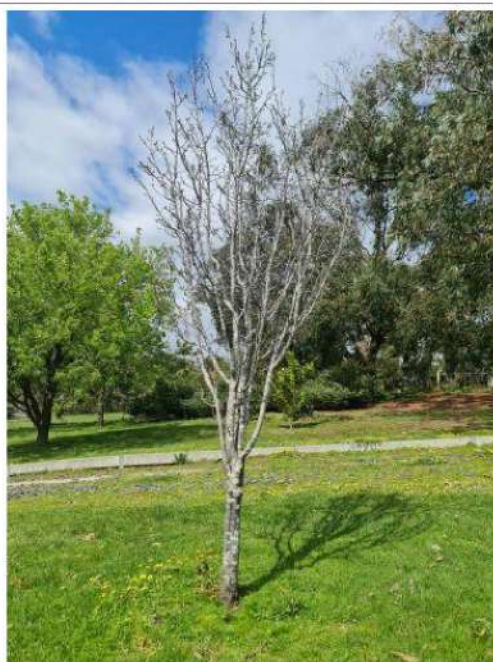
Tree ID: 12**Genus / species:** *Citrus reticulata*

Evergreen Mandarin

Height (m): 2 **Structure:** Fair**Width (m):** 2 **Health:** Good**DBH (cm):** 5 Measured **Maturity:** Young**Origin:** Exotic **ULE (years):** 15 - 30**Retained?:** Removed **Form:** Good**Retention Value:** Very low**Removal / retention reason:** N/A.**Amenity value:** Very low**Works Required:** N/A.**SRZ (m):** 1.6 **Works priority:** N/A**TPZ (m):** 2.0 **Construction Impact:** High**mTPZ (m):** = TPZ

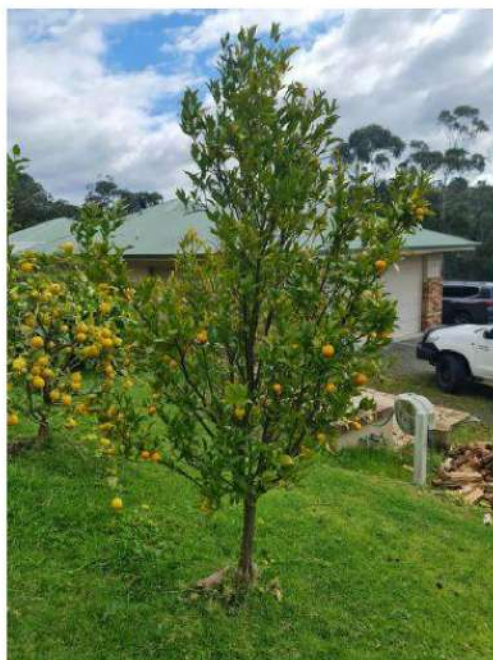
**Tree ID: 13****Genus / species:** *Citrus limon*

Evergreen Lemon

SRZ (m): 1.6 **Works priority:** N/A**TPZ (m):** 2.0 **Construction Impact:** High**mTPZ (m):** = TPZ

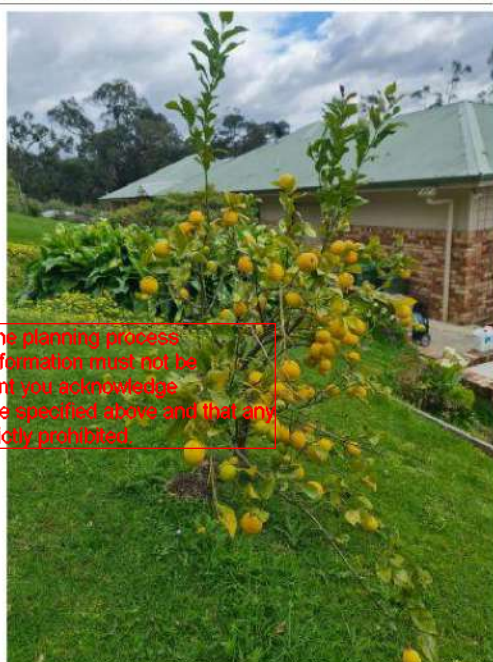
**Tree ID: 14****Genus / species:** *Malus domestica*

Deciduous Apple

Height (m): 2 **Structure:** Good**Width (m):** 2 **Health:** Good**DBH (cm):** 6 Estimated **Maturity:** Young**Origin:** Exotic **ULE (years):** 15 - 30**Retained?:** Removed **Form:** Good**Retention Value:** Very low**Removal / retention reason:** N/A.**Amenity value:** Very low**Works Required:** N/A.**SRZ (m):** 1.6 **Works priority:** N/A**TPZ (m):** 2.0 **Construction Impact:** High**mTPZ (m):** = TPZ

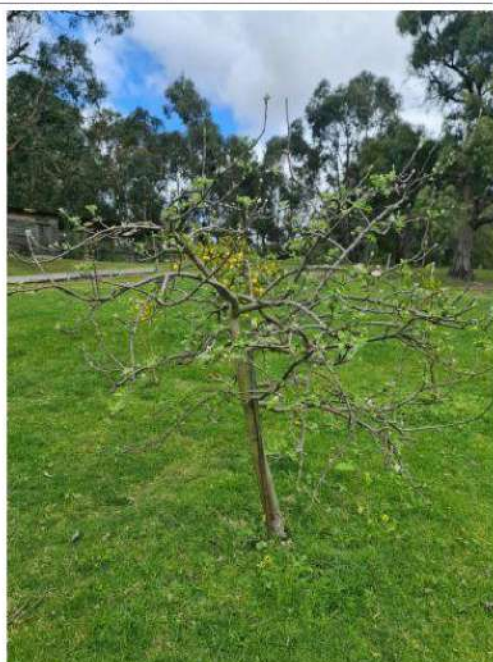
Tree ID: 15**Genus / species:** *Malus domestica*

Deciduous Apple

Height (m): 1 **Structure:** Fair**Width (m):** 2 **Health:** Good**DBH (cm):** 5 Estimated **Maturity:** Young**Origin:** Exotic **ULE (years):** 15 - 30**Retained?:** Removed **Form:** Good**Retention Value:** Very low**Removal / retention reason:** N/A.**Amenity value:** Very low**Works Required:** N/A.**SRZ (m):** 1.6 **Works priority:** N/A**TPZ (m):** 2.0 **Construction Impact:** High**mTPZ (m):** = TPZ

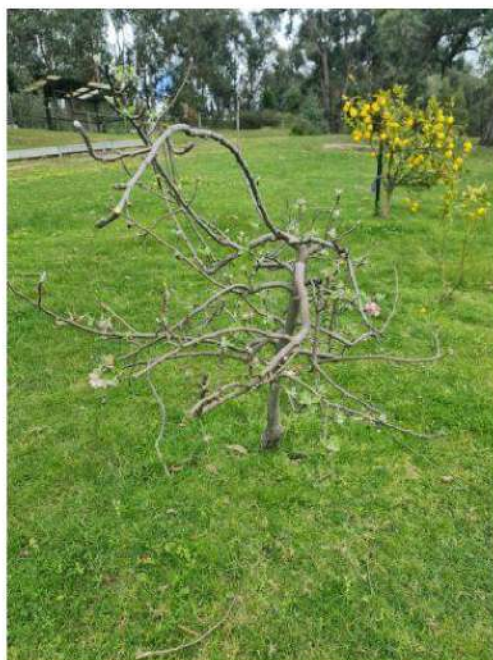
**Tree ID: 16****Genus / species:** *Pyrus communis*

Deciduous Common Pear

SRZ (m): 1.6 **Works priority:** N/A**TPZ (m):** 2.0 **Construction Impact:** High**mTPZ (m):** = TPZ

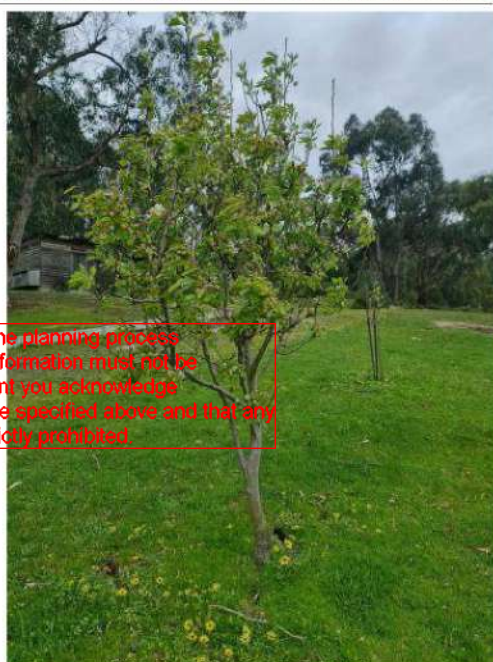
**Tree ID: 17****Genus / species:** *Citrus limon*

Evergreen Lemon

Height (m): 1 **Structure:** Good**Width (m):** 2 **Health:** Good**DBH (cm):** 5 Estimated **Maturity:** Young**Origin:** Exotic **ULE (years):** 15 - 30**Retained?:** Removed **Form:** Good**Retention Value:** Very low**Removal / retention reason:** N/A.**Amenity value:** Very low**Works Required:** N/A.**SRZ (m):** 1.6 **Works priority:** N/A**TPZ (m):** 2.0 **Construction Impact:** High**mTPZ (m):** = TPZ

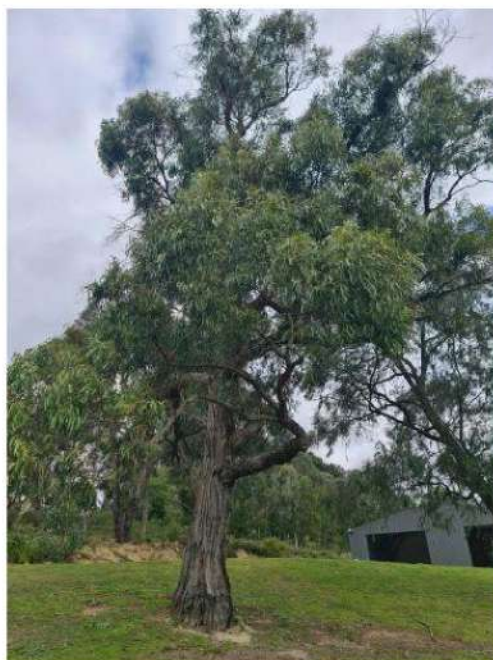
**Tree ID: 19****Genus / species:** *Eucalyptus dives*

Evergreen Broad-leaved Peppermint

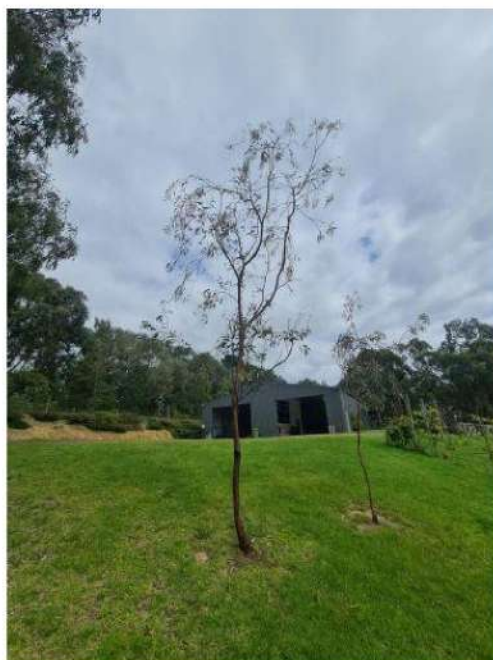
**Tree ID: 22****Genus / species:** *Eucalyptus caesia* 'Silver Princess'

Evergreen Gungurru

Works Required: N/A.**SRZ (m):** 1.6 **Works priority:** N/A**TPZ (m):** 2.0 **Construction Impact:** High**mTPZ (m):** = TPZ

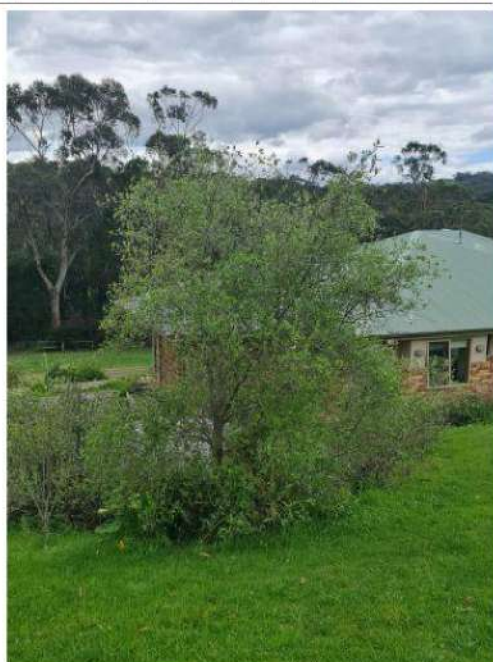
Tree ID: 24**Genus / species:** *Eriobotrya japonica*

Evergreen Loquat

Height (m): 2 **Structure:** Good**Width (m):** 3 **Health:** Good**DBH (cm):** 5 Estimated **Maturity:** Young**Origin:** Exotic **ULE (years):** 15 - 30**Retained?:** Removed **Form:** Good**Retention Value:** Very low**Removal / retention reason:** N/A.**Amenity value:** Very low**Works Required:** N/A.**SRZ (m):** 1.6 **Works priority:** N/A**TPZ (m):** 2.0 **Construction Impact:** High**mTPZ (m):** = TPZ

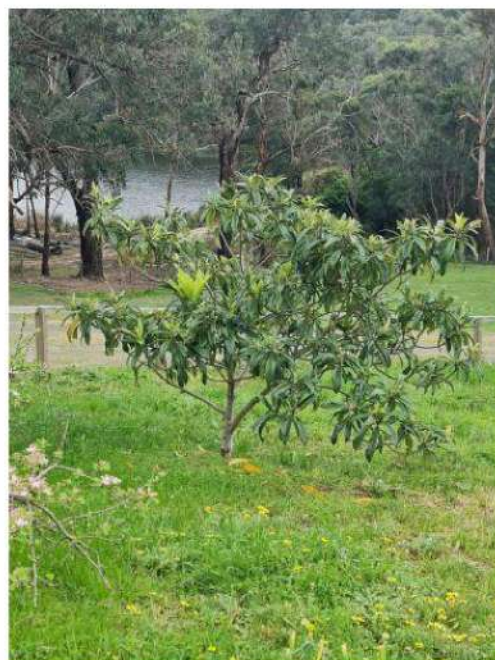
**Tree ID: 25****Genus / species:** *Eucalyptus dives*

Evergreen Broad-leaved Peppermint

Retention Value: Low
Removal / retention reason: Adjoining property
Amenity value: Low

Works Required: N/A.**SRZ (m):** 1.8 **Works priority:** N/A**TPZ (m):** 2.4 **Construction Impact:** None**mTPZ (m):** = TPZ

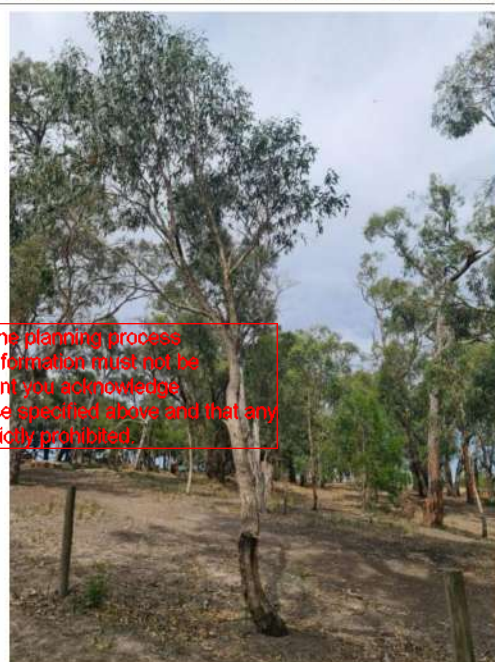
**Tree ID: 26****Genus / species:** *Eucalyptus goniocalyx*

Evergreen Long leaved Box

Height (m): 20 **Structure:** Fair**Width (m):** 22 **Health:** Good**DBH (cm):** 128 Measured **Maturity:** Mature**Origin:** Melbourne **ULE (years):** 30 - 60**Retained?:** Retained **Form:** Good**Retention Value:** High**Removal / retention reason:** N/A.**Amenity value:** High**Works Required:** N/A.**SRZ (m):** 3.9 **Works priority:** N/A**TPZ (m):** 15.0 **Construction Impact:** None**mTPZ (m):** = TPZ

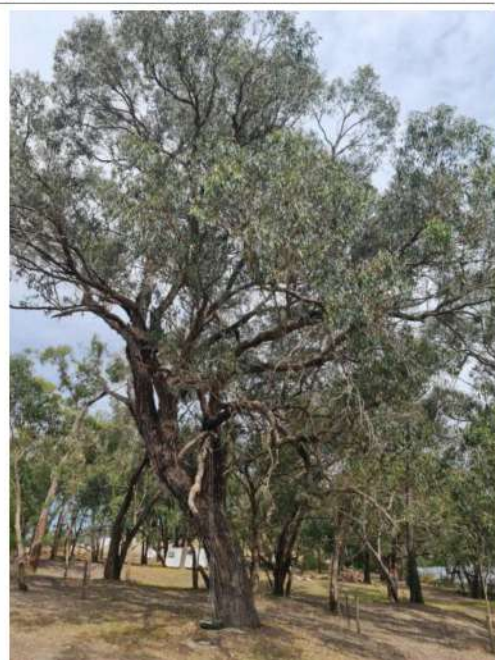
Tree ID: 27**Genus / species:** *Eucalyptus ovata*

Evergreen Swamp Gum

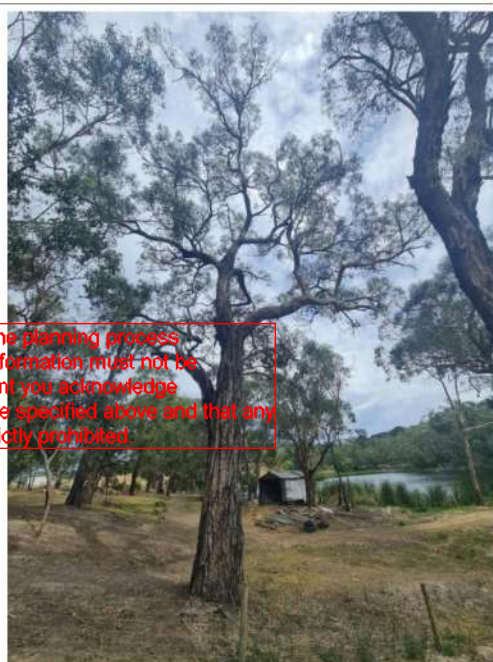
**Tree ID: 28****Genus / species:** *Eucalyptus dives*

Evergreen Broad-leaved Peppermint

Amenity value: High

Works Required: N/A.**SRZ (m):** 4 **Works priority:** N/A**TPZ (m):** 15.0 **Construction Impact:** None**mTPZ (m):** = TPZ

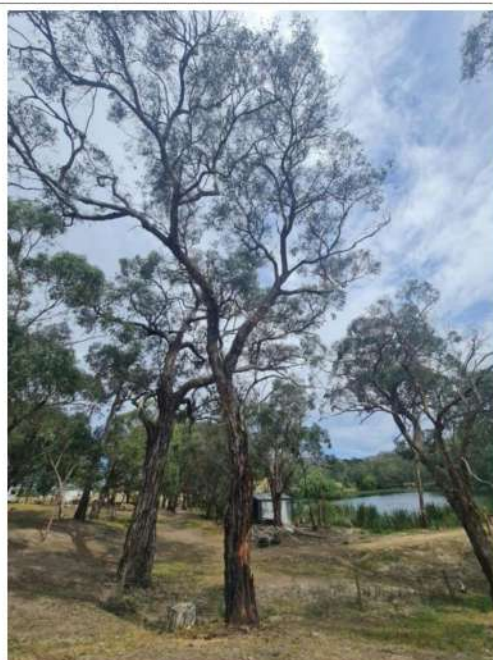
**Tree ID: 29****Genus / species:** *Eucalyptus dives*

Evergreen Broad-leaved Peppermint

Height (m): 20 **Structure:** Fair**Width (m):** 20 **Health:** Fair**DBH (cm):** 79 Measured **Maturity:** Mature**Origin:** Melbourne **ULE (years):** 15 - 30**Retained?:** Retained **Form:** Good**Retention Value:** High**Removal / retention reason:** N/A.**Amenity value:** High**Works Required:** N/A.**SRZ (m):** 3.2 **Works priority:** N/A**TPZ (m):** 9.5 **Construction Impact:** None**mTPZ (m):** = TPZ

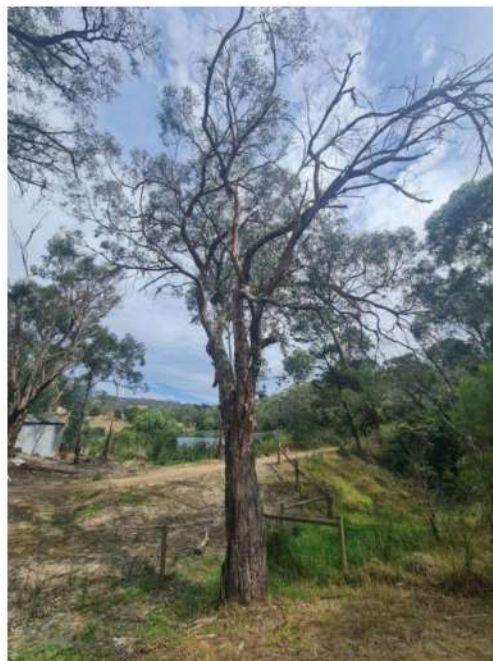
Tree ID: 30**Genus / species:** *Eucalyptus dives*

Evergreen Broad-leaved Peppermint

Height (m): 18 **Structure:** Fair
Width (m): 18 **Health:** Fair
DBH (cm): 85 Measured **Maturity:** Mature
Origin: Melbourne **ULE (years):** 15 - 30
Retained?: Retained **Form:** Fair
Retention Value: High
Removal / retention reason: N/A.
Amenity value: High
Works Required: N/A.

SRZ (m): 3.3 **Works priority:** N/A
TPZ (m): 10.2 **Construction Impact:** None
mTPZ (m): = TPZ

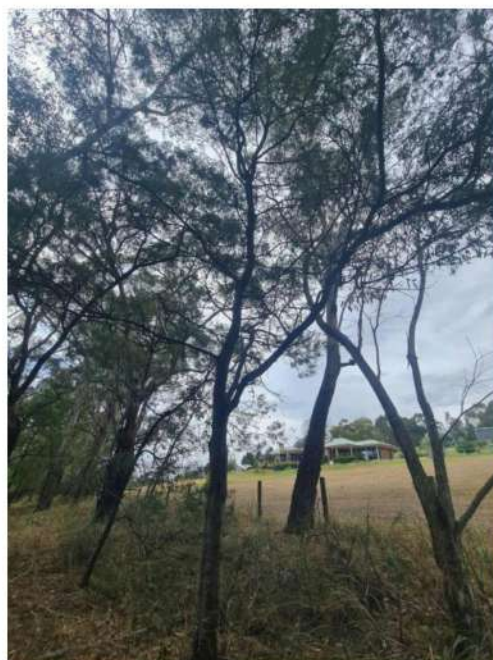
Tree ID: 33**Genus / species:** *Acacia dealbata*

Evergreen Silver Wattle

Retention Value: Low**Removal / retention reason:** Adjoining property.**Amenity value:** Moderate**Works Required:** N/A.

SRZ (m): 1.9 **Works priority:** N/A
TPZ (m): 3.0 **Construction Impact:** None
mTPZ (m): = TPZ

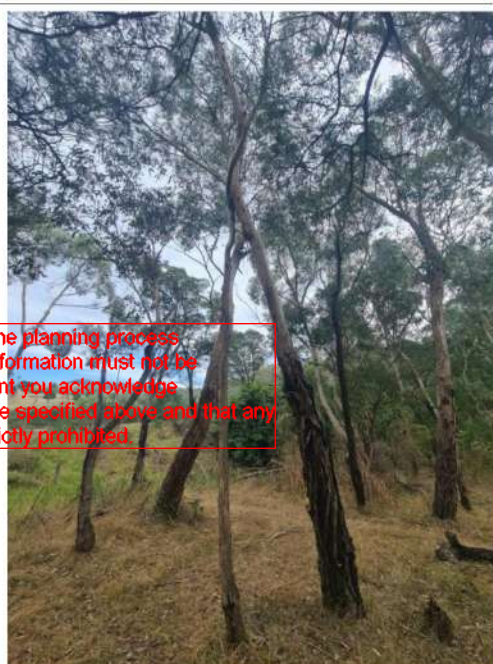
**Tree ID: 34****Genus / species:** *Eucalyptus ovata*

Evergreen Swamp Gum

Retention Value: Low**Removal / retention reason:** Adjoining property**Amenity value:** Low**Works Required:** N/A.

SRZ (m): 1.6 **Works priority:** N/A
TPZ (m): 2.0 **Construction Impact:** None
mTPZ (m): = TPZ

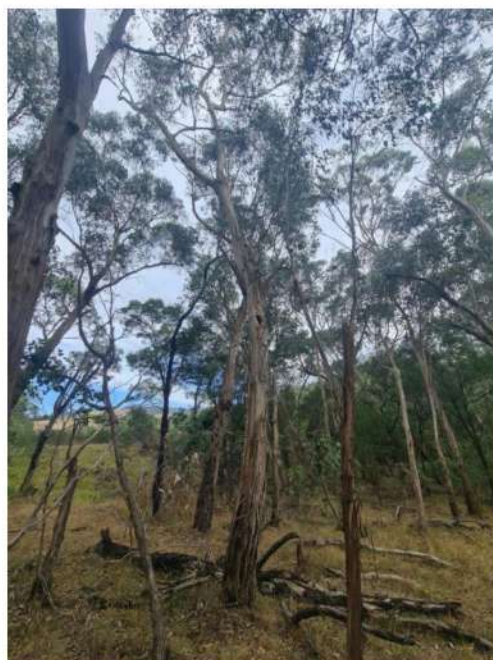
Tree ID: 36**Genus / species:** *Eucalyptus ovata*

Evergreen Swamp Gum

Height (m): 18 **Structure:** Fair
Width (m): 12 **Health:** Good
DBH (cm): 39 Measured **Maturity:** Mature
Origin: Melbourne **ULE (years):** 30 - 60
Retained?: Retained **Form:** Fair
Retention Value: Moderate
Removal / retention reason: Adjoining property.
Amenity value: Moderate
Works Required: N/A.

SRZ (m): 2.3 **Works priority:** N/A
TPZ (m): 4.7 **Construction Impact:** None
mTPZ (m): = TPZ

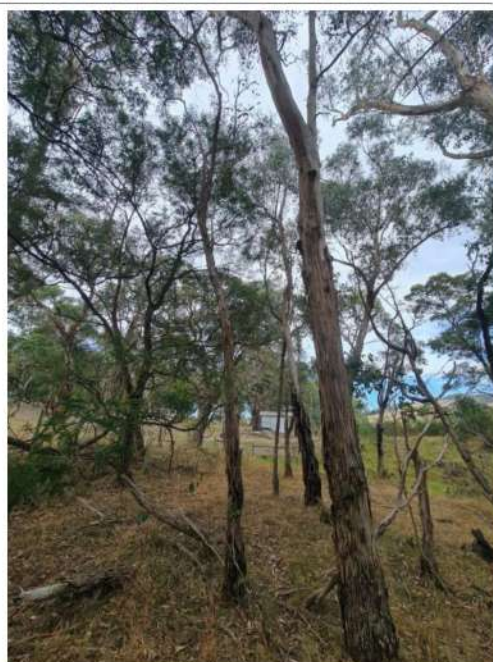
Tree ID: 38**Genus / species:** *Eucalyptus ovata*

Height (m): 10 **Structure:** Good
Width (m): 6 **Health:** Very poor
DBH (cm): 19 Measured **Maturity:** Mature
Origin: Melbourne **ULE (years):** 30 - 60
Retained?: Retained **Form:** Fair
Retention Value: Very low
Removal / retention reason: Adjoining property.
Amenity value: Very low
Works Required: N/A.

SRZ (m): 1.7 **Works priority:** N/A
TPZ (m): 2.3 **Construction Impact:** None
mTPZ (m): = TPZ

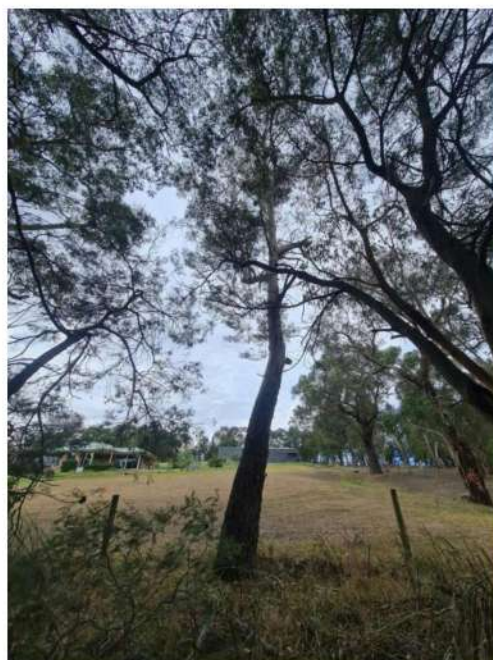
Tree ID: 39**Genus / species:** *Eucalyptus ovata*

Evergreen Swamp Gum

Height (m): 22 **Structure:** Fair
Width (m): 16 **Health:** Fair
DBH (cm): 59 Measured **Maturity:** Mature
Origin: Melbourne **ULE (years):** 30 - 60
Retained?: Retained **Form:** Fair
Retention Value: High
Removal / retention reason: Adjoining property.
Amenity value: High
Works Required: N/A.

SRZ (m): 2.8 **Works priority:** N/A
TPZ (m): 7.1 **Construction Impact:** None
mTPZ (m): = TPZ

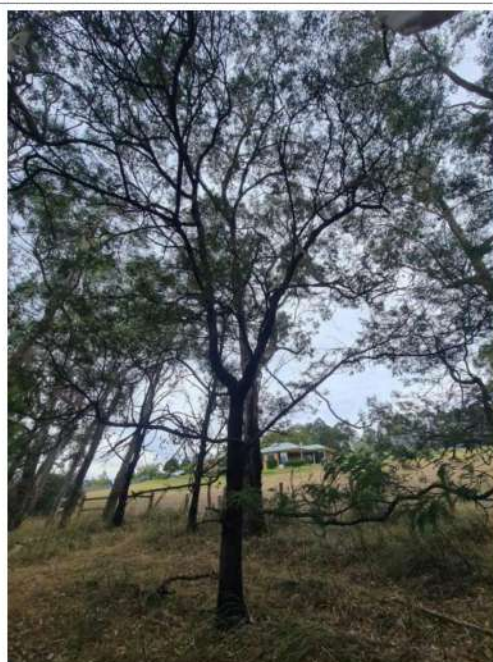
Tree ID: 41**Genus / species:** *Acacia dealbata*

Height (m): 15 **Structure:** Fair
Width (m): 12 **Health:** Fair
DBH (cm): 29 Measured **Maturity:** Mature
Origin: Melbourne **ULE (years):** 15 - 30
Retained?: Retained **Form:** Poor
Retention Value: Moderate
Removal / retention reason: Adjoining property.
Amenity value: Moderate
Works Required: N/A.

SRZ (m): 2.1 **Works priority:** N/A
TPZ (m): 3.5 **Construction Impact:** None
mTPZ (m): = TPZ

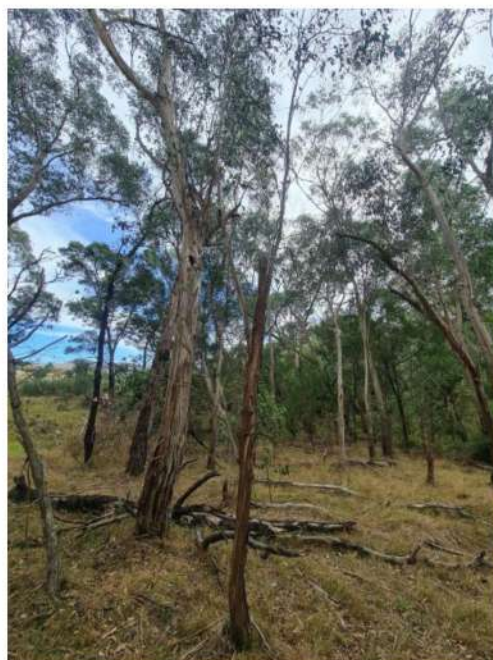
Tree ID: 42**Genus / species:** *Eucalyptus ovata*

Evergreen Swamp Gum

Height (m): 5 **Structure:** Fair
Width (m): 4 **Health:** Fair
DBH (cm): 11 Measured **Maturity:** Mature
Origin: Melbourne **ULE (years):** 15 - 30
Retained?: Retained **Form:** Fair
Retention Value: Low
Removal / retention reason: Adjoining property.
Amenity value: Low
Works Required: N/A.

SRZ (m): 1.6 **Works priority:** N/A
TPZ (m): 2.0 **Construction Impact:** None
mTPZ (m): = TPZ

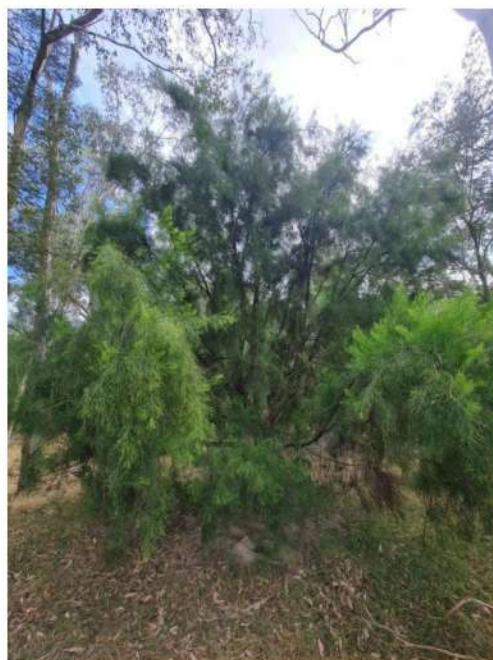
Tree ID: 45**Genus / species:** *Callitris sp.*

Evergreen Native Pine

Height (m): 8 **Structure:** Good**Width (m):** 8 **Health:** Good**DBH (cm):** 25 Measured **Maturity:** Mature**Origin:** Australian **ULE (years):** 30 - 60**Retained?:** Retained **Form:** Good**Retention Value:** Low**Removal / retention reason:** Adjoining property.**Amenity value:** Low**Works Required:** N/A.**SRZ (m):** 1.9 **Works priority:** N/A**TPZ (m):** 3.0 **Construction Impact:** None**mTPZ (m):** = TPZ

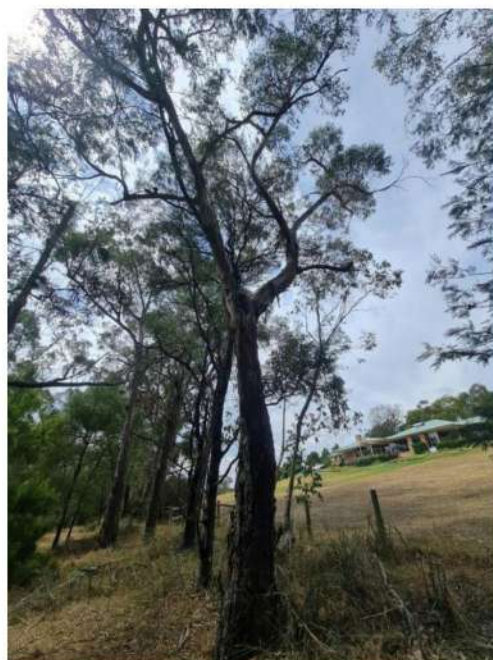
Tree ID: 48**Genus / species:** *Eucalyptus ovata*

Evergreen Swamp Gum

Height (m): 17 **Structure:** Fair
Width (m): 14 **Health:** Fair
DBH (cm): 65 Measured **Maturity:** Mature
Origin: Melbourne **ULE (years):** 15 - 30
Retained?: Retained **Form:** Fair
Retention Value: Moderate
Removal / retention reason: Adjoining property.
Amenity value: Moderate
Works Required: N/A.

SRZ (m): 2.9 **Works priority:** N/A
TPZ (m): 7.8 **Construction Impact:** None
mTPZ (m): = TPZ

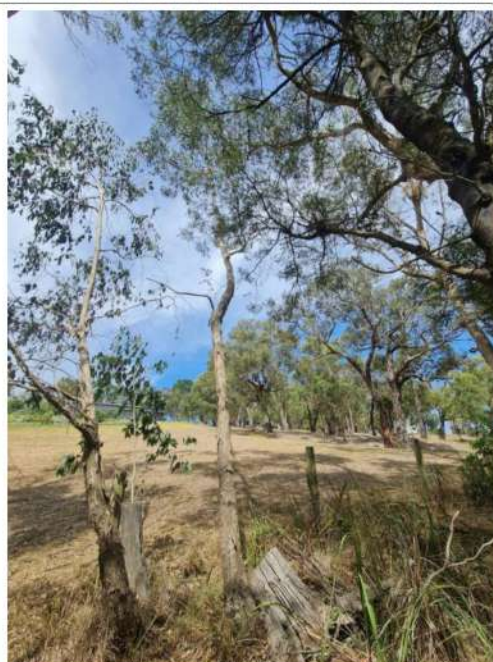
**Tree ID: 50****Genus / species:** *Eucalyptus ovata*

Evergreen Swamp Gum

Height (m): 8 **Structure:** Fair
Width (m): 5 **Health:** Good
DBH (cm): 14 Measured **Maturity:** Mature
Origin: Melbourne **ULE (years):** 30 - 60
Retained?: Retained **Form:** Poor
Retention Value: Low
Removal / retention reason: Adjoining property.
Amenity value: Low
Works Required: N/A.

SRZ (m): 1.6 **Works priority:** N/A
TPZ (m): 2.0 **Construction Impact:** None
mTPZ (m): = TPZ
