Notice of Application for a Planning Permit

The land affected by the application is located at:	PC370839 V11086 F820 50 Lilliput Lane, Pakenham VIC 3810
The application is for a permit to:	Earthworks and Vegetation Removal
A permit is required under the following clauses of the planning scheme:

Proposed Use	Proposed Landscape Works including Vegetation Removal & Site Works, proposed Pool & in-ground trampoline
Current Use	Single storey dwelling with associated outbuildings
Cost of Works	\$95,000
Site Address	50 Lilliput Lane Pakenham 3810

This report was commissioned by 3D Design Group to assess the condition of 104 trees located on or adjacent to 50 Lilliput Lane, Pakenham and to evaluate the impacts on these trees arising from the proposed development on this site.

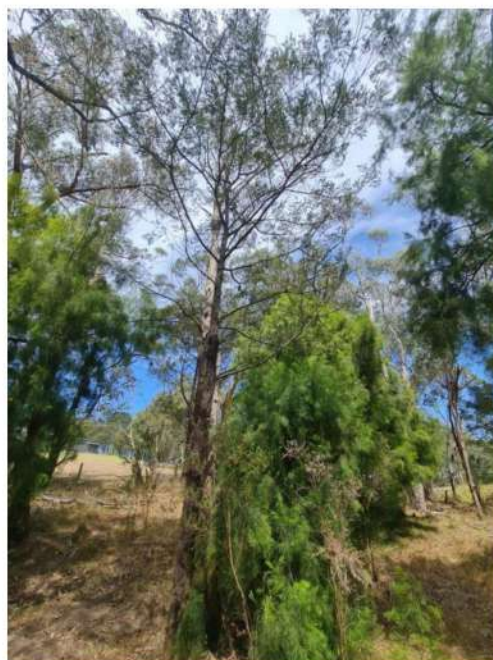
Tree ID: 54**Genus / species:** *Acacia dealbata*

Evergreen Silver Wattle

Height (m): 11 **Structure:** Good
Width (m): 8 **Health:** Fair
DBH (cm): 17 Measured **Maturity:** Mature
Origin: Melbourne **ULE (years):** 15 - 30
Retained?: Retained **Form:** Good
Retention Value: Moderate
Removal / retention reason: Adjoining property.
Amenity value: Moderate
Works Required: N/A.

SRZ (m): 1.7 **Works priority:** N/A
TPZ (m): 2.0 **Construction Impact:** None
mTPZ (m): = TPZ

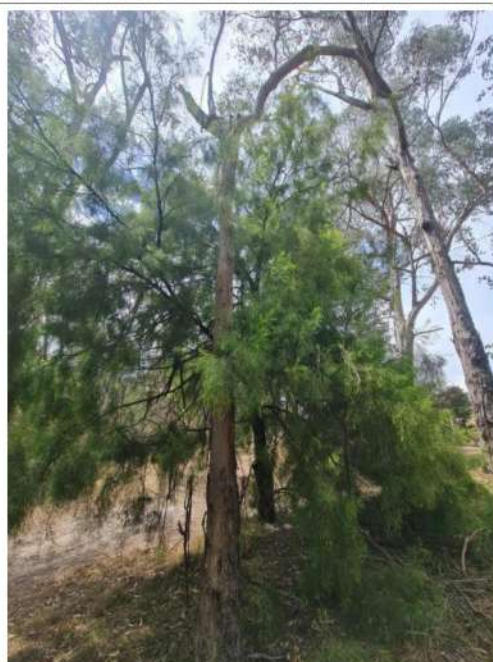
**Tree ID: 56****Genus / species:** *Eucalyptus ovata*

Evergreen Swamp Gum

Height (m): 11 **Structure:** Fair
Width (m): 6 **Health:** Very poor
DBH (cm): 29 Measured **Maturity:** Mature
Origin: Melbourne **ULE (years):** 5 - 15
Retained?: Retained **Form:** Poor
Retention Value: Low
Removal / retention reason: Adjoining property.
Amenity value: Low
Works Required: N/A.

SRZ (m): 2.1 **Works priority:** N/A
TPZ (m): 3.5 **Construction Impact:** None
mTPZ (m): = TPZ

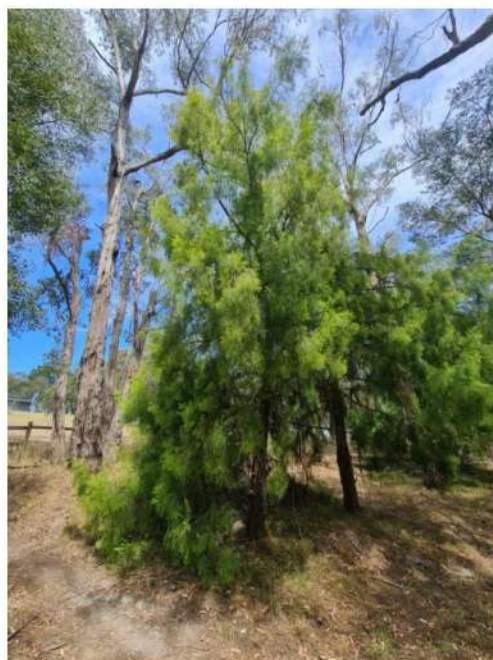
Tree ID: 57**Genus / species:** *Callitris sp.*

Evergreen Native Pine

Height (m): 8 **Structure:** Good**Width (m):** 8 **Health:** Good**DBH (cm):** 24 Measured **Maturity:** Mature**Origin:** Australian **ULE (years):** 30 - 60**Retained?:** Retained **Form:** Good**Retention Value:** Moderate**Removal / retention reason:** Adjoining property.**Amenity value:** Moderate**Works Required:** N/A.**SRZ (m):** 1.9 **Works priority:** N/A**TPZ (m):** 2.9 **Construction Impact:** None**mTPZ (m):** = TPZ

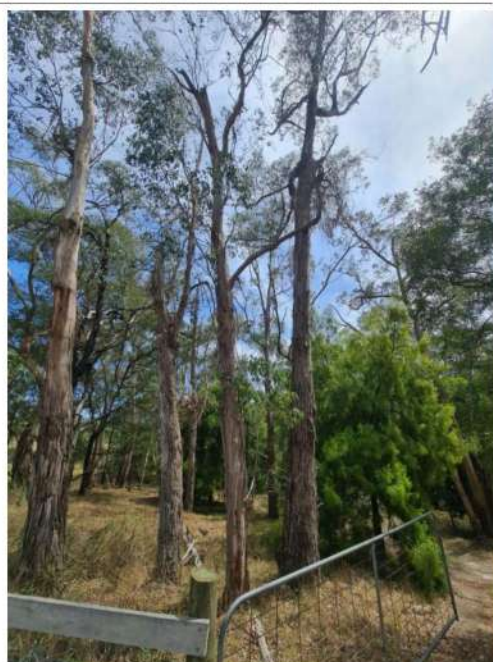
**Tree ID: 59****Genus / species:** *Eucalyptus ovata*

Evergreen Swamp Gum

Height (m): 12 **Structure:** Poor**Width (m):** 5 **Health:** Poor**DBH (cm):** 31 Measured **Maturity:** Mature**Origin:** Melbourne **ULE (years):** 15 - 30**Retained?:** Retained **Form:** Fair**Retention Value:** Moderate**Removal / retention reason:** Adjoining property.**Amenity value:** Moderate**Works Required:** N/A.**SRZ (m):** 2.1 **Works priority:** N/A**TPZ (m):** 3.7 **Construction Impact:** None**mTPZ (m):** = TPZ

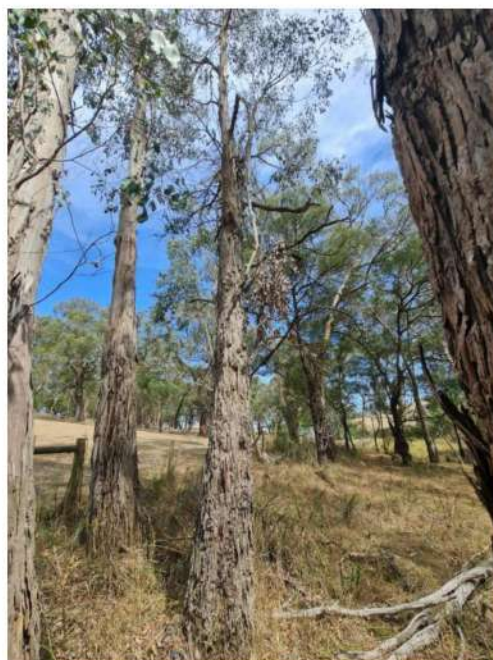
Height (m): 10 **Structure:** Poor
Width (m): 6 **Health:** Fair
DBH (cm): 43 Measured **Maturity:** Mature
Origin: Melbourne **ULE (years):** 15 - 30
Retained?: Retained **Form:** Fair
Retention Value: Moderate
Removal / retention reason: Adjoining property.
Amenity value: Moderate
Works Required: N/A.

SRZ (m): 2.4 **Works priority:** N/A
TPZ (m): 5.2 **Construction Impact:** None
mTPZ (m): = TPZ

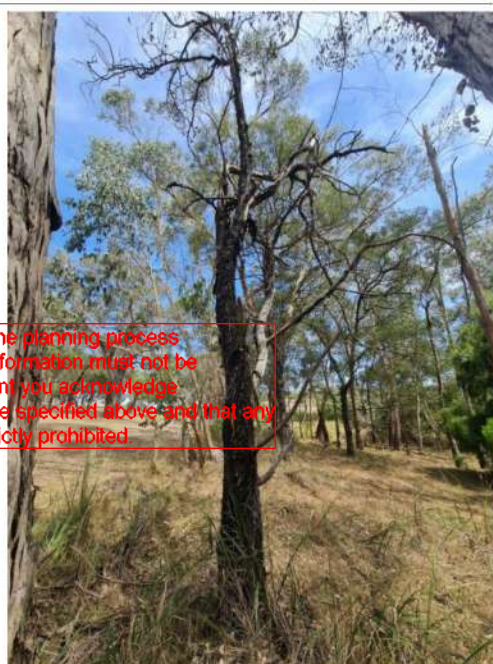
**Tree ID: 61****Genus / species:** *Acacia* sp.

Works Required: N/A.

SRZ (m): 2.3 **Works priority:** N/A
TPZ (m): 4.4 **Construction Impact:** None
mTPZ (m): = TPZ

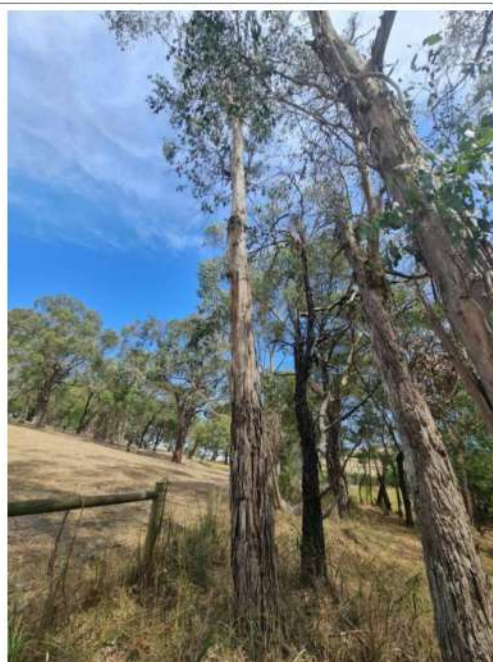
**Tree ID: 62****Genus / species:** *Eucalyptus ovata*

Height (m): 23 **Structure:** Fair
Width (m): 10 **Health:** Fair
DBH (cm): 53 Measured **Maturity:** Mature
Origin: Melbourne **ULE (years):** 30 - 60
Retained?: Retained **Form:** Fair
Retention Value: High
Removal / retention reason: Adjoining property.
Amenity value: High
Works Required: N/A.

SRZ (m): 2.6 **Works priority:** N/A
TPZ (m): 6.4 **Construction Impact:** Low
mTPZ (m): = TPZ

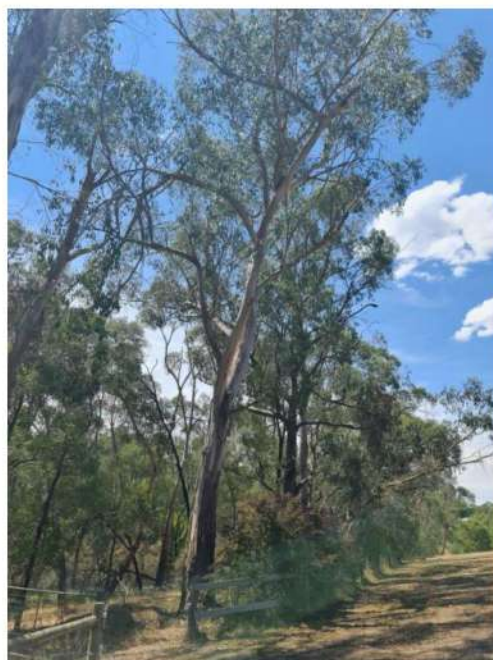
Tree ID: 63**Genus / species:** *Eucalyptus ovata*

Retention Value: High**Removal / retention reason:** Adjoining property.**Amenity value:** High**Works Required:** N/A.

SRZ (m): 3.3 **Works priority:** N/A
TPZ (m): 10.3 **Construction Impact:** Moderate
mTPZ (m): = TPZ

However, this tree will remain viable provided that the construction impact could be reduced from Moderate to Low by improving the growing conditions between the proposed batter and retained trees on the adjoining property. Mulching and irrigation will assist the tree during the construction phase. Irrigation should be maintained for 3 years.

1. A services plan should be created for this site and this construction impact report should be revised as required to ensure that services installation impacts on retained trees are avoided.
2. A Tree Management Plan should be created for this site to inform tree management guide construction within the Tree Protection Zones for retained trees.
3. Reducing the construction impact from 'Moderate' to 'Low' could be achieved by and improving the growing conditions between the trees and the edge of batter with mulching and irrigation.
 - a. Irrigation should be maintained for 3 years.
 - b. Excavation deeper than 0.1 metres below existing grade or compaction must be avoided within the TPZ for trees 63 and 67.

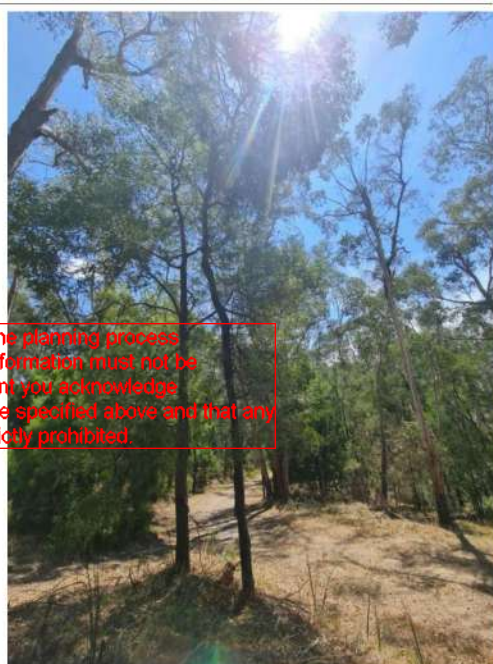
**Tree ID: 64****Genus / species:** *Acacia dealbata*

Retention Value: Low**Removal / retention reason:** Adjoining property**Amenity value:** Low**Works Required:** N/A.

SRZ (m): 1.6 **Works priority:** N/A
TPZ (m): 2.0 **Construction Impact:** None
mTPZ (m): = TPZ

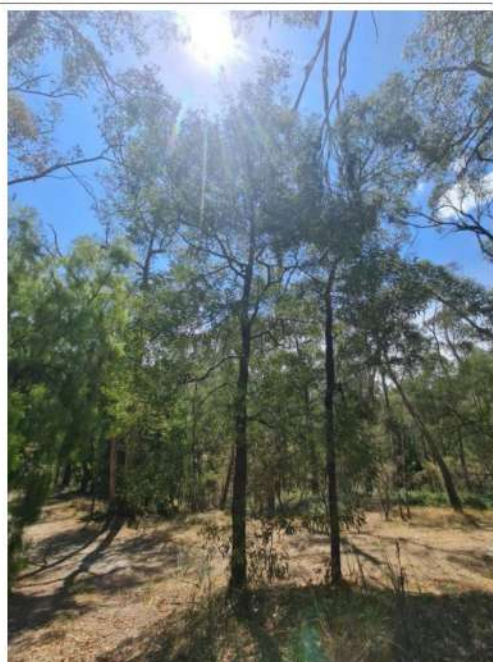
Tree ID: 65**Genus / species:** *Acacia melanoxylon*

Retention Value: Moderate**Removal / retention reason:** Adjoining property.**Amenity value:** Moderate**Works Required:** N/A.

SRZ (m): 1.8 **Works priority:** N/A
TPZ (m): 2.5 **Construction Impact:** None
mTPZ (m): = TPZ

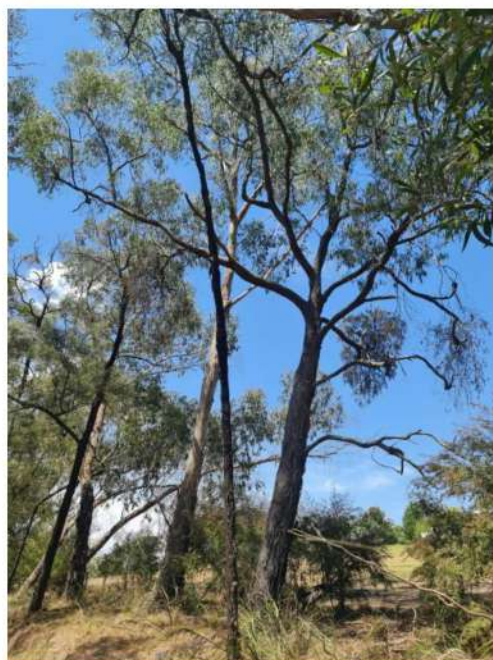
Tree ID: 66**Genus / species:** *Acacia sp.*

Height (m): 10 **Structure:** Very poor**Width (m):** 2 **Health:** Dead**DBH (cm):** 14 Measured **Maturity:** Over mature**Origin:** Australian **ULE (years):** 0**Retained?:** Retained **Form:** Very poor**Retention Value:** Very low**Removal / retention reason:** Adjoining property.**Amenity value:** Very low**Works Required:** N/A.**SRZ (m):** 1.6 **Works priority:** N/A**TPZ (m):** 2.0 **Construction Impact:** None**mTPZ (m):** = TPZ

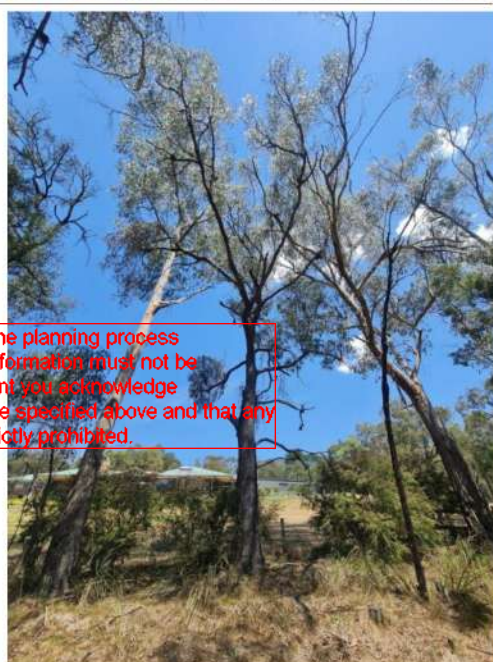
**Tree ID: 67****Genus / species:** *Eucalyptus dives*

Amenity value: High

Works Required: N/A.**SRZ (m):** 2.8 **Works priority:** N/A**TPZ (m):** 7.6 **Construction Impact:** Moderate**mTPZ (m):** = TPZ

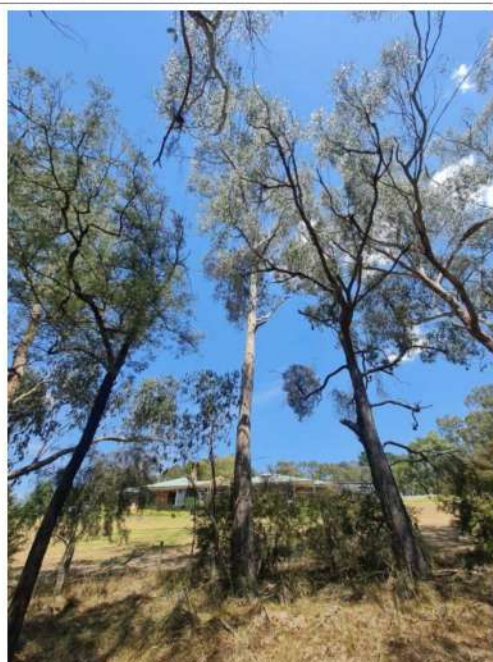
**Tree ID: 68****Genus / species:** *Eucalyptus ovata*

Height (m): 24 **Structure:** Fair**Width (m):** 12 **Health:** Fair**DBH (cm):** 61 Measured **Maturity:** Mature**Origin:** Melbourne **ULE (years):** 30 - 60**Retained?:** Retained **Form:** Good**Retention Value:** High**Removal / retention reason:** Adjoining property.**Amenity value:** High**Works Required:** N/A.**SRZ (m):** 2.8 **Works priority:** N/A**TPZ (m):** 7.3 **Construction Impact:** Low**mTPZ (m):** = TPZ

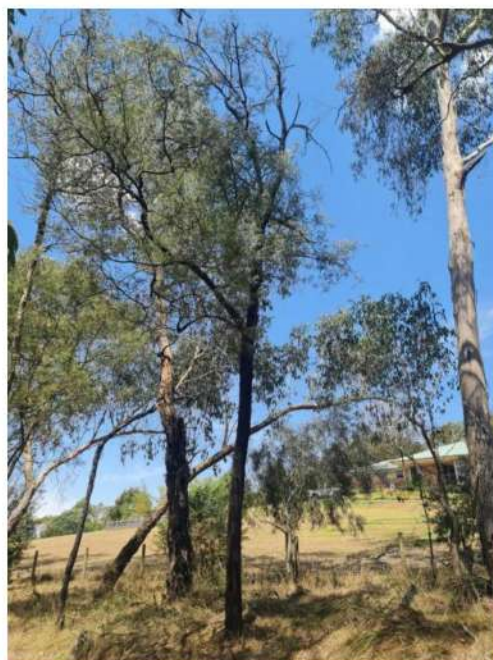
Tree ID: 69**Genus / species:** *Acacia dealbata*

Height (m): 15 **Structure:** Poor
Width (m): 8 **Health:** Very poor
DBH (cm): 29 Measured **Maturity:** Mature
Origin: Melbourne **ULE (years):** 5 - 15
Retained?: Retained **Form:** Fair
Retention Value: Low
Removal / retention reason: Adjoining property.
Amenity value: Moderate
Works Required: N/A.

SRZ (m): 2.1 **Works priority:** N/A
TPZ (m): 3.5 **Construction Impact:** None
mTPZ (m): = TPZ

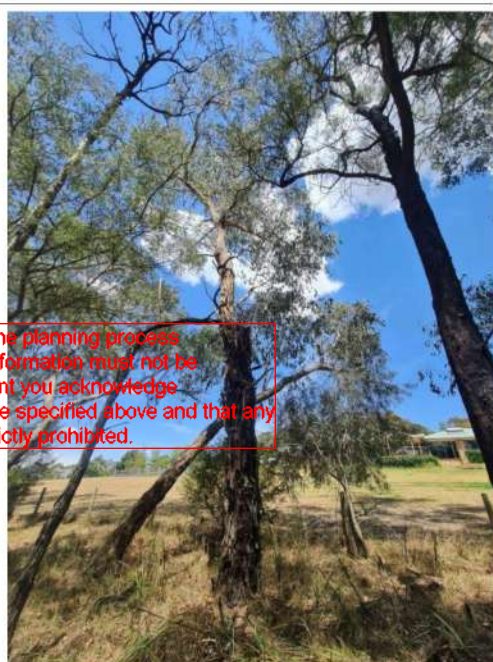
**Tree ID: 70****Genus / species:** *Eucalyptus ovata*

Works Required: N/A.

SRZ (m): 2.7 **Works priority:** N/A
TPZ (m): 6.8 **Construction Impact:** Low
mTPZ (m): = TPZ

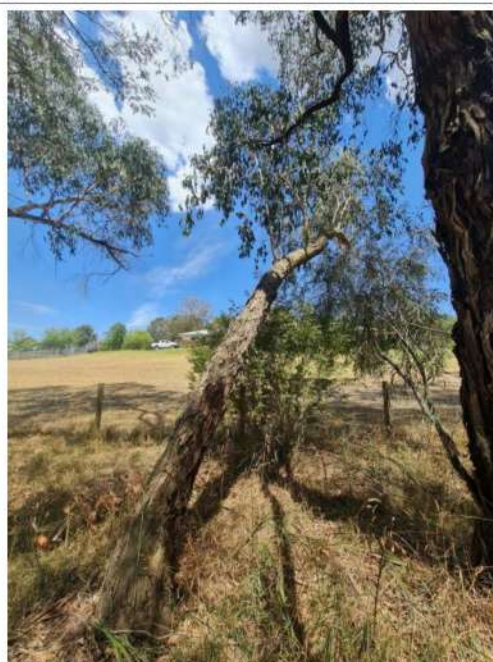
**Tree ID: 71****Genus / species:** *Eucalyptus ovata*

Height (m): 8 **Structure:** Fair
Width (m): 5 **Health:** Good
DBH (cm): 33 Measured **Maturity:** Mature
Origin: Melbourne **ULE (years):** 15 - 30
Retained?: Retained **Form:** Poor
Retention Value: Low
Removal / retention reason: Adjoining property.
Amenity value: Low
Works Required: N/A.

SRZ (m): 2.2 **Works priority:** N/A
TPZ (m): 4.0 **Construction Impact:** None
mTPZ (m): = TPZ

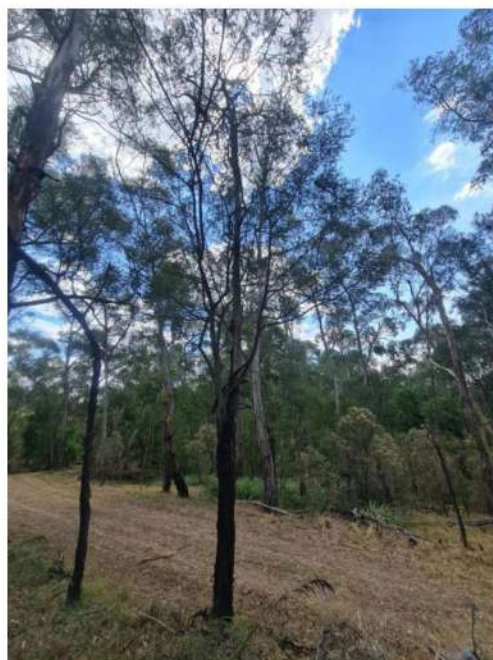
Tree ID: 72**Genus / species:** *Acacia dealbata*

Height (m): 8 **Structure:** Poor
Width (m): 5 **Health:** Poor
DBH (cm): 26 Measured **Maturity:** Over mature
Origin: Melbourne **ULE (years):** 5 - 15
Retained?: Retained **Form:** Good
Retention Value: Low
Removal / retention reason: Adjoining property.
Amenity value: Low
Works Required: N/A.

SRZ (m): 2 **Works priority:** N/A
TPZ (m): 3.1 **Construction Impact:** None
mTPZ (m): = TPZ

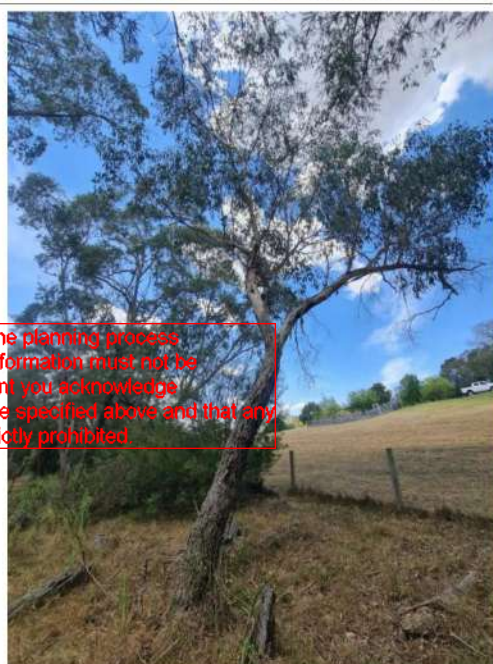
**Tree ID: 73****Genus / species:** *Eucalyptus ovata*

Works Required: N/A.

SRZ (m): 2.4 **Works priority:** N/A
TPZ (m): 4.8 **Construction Impact:** None
mTPZ (m): = TPZ

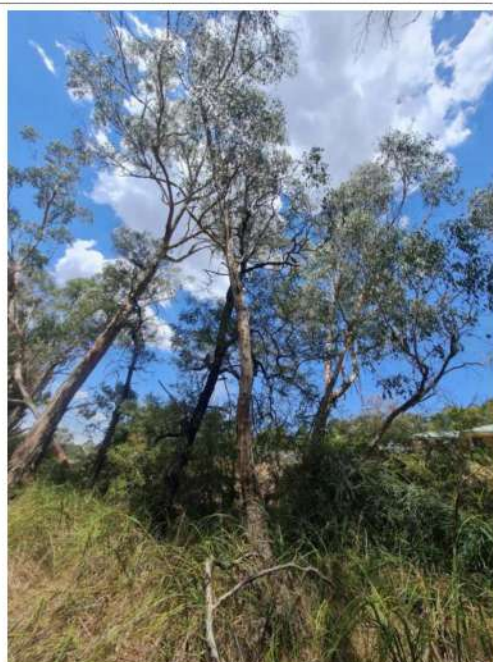
**Tree ID: 74****Genus / species:** *Eucalyptus ovata*

Works Required: N/A.

SRZ (m): 2 **Works priority:** N/A
TPZ (m): 3.2 **Construction Impact:** None
mTPZ (m): = TPZ

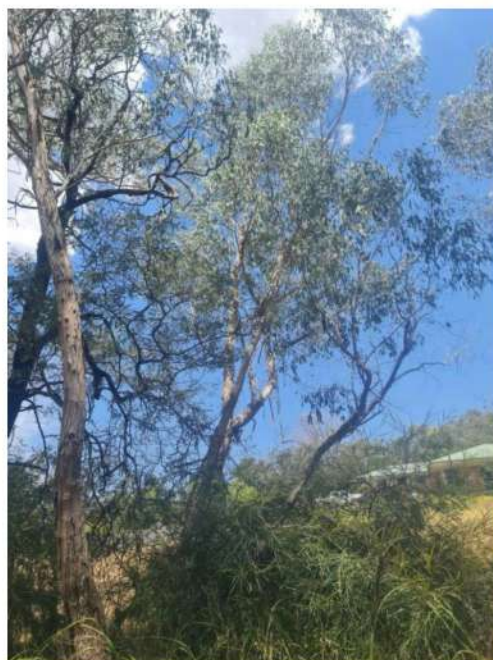
Tree ID: 75**Genus / species:** *Eucalyptus ovata*

Retention Value: Moderate**Removal / retention reason:** Adjoining property.**Amenity value:** Moderate**Works Required:** N/A.

SRZ (m): 2.3 **Works priority:** N/A
TPZ (m): 4.6 **Construction Impact:** None
mTPZ (m): = TPZ

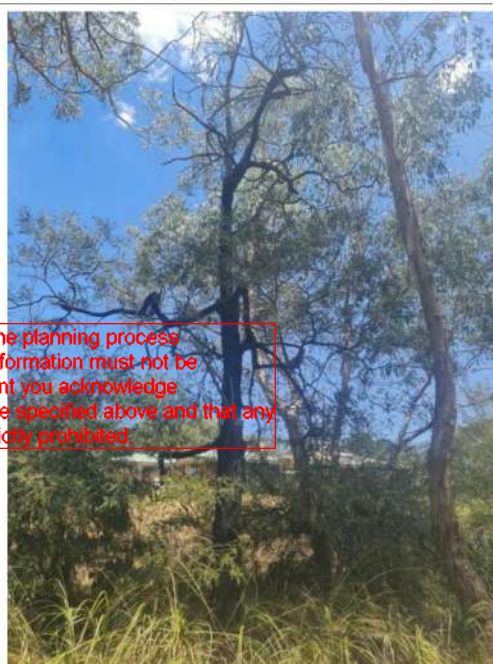
**Tree ID: 76****Genus / species:** *Acacia dealbata*

Works Required: N/A.

SRZ (m): 2.1 **Works priority:** N/A
TPZ (m): 3.7 **Construction Impact:** None
mTPZ (m): = TPZ

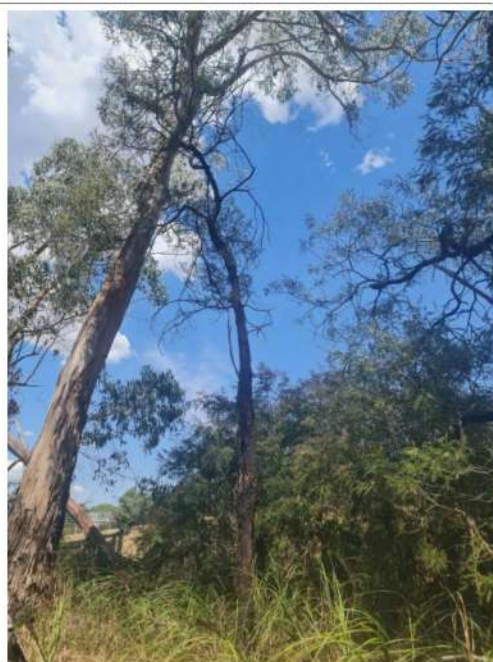
**Tree ID: 77****Genus / species:** *Acacia dealbata*

Retention Value: Very low**Removal / retention reason:** Adjoining property.**Amenity value:** Low**Works Required:** N/A.

SRZ (m): 1.9 **Works priority:** N/A
TPZ (m): 2.8 **Construction Impact:** None
mTPZ (m): = TPZ

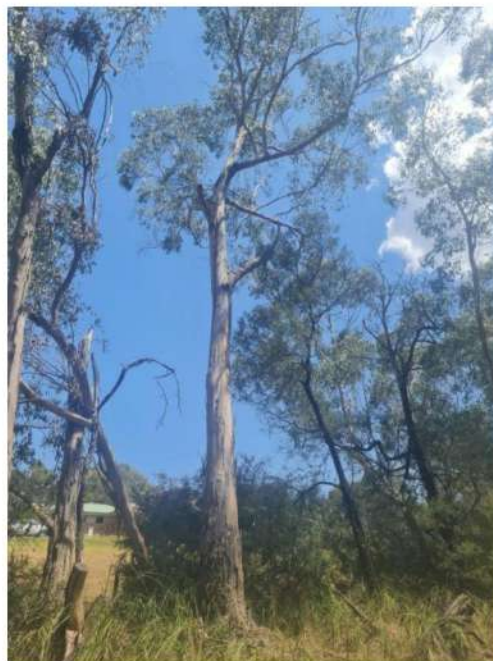
Tree ID: 78**Genus / species:** *Eucalyptus ovata*

Height (m): 25 **Structure:** Fair
Width (m): 16 **Health:** Fair
DBH (cm): 81 Measured **Maturity:** Mature
Origin: Melbourne **ULE (years):** 15 - 30
Retained?: Retained **Form:** Fair
Retention Value: High
Removal / retention reason: Adjoining property.
Amenity value: High
Works Required: N/A.

SRZ (m): 3.2 **Works priority:** N/A
TPZ (m): 9.7 **Construction Impact:** Low
mTPZ (m): = TPZ

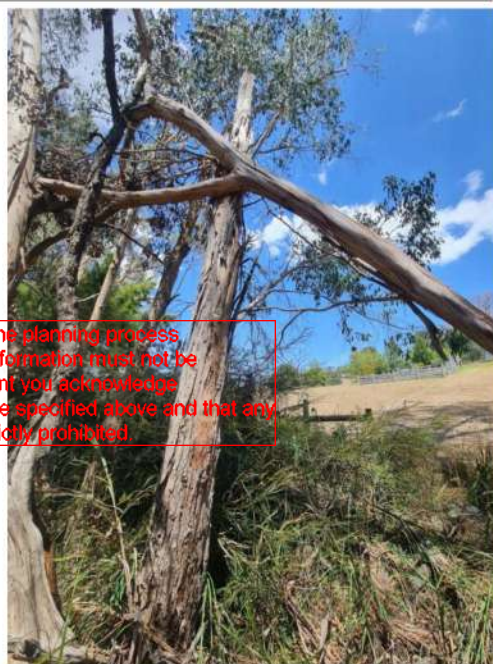
**Tree ID: 79****Genus / species:** *Eucalyptus ovata*

Works Required: N/A.

SRZ (m): 2.3 **Works priority:** N/A
TPZ (m): 4.7 **Construction Impact:** None
mTPZ (m): = TPZ

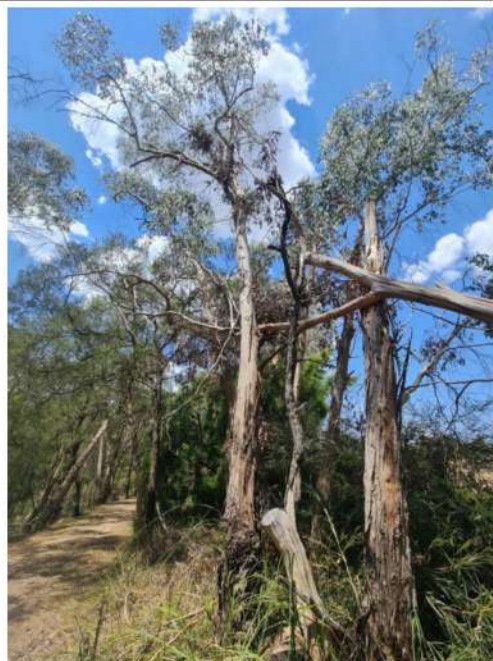
**Tree ID: 80****Genus / species:** *Eucalyptus ovata*

Height (m): 17 **Structure:** Fair
Width (m): 8 **Health:** Fair
DBH (cm): 41 Measured **Maturity:** Mature
Origin: Melbourne **ULE (years):** 15 - 30
Retained?: Retained **Form:** Fair
Retention Value: Moderate
Removal / retention reason: Adjoining property.
Amenity value: Moderate
Works Required: N/A.

SRZ (m): 2.4 **Works priority:** N/A
TPZ (m): 4.9 **Construction Impact:** None
mTPZ (m): = TPZ

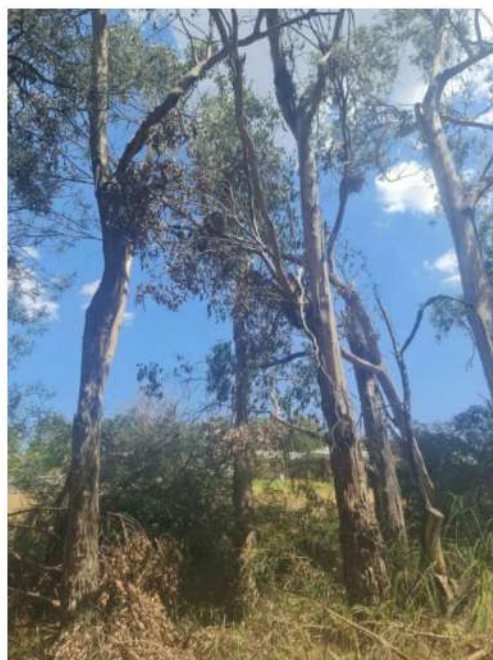
Tree ID: 81**Genus / species:** *Eucalyptus ovata*

Height (m): 12 **Structure:** Good**Width (m):** 6 **Health:** Good**DBH (cm):** 29 Measured **Maturity:** Mature**Origin:** Melbourne **ULE (years):** 30 - 60**Retained?:** Retained **Form:** Fair**Retention Value:** Moderate**Removal / retention reason:** Adjoining property.**Amenity value:** Moderate**Works Required:** N/A.**SRZ (m):** 2.1 **Works priority:** N/A**TPZ (m):** 3.5 **Construction Impact:** None**mTPZ (m):** = TPZ

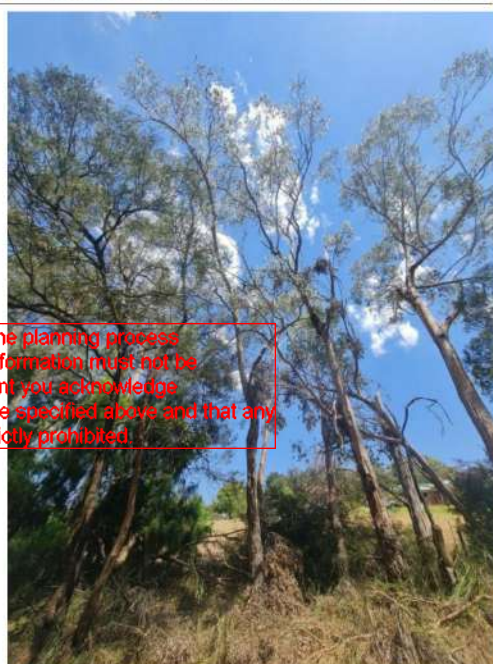
**Tree ID: 82****Genus / species:** *Eucalyptus ovata*

Amenity value: Moderate

Works Required: N/A.**SRZ (m):** 2.1 **Works priority:** N/A**TPZ (m):** 3.6 **Construction Impact:** None**mTPZ (m):** = TPZ

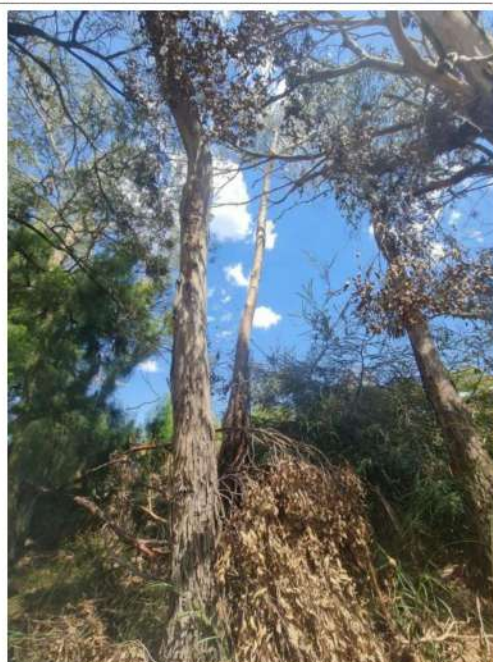
**Tree ID: 83****Genus / species:** *Eucalyptus ovata*

Height (m): 12 **Structure:** Fair**Width (m):** 5 **Health:** Fair**DBH (cm):** 33 Measured **Maturity:** Mature**Origin:** Melbourne **ULE (years):** 15 - 30**Retained?:** Retained **Form:** Fair**Retention Value:** Moderate**Removal / retention reason:** Adjoining property.**Amenity value:** Moderate**Works Required:** N/A.**SRZ (m):** 2.2 **Works priority:** N/A**TPZ (m):** 4.0 **Construction Impact:** None**mTPZ (m):** = TPZ

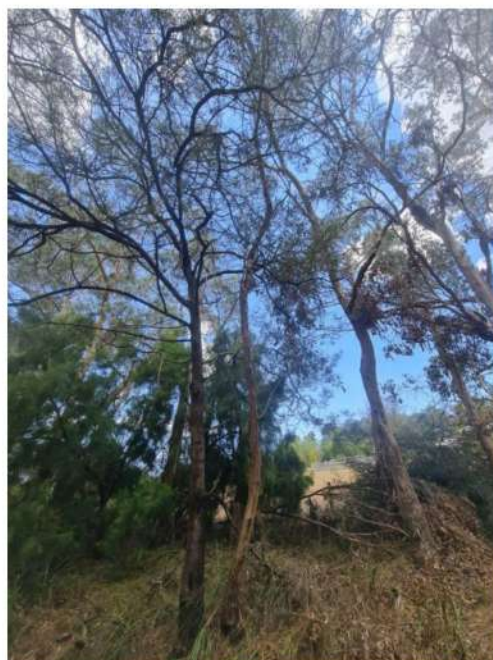
Tree ID: 84**Genus / species:** *Eucalyptus ovata*

Retention Value: Low**Removal / retention reason:** Adjoining property.**Amenity value:** Low**Works Required:** N/A.

SRZ (m): 1.6 **Works priority:** N/A
TPZ (m): 2.0 **Construction Impact:** None
mTPZ (m): = TPZ

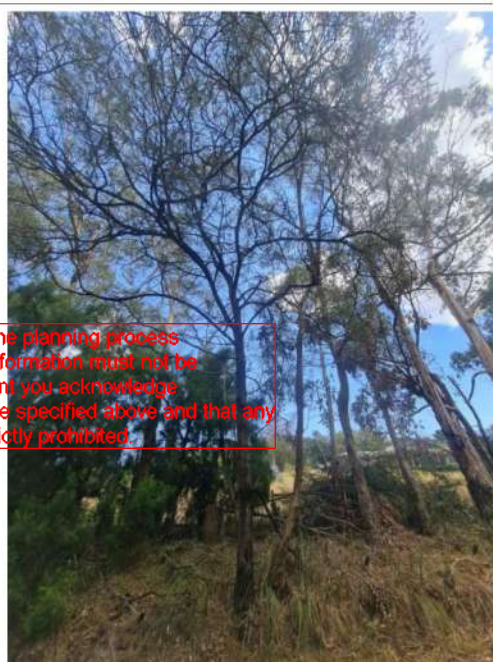
**Tree ID: 85****Genus / species:** *Acacia dealbata*

Works Required: N/A.

SRZ (m): 2 **Works priority:** N/A
TPZ (m): 3.2 **Construction Impact:** None
mTPZ (m): = TPZ

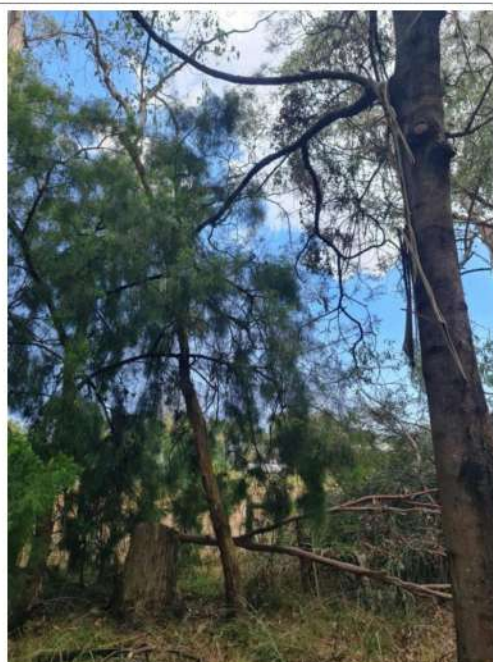
**Tree ID: 86****Genus / species:** *Eucalyptus ovata*

Retention Value: Moderate**Removal / retention reason:** Adjoining property.**Amenity value:** Moderate**Works Required:** N/A.

SRZ (m): 1.7 **Works priority:** N/A
TPZ (m): 2.0 **Construction Impact:** None
mTPZ (m): = TPZ

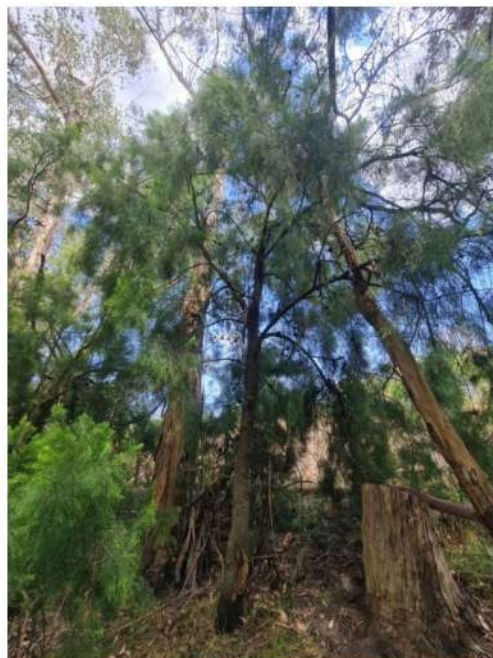
Tree ID: 87**Genus / species:** *Callitris sp.*

Retention Value: Low**Removal / retention reason:** Adjoining property.**Amenity value:** Low**Works Required:** N/A.

SRZ (m): 1.6 **Works priority:** N/A
TPZ (m): 2.0 **Construction Impact:** None
mTPZ (m): = TPZ

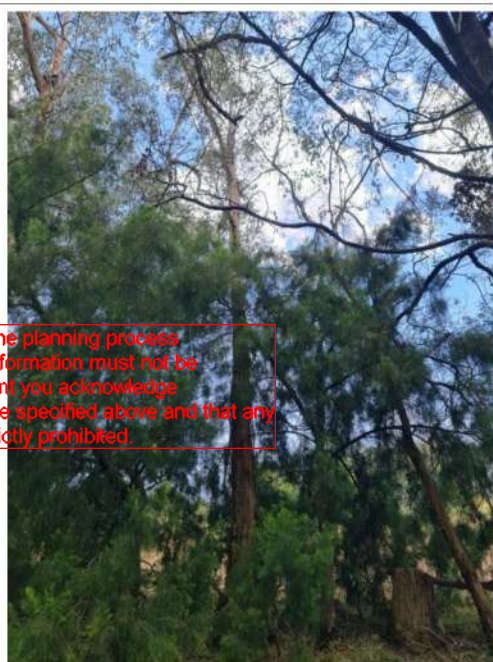
**Tree ID: 88****Genus / species:** *Eucalyptus ovata*

Works Required: N/A.

SRZ (m): 2.5 **Works priority:** N/A
TPZ (m): 5.4 **Construction Impact:** None
mTPZ (m): = TPZ

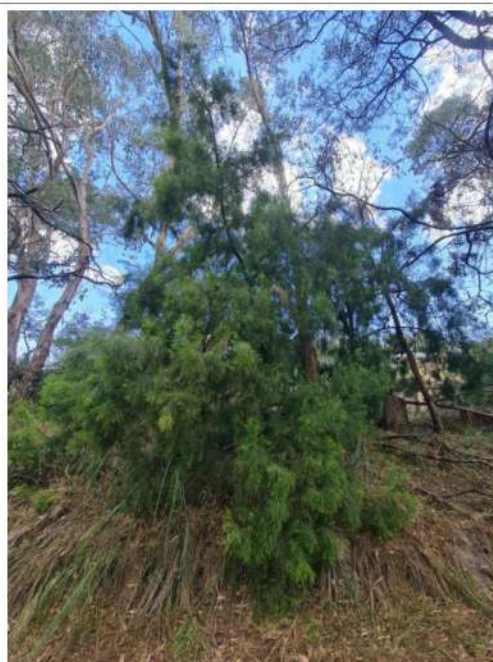
**Tree ID: 89****Genus / species:** *Callitris sp.*

Retention Value: Low**Removal / retention reason:** Adjoining property.**Amenity value:** Low**Works Required:** N/A.

SRZ (m): 1.7 **Works priority:** N/A
TPZ (m): 2.2 **Construction Impact:** None
mTPZ (m): = TPZ

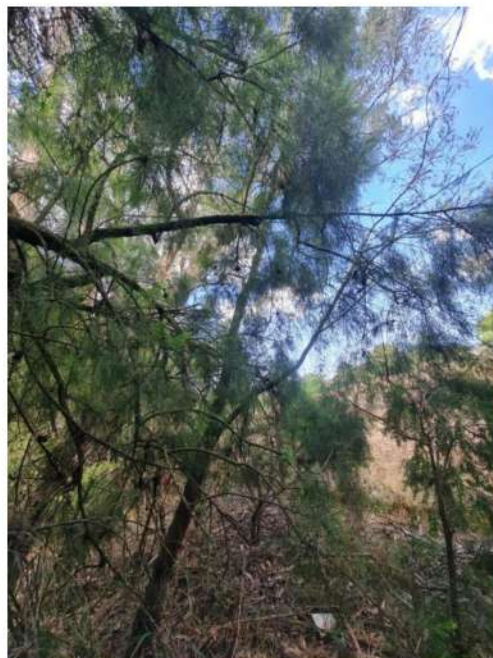
Tree ID: 90**Genus / species:** *Acacia dealbata*

Height (m): 7 **Structure:** Good**Width (m):** 6 **Health:** Fair**DBH (cm):** 15 Measured **Maturity:** Mature**Origin:** Melbourne **ULE (years):** 15 - 30**Retained?:** Retained **Form:** Poor**Retention Value:** Low**Removal / retention reason:** Adjoining property.**Amenity value:** Low**Works Required:** N/A.**SRZ (m):** 1.6 **Works priority:** N/A**TPZ (m):** 2.0 **Construction Impact:** None**mTPZ (m):** = TPZ

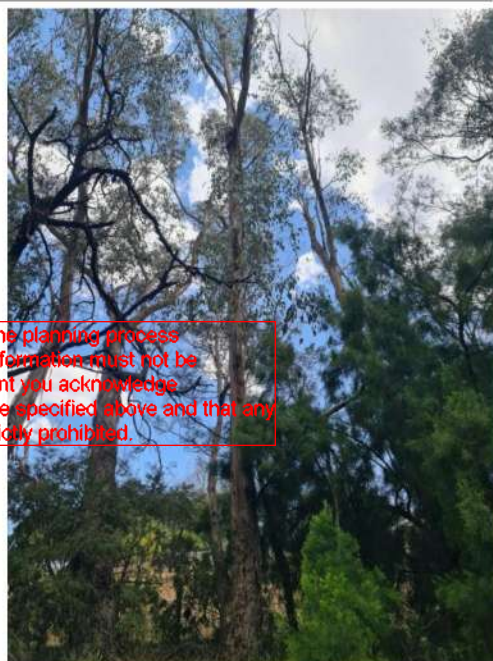
**Tree ID: 91****Genus / species:** *Eucalyptus ovata*

Amenity value: Moderate

Works Required: N/A.**SRZ (m):** 2.4 **Works priority:** N/A**TPZ (m):** 5.2 **Construction Impact:** None**mTPZ (m):** = TPZ

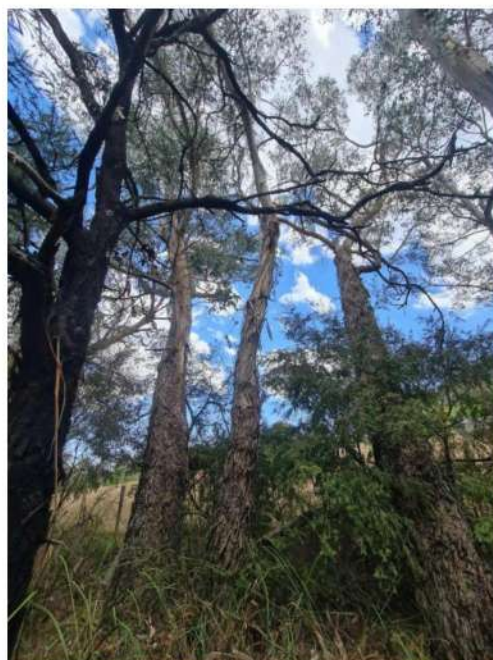
Height (m): 12 **Structure:** Good
Width (m): 8 **Health:** Fair
DBH (cm): 36 Measured **Maturity:** Mature
Origin: Melbourne **ULE (years):** 15 - 30
Retained?: Retained **Form:** Fair
Retention Value: Moderate
Removal / retention reason: Adjoining property.
Amenity value: Moderate
Works Required: N/A.

SRZ (m): 2.3 **Works priority:** N/A
TPZ (m): 4.3 **Construction Impact:** None
mTPZ (m): = TPZ

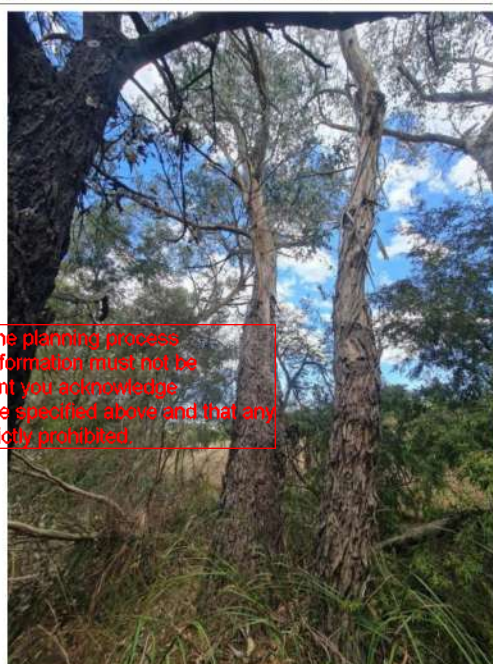
Works Required: N/A.

SRZ (m): 2.9 **Works priority:** N/A
TPZ (m): 7.8 **Construction Impact:** None
mTPZ (m): = TPZ

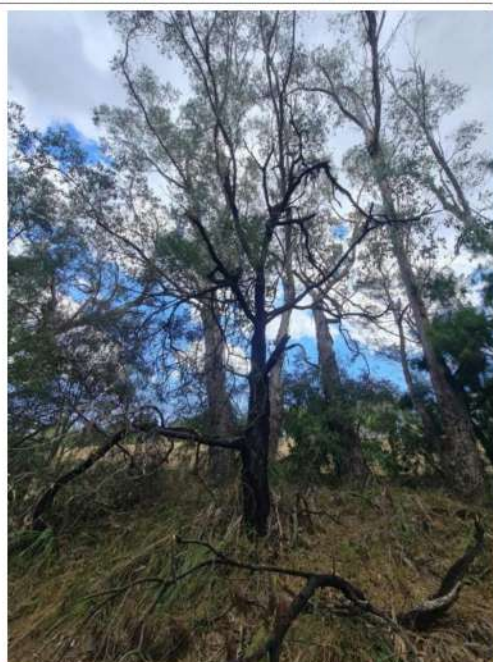
Tree ID: 95**Genus / species:** *Acacia dealbata*

Height (m): 9 **Structure:** Poor
Width (m): 6 **Health:** Very poor
DBH (cm): 35 Measured **Maturity:** Over mature
Origin: Melbourne **ULE (years):** 1 - 5
Retained?: Retained **Form:** Poor
Retention Value: Very low
Removal / retention reason: Adjoining property.
Amenity value: Low
Works Required: N/A.

SRZ (m): 2.2 **Works priority:** N/A
TPZ (m): 4.2 **Construction Impact:** None
mTPZ (m): = TPZ

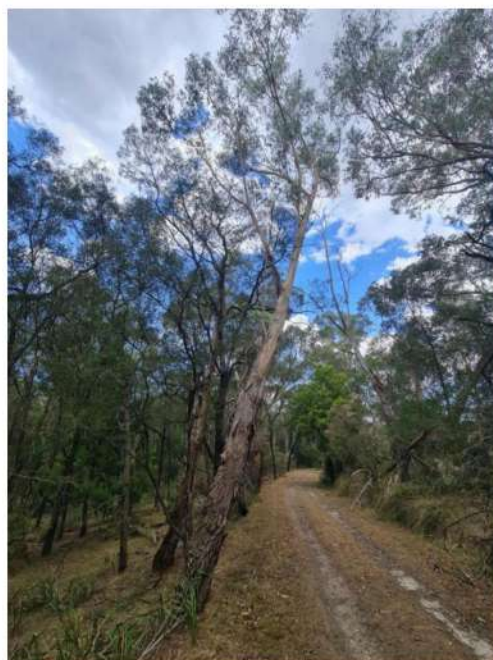
Tree ID: 96**Genus / species:** *Eucalyptus ovata*

Height (m): 18 **Structure:** Good**Width (m):** 10 **Health:** Fair**DBH (cm):** 46 Measured **Maturity:** Mature**Origin:** Melbourne **ULE (years):** 30 - 60**Retained?:** Retained **Form:** Poor**Retention Value:** High**Removal / retention reason:** Adjoining property.**Amenity value:** High**Works Required:** N/A.**SRZ (m):** 2.5 **Works priority:** N/A**TPZ (m):** 5.5 **Construction Impact:** None**mTPZ (m):** = TPZ

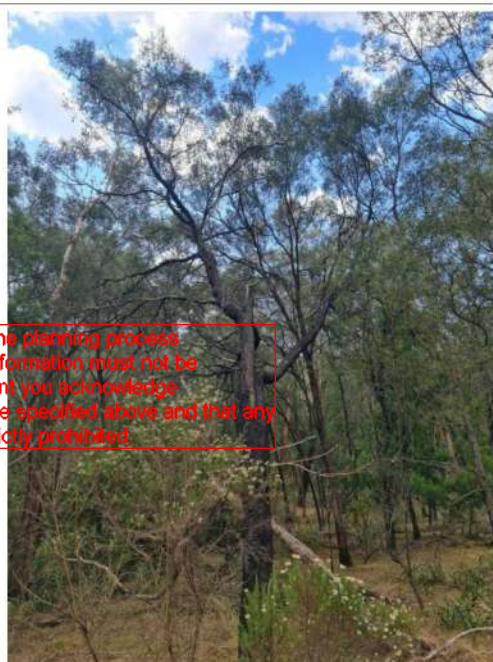
**Tree ID: 97****Genus / species:** *Acacia dealbata*

Retention Value: Moderate
Removal / retention reason: Adjoining property
Amenity value: Moderate

Works Required: N/A.**SRZ (m):** 2.1 **Works priority:** N/A**TPZ (m):** 3.6 **Construction Impact:** None**mTPZ (m):** = TPZ

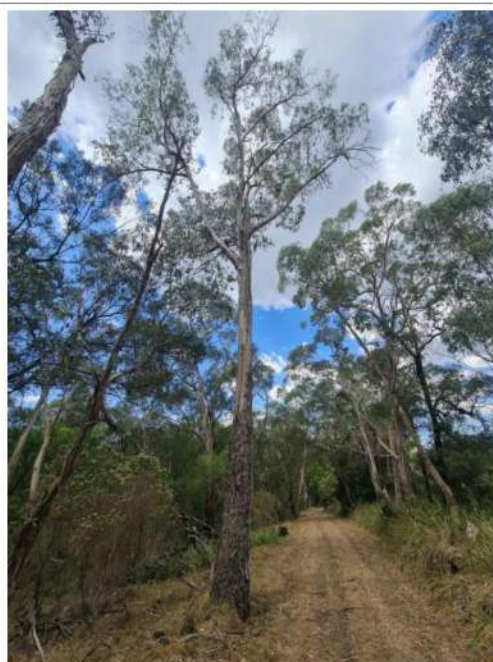
**Tree ID: 98****Genus / species:** *Eucalyptus ovata*

Height (m): 24 **Structure:** Fair**Width (m):** 12 **Health:** Fair**DBH (cm):** 59 Measured **Maturity:** Mature**Origin:** Melbourne **ULE (years):** 15 - 30**Retained?:** Retained **Form:** Good**Retention Value:** High**Removal / retention reason:** Adjoining property.**Amenity value:** High**Works Required:** N/A.**SRZ (m):** 2.8 **Works priority:** N/A**TPZ (m):** 7.1 **Construction Impact:** None**mTPZ (m):** = TPZ

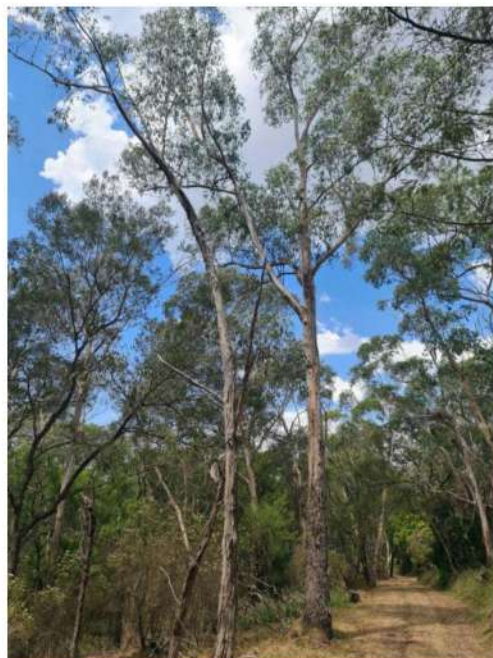
Tree ID: 99**Genus / species:** *Eucalyptus ovata*

Height (m): 14 **Structure:** Fair
Width (m): 5 **Health:** Fair
DBH (cm): 28 Measured **Maturity:** Mature
Origin: Melbourne **ULE (years):** 15 - 30
Retained?: Retained **Form:** Poor
Retention Value: Moderate
Removal / retention reason: Adjoining property.
Amenity value: Moderate
Works Required: N/A.

SRZ (m): 2 **Works priority:** N/A
TPZ (m): 3.4 **Construction Impact:** None
mTPZ (m): = TPZ

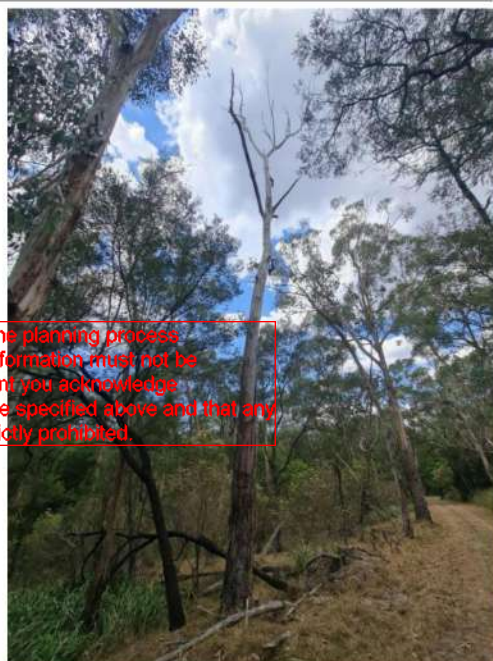
**Tree ID: 100****Genus / species:** *Eucalyptus* sp.

Works Required: N/A.

SRZ (m): 2.6 **Works priority:** N/A
TPZ (m): 6.0 **Construction Impact:** None
mTPZ (m): = TPZ

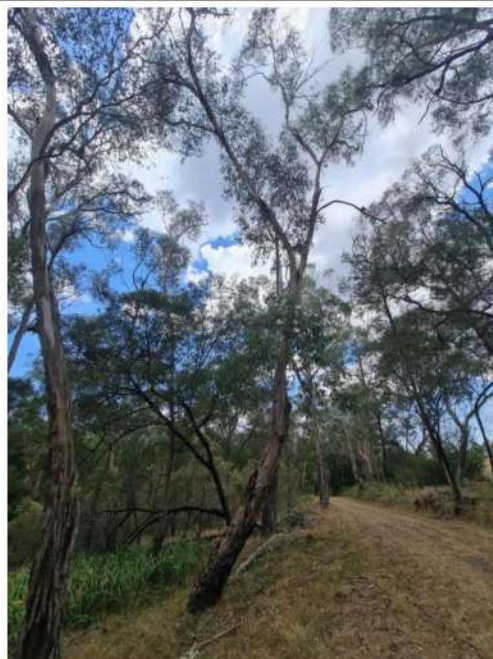
**Tree ID: 101****Genus / species:** *Eucalyptus ovata*

Height (m): 20 **Structure:** Fair
Width (m): 8 **Health:** Fair
DBH (cm): 45 Measured **Maturity:** Mature
Origin: Melbourne **ULE (years):** 15 - 30
Retained?: Retained **Form:** Fair
Retention Value: High
Removal / retention reason: Adjoining property.
Amenity value: High
Works Required: N/A.

SRZ (m): 2.5 **Works priority:** N/A
TPZ (m): 5.4 **Construction Impact:** None
mTPZ (m): = TPZ

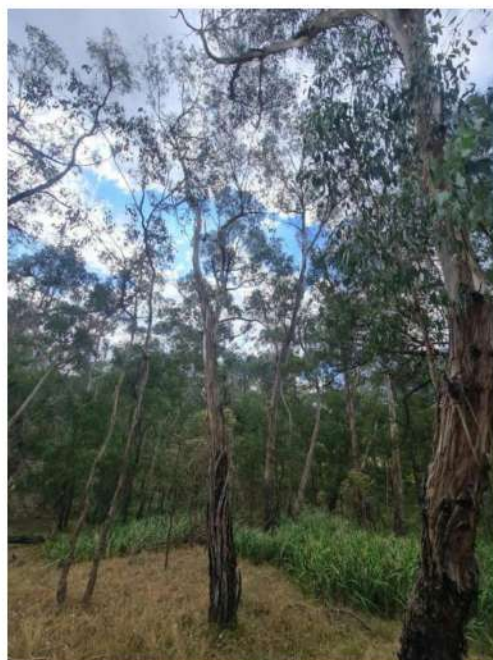
Tree ID: 102**Genus / species:** *Eucalyptus ovata*

Height (m): 21 **Structure:** Good**Width (m):** 12 **Health:** Fair**DBH (cm):** 41 Measured **Maturity:** Mature**Origin:** Melbourne **ULE (years):** 15 - 30**Retained?:** Retained **Form:** Fair**Retention Value:** High**Removal / retention reason:** Adjoining property.**Amenity value:** High**Works Required:** N/A.**SRZ (m):** 2.4 **Works priority:** N/A**TPZ (m):** 4.9 **Construction Impact:** None**mTPZ (m):** = TPZ

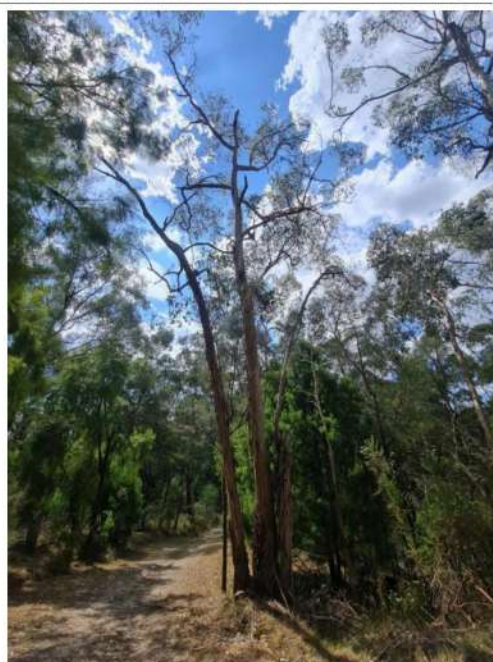
Height (m): 23 **Structure:** Fair**Width (m):** 12 **Health:** Poor**DBH (cm):** 63 Measured **Maturity:** Mature**Origin:** Melbourne **ULE (years):** 15 - 30**Retained?:** Retained **Form:** Fair**Retention Value:** High**Removal / retention reason:** Adjoining property.**Amenity value:** High**Works Required:** N/A.**SRZ (m):** 2.8 **Works priority:** N/A**TPZ (m):** 7.6 **Construction Impact:** None**mTPZ (m):** = TPZ
